AIRPROX REPORT No 2014166Date/Time: 29 Aug 2014 1254ZPosition: 5142N 00108W
(1nm E Oxford)Airspace: Oxford AIAA (Class: G)Aircraft 1 Aircraft 2Type: Tutor Rockwell 695
Jet prop 1000Operator: HQ Air (Trg) Civ ExecAlt/FL: 4000ft FL45
NKConditions: VMC VMCVisibility: 10km 10kmReported Separation:

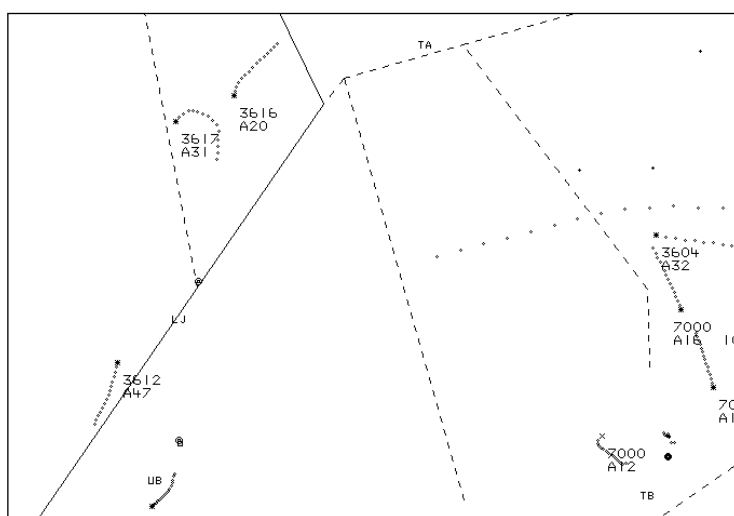
At 1246:11 the Tutor was informed of two sets of traffic on non-Airprox traffic and approved to manoeuvre in the block between 3000 and 6000ft. At 1249:47 and at 1249:58 (Figure 1), the Tutor was informed of two further tracks, “[Tutor c/s] traffic north five miles tracking currently west indicating one thousand seven hundred feet below” and “[Tutor c/s] further traffic err inbound on radar north east five miles tracking south indicating two thousand seven hundred feet below.” The Rockwell 695 was tracking towards Benson from the east.

Figure 1: Tutor Traffic Information at 1249:58 (Tutor 3612; Rockwell 695 3604; 3616/3617 Benson non-Airprox traffic).

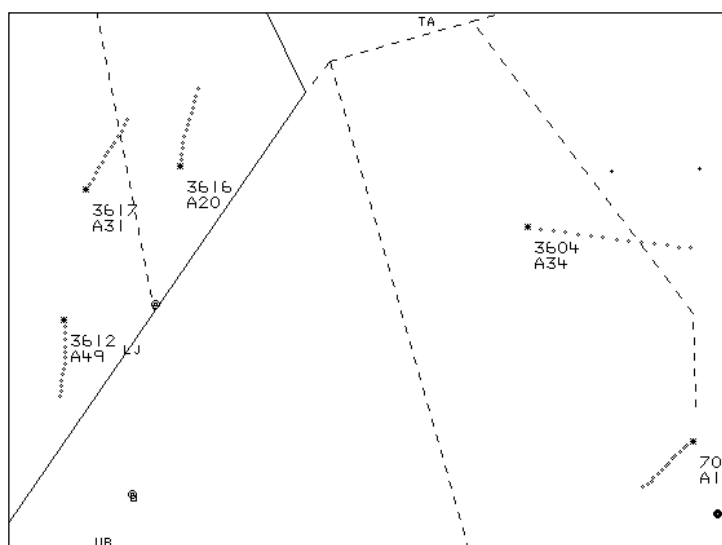
At 1250:56 (Figure 2), Zone called non-Airprox traffic to the Rockwell 695, “[Rockwell 695 c/s] traffic twelve o'clock five miles crossing right left one thousand two hundred feet below inbound on radar at Benson.” The Rockwell 695 confirmed ‘traffic in sight’.

Figure 2: Traffic Information at 1250:56.

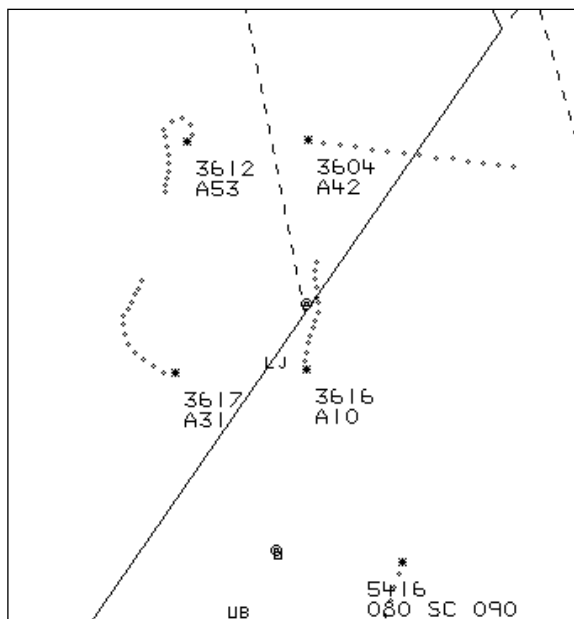
The Rockwell 695 confirmed a further climb to FL65 at 1253:01 (Figure 3).

Figure 3: Geometry at 1253:01 as Rockwell 695 informs Zone of climb to FL65.

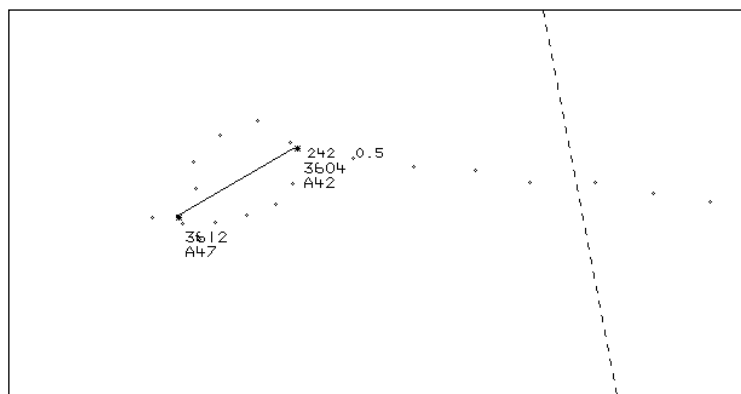
At 1253:28 (Figure 4), Zone passed information as, “[Rockwell 695 c/s] traffic south west one mile tracking north east visual with you indicating slightly below.” The Rockwell 695 replied with “looking” at 1253:33.

Figure 4: Traffic Information at 1253:28.

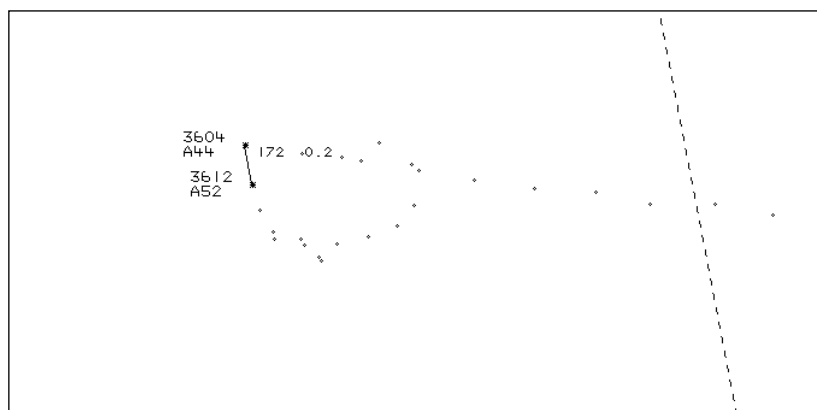
The CPA was at 1253:39 (Figure 5) with 800ft vertical separation and 0.2nm horizontal separation.

Figure 5: CPA at 1253:39.
