AIRPROX REPORT No 2014196Date/Time: 3 Oct 2014 1213ZPosition: 5155N 00230W
(3nm E of Ross-on-Wye)Airspace: London FIR (Class: G)Aircraft 1 Aircraft 2Type: PA28 Beech 76Operator: Civ Trg Civ CommAlt/FL: 2000ft 2100ft
QNH (1021hPa) QNH (1021hPa)Conditions: VMC VMCVisibility: 30km >10kmReported Separation:

**PART A: SUMMARY OF INFORMATION REPORTED TO UKAB**

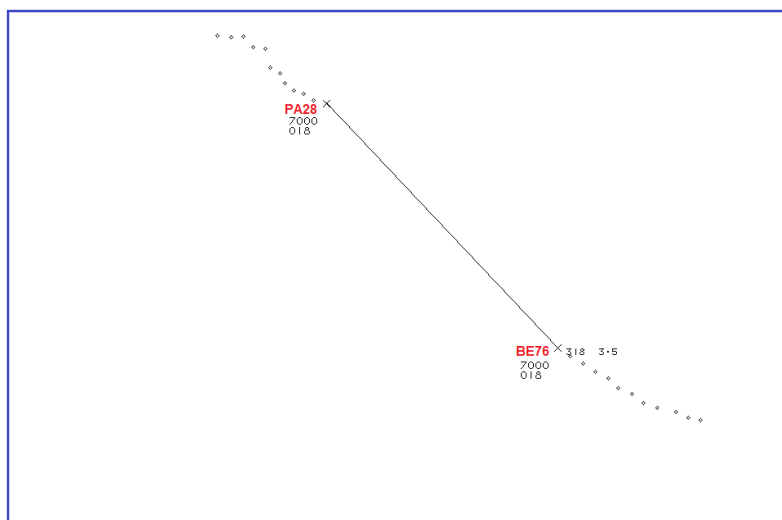
Figure 1 – Swanwick MRT at 1212:40

At 1212:40 radar showed the two aircraft at the same level FL018, which converts to an altitude of 2000ft (2016ft on the Gloucester QNH 1021hPa with 1hPa equal to 27ft). The horizontal distance between the two aircraft was 3.5nm – Figure 1.

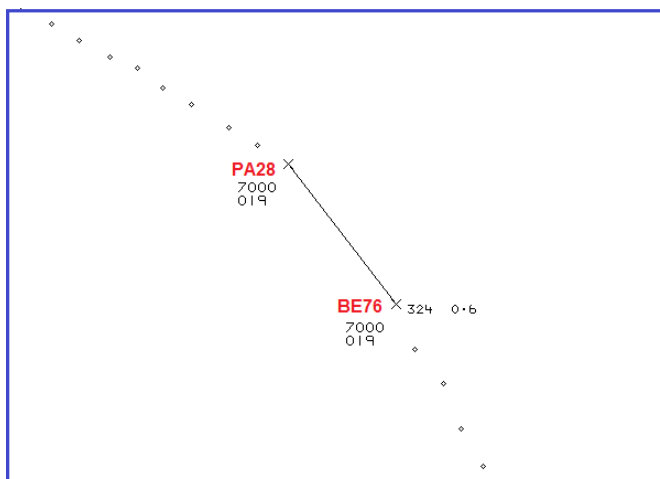
Figure 2 – Swanwick MRT at 1213:23

At 1213:23 the distance between the two aircraft was 0.6nm, with both aircraft indicating FL019 (2100ft) – Figure 2.

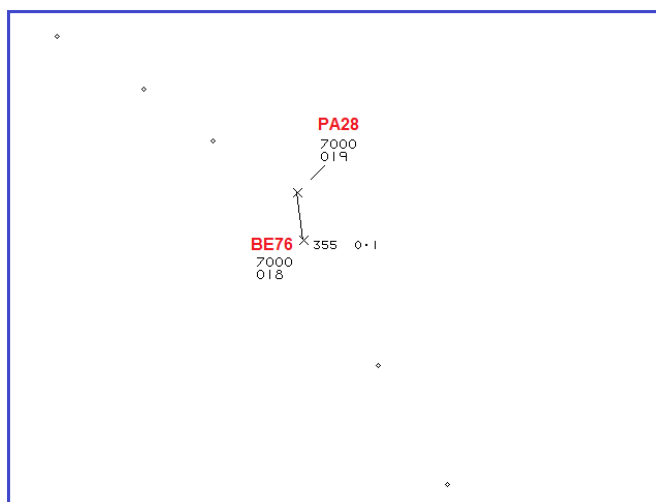
Figure 3 – Swanwick MRT at 1213:31

At 1213:31 the BE76 was indicating 100ft below the PA28 at a range of 0.1nm – Figure 3.

The CPA was estimated to have occurred at 1213:28 at a horizontal distance of less than 0.1nm and vertical distance of 100ft. The next radar update at 1213:35 showed the two aircraft had passed and were diverging – Figure 4.
