AIRPROX REPORT No 2014217

Date/Time: 11 Nov 2014 1633Z (Twilight)¹

Position: 5136N 00001W
(RAF Benson – elevation 203ft)

Reporter: RAF Benson Aerodrome Controller

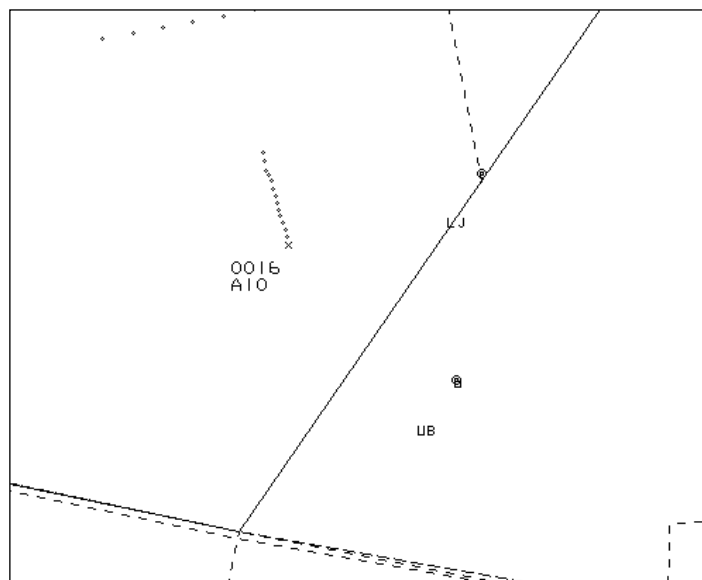
At 1631:45 (Figure 1), the Merlin pilot reported switching to Approach and the Tower controller queried the departure. The Merlin pilot replied at 1631:51 with, "[Merlin C/S] *apologies, slight change of plan, we are looking to depart out to the west for approximately ten minutes for {unreadable}.*"

Figure 1: Merlin reports switching to Approach at 1631:45 (Helimed squawk 0016)

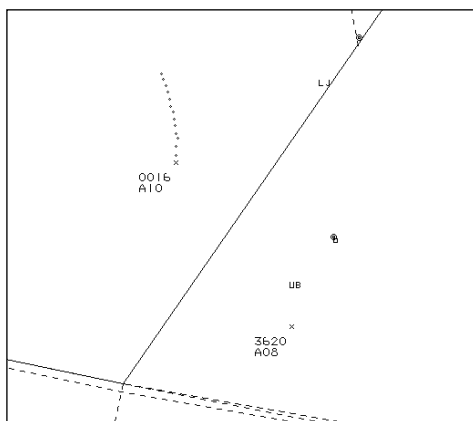
At 1632:10, Tower advised, "[Merlin C/S] *Helimed aircraft north, north-west, four miles, tracking south west, three hundred feet above.*" The Merlin pilot replied with '*looking*'; the Merlin appeared on radar replay at 1632:18 (Figure 2).

Figure 2: Merlin looking for traffic and appeared on radar replay at 1632:18

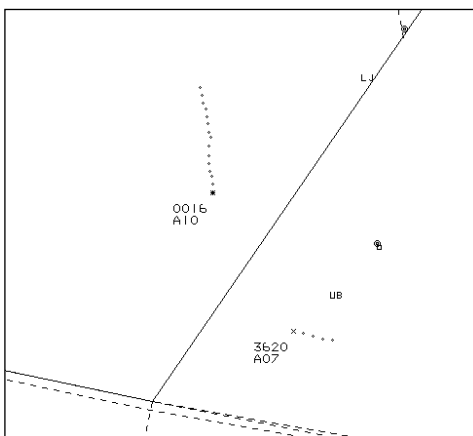
At 1632:21, Approach passed Traffic Information, “[Helimed C/S] traffic south three miles tracking west, indicating three hundred feet below, believed to be the heli...it’s believed to be a Merlin.” At 1632:30 (Figure 3), the Helimed pilot called visual.

Figure 3: Helimed calls visual at 1632:30

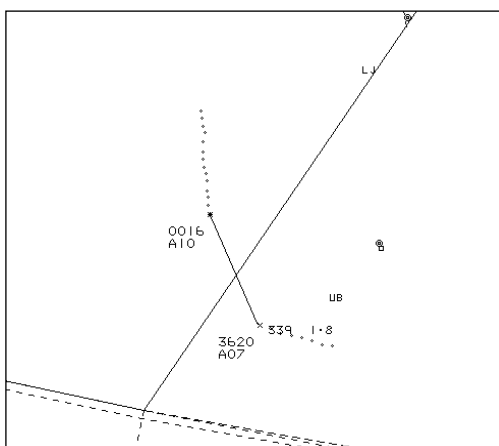
At 1632:46 (Figure 4), the Merlin pilot called Approach for a Basic Service. At this point, the Merlin faded from radar coverage with 1.8nm horizontal separation from the EC135. The Basic Service was applied at 1632:57.

Figure 4: Merlin requested a Basic Service at 1632:46
