AIRPROX REPORT No 2014222

Date/Time: 26 Nov 2014 1505Z

Position: 5742N 00320W
(Lossiemouth)

Airspace: Lossiemouth ATZ (Class: G)

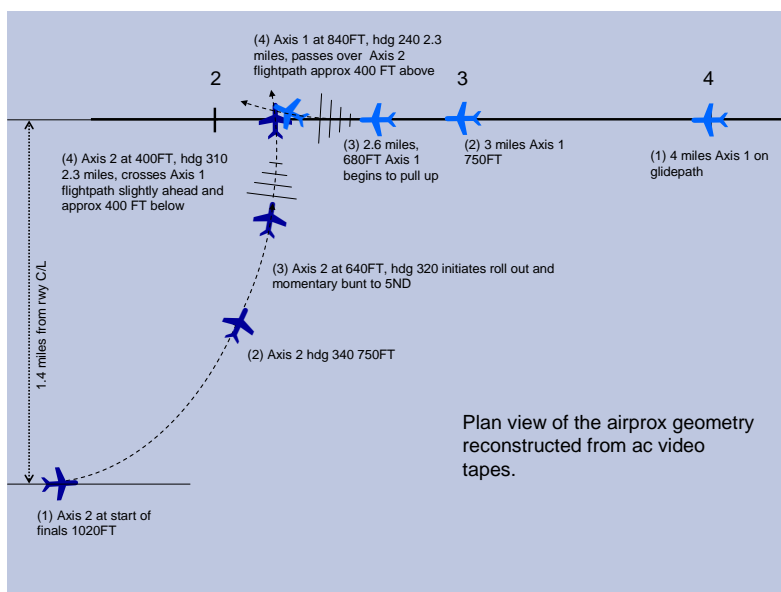
Figure 1: Unit reconstruction of the incident.

Due to the heights and geography involved, a radar replay could not be traced; however, the unit involved produced a reconstruction of the incident as per Figure 1.

confliction and had been maintaining an effective lookout, as well as conducting their respective approaches. Both crews and Talkdown were uncomfortable with the geometry and, ultimately, avoiding action from Axis 2 provided approximately 400ft height separation (Figure 1).
