AIRPROX REPORT No 2013040

Date/Time: 19 May 2013 1438Z (Sunday)

Position: 5154N 00210W
(Gloucestershire A/D)

Airspace: Gloucestershire ATZ (Class: G)

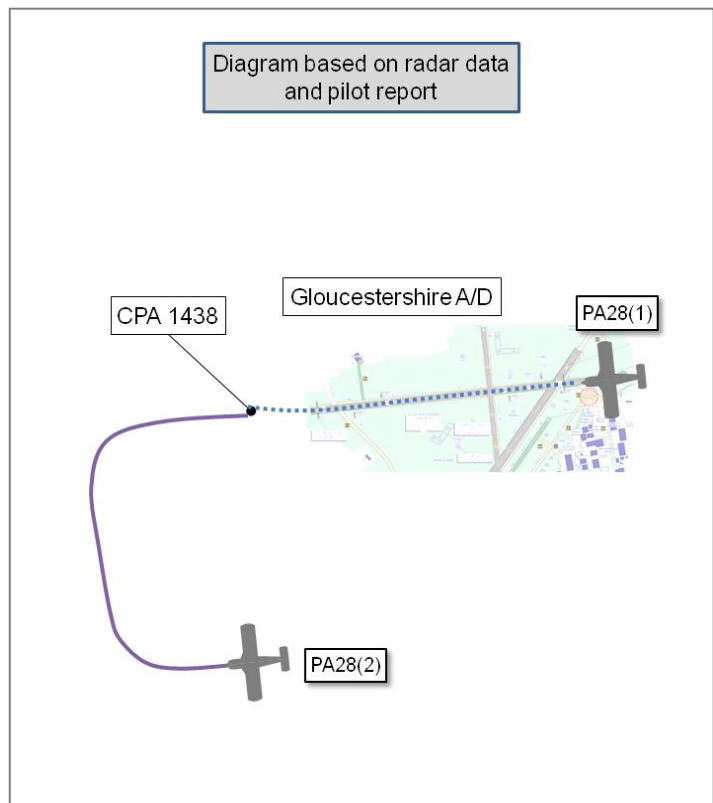
ATSI reports the Airprox occurred at 1438:28, 0.5nm to the SW of Gloucestershire A/D, within the Class G airspace of the Gloucestershire (Gloster) ATZ, between PA28(1) and PA28(2).

At 1436:28, the PA28(2) was shown on radar downwind RH for Gloster RW09. As the PA28(1) was rolling the PA28(2) was shown turning onto R base for RW09, 1.4nm SW of Gloster. At 1438:00 the PA28(2) was shown on short final for RW09.

The PA28(1) did not appear on radar until 1438:42, after the Airprox has occurred, after the PA28(1) pilot made a R turn and tracked W. By using the radar recording and projected flight path history, it was estimated that the Airprox occurred at 1438:28, shortly after the PA28(1) pilot became airborne. The PA28(2) was estimated to have passed less than 0.1nm to the S of the PA28(1), on a 0.5nm final for RW09. The PA28(1) pilot's written report estimated that the PA28(2) was to his L and below and estimated the horizontal distance between the two aircraft as 100m at the CPA.
