AIRPROX REPORT No 2013051

Date/Time: 16 Jun 2013 1258Z (Sunday)

Position: 5131N 00014E
(1.7nm NE of Damyns Hall A/D
- elevation 56ft)

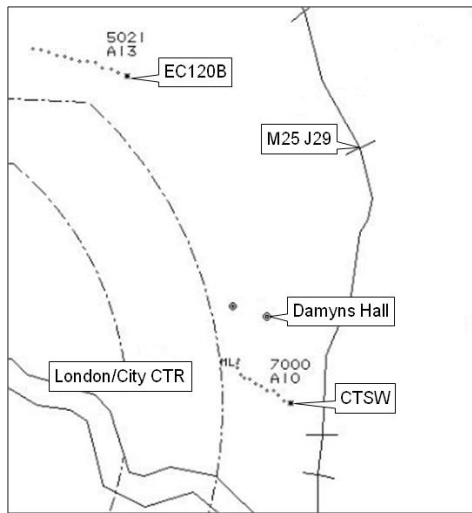
Figure 1: MRT 1255:59.

CAA ATSI had access to the written report of both pilots, recorded area surveillance³ and recording of the Farnborough LARS (East) frequency 123.225MHz. The Airprox was not observed by or reported to Farnborough ATC. The EC120B contacted Farnborough LARS (East), from LARS (North), at 1255:40 UTC. Squawk 5021 was assigned, London QNH 1014hPa passed and a BS agreed. EC120B is 4.4nm NNW of Damyns Hall at 1300ft, CTSW is about to turn downwind RW21 at 1000ft (see Figure 1). No further transmissions were made between the EC120B and LARS (East) until 1301:00.

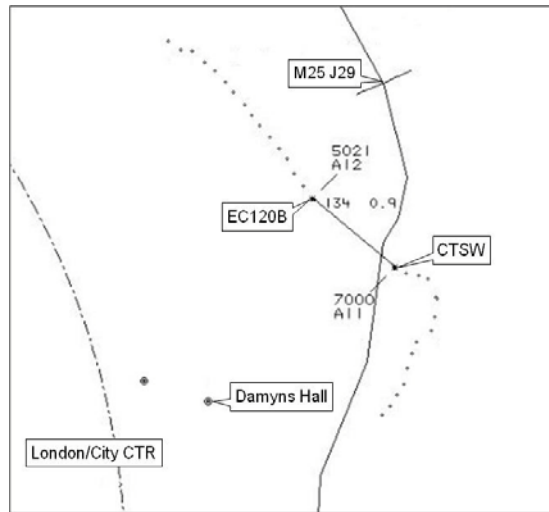
Figure 2: MRT 1258:07

When the EC120B was 1.9nm NE of Damyns Hall⁴, the CTSW had turned base leg at 1100ft and the EC120B was on a south-easterly track at 1200ft. The aircraft were 0.9nm apart on converging tracks. See Figure 2.

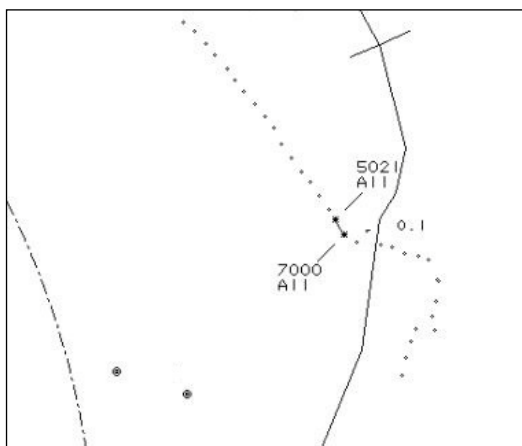
Figure 3: MRT 1258:22

The tracks of the two ac then crossed (1.7nm NE of Damyns Hall) between 1258:22 and 1258:26 as both ac were at 1100ft, 0.1nm apart. See Figures 3 and 4.
