## **AIRPROX REPORT No 2013054**

Date/Time: 23 Jun 2013 1255Z (Sunday)

Position: 5642N 00433W  
(N FINDO)

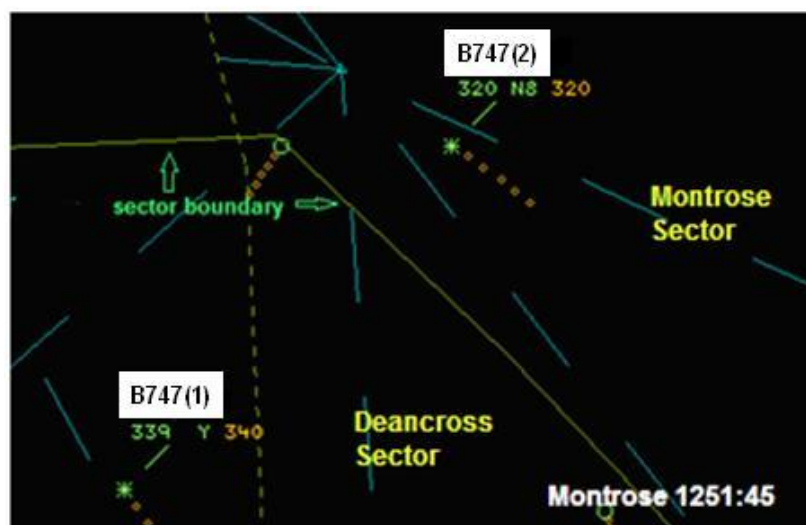
Figure 1.

At 1250:40, the B747(2) pilot requested climb from FL320 to FL340 from ATCO(1). The controller replied standby and that he would call him back. The controller reported being aware that he was unable to give the B747(2) pilot a climb at that time due to other traffic and instead dealt with other issues. ATCO(1) then co-ordinated climb for the B747(2) to FL340 with the next sector and at 1251:45 ATCO(1) instructed the B747(2) pilot to climb to FL340. The B747(1) had 20.1nm to run to the Montrose sector boundary (see Figure 1 below).

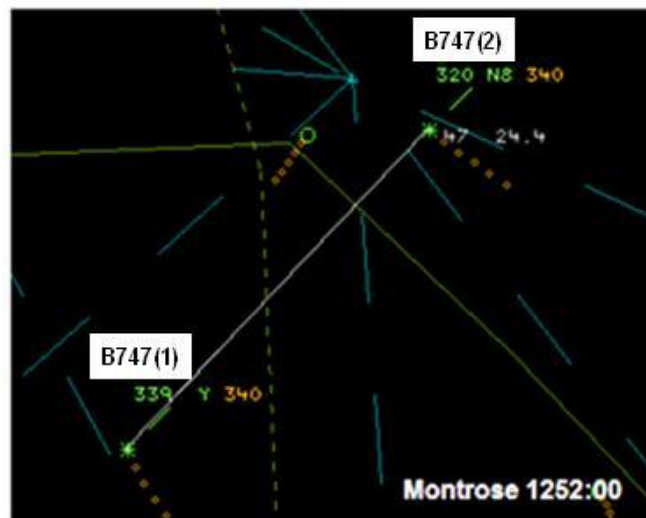
Figure 2.

At 1252:00, the B747(1) pilot contacted the Montrose sector maintaining FL340 (indicating FL339). The two ac were 24.3nm apart on converging tracks (see Figure 2 below). ATCO(1) reported that his usual method of working was to put the electronic strips of conflicting traffic together and suitably highlighted. On this occasion ATCO(1) had not done this.

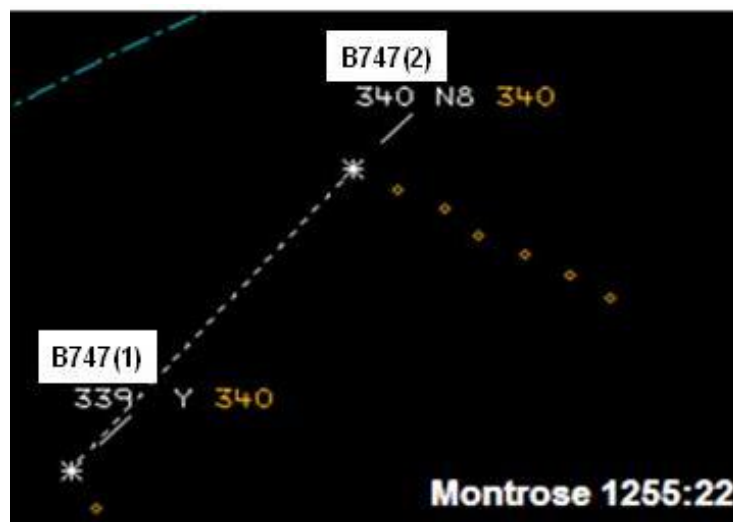
Figure 3.

At 1255:22, low-level STCA was triggered as the two ac were 9.8nm apart (see Figure 3). Just prior to this ATCO(1) had realised that the two ac were in conflict; however, he was unable to issue instructions due to another ac transmitting on the frequency. At the end of this transmission ATCO(1) transmitted, *“avoiding action [B747(1) C/S] turn left immediately heading two seven zero degrees, traffic in your right one o’clock.”* The B747(1) pilot read back, *“two seven zero [B747(1) C/S]”*. Avoiding action was then passed to the B747(2) pilot, *“[B747(2) C/S] avoiding action turn right immediately heading zero five zero degrees traffic in your left eleven o’clock”*. The B747(2) pilot replied using his C/S digits only.

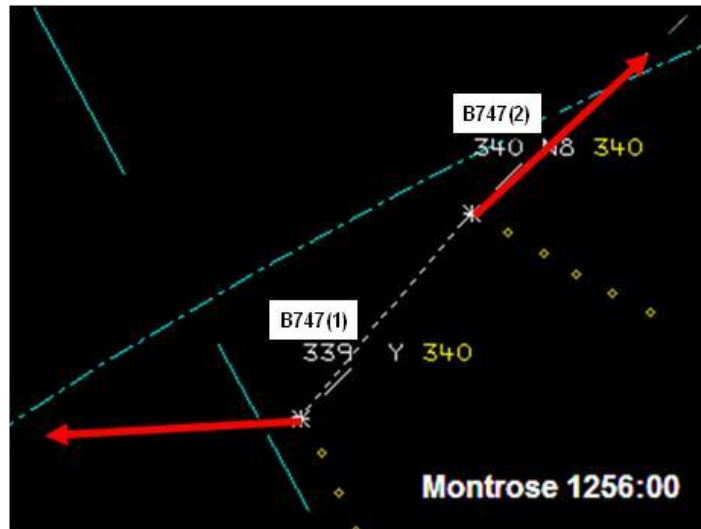
Figure 4.

At 1256:00, the two ac were 6.6nm apart still on converging headings (see Figure 4, with the headings previously given by ATCO(1) superimposed in red). The B747(2) pilot transmitted, *“and just to confirm did you give us a heading for [B747(2) C/S]”*. ATCO(1) replied, *“[B747(2) C/S] affirm avoiding action turn right immediately heading zero five zero degrees.”* The B747(2) pilot read back *“zero five zero right turn [B747(2) C/S].”*

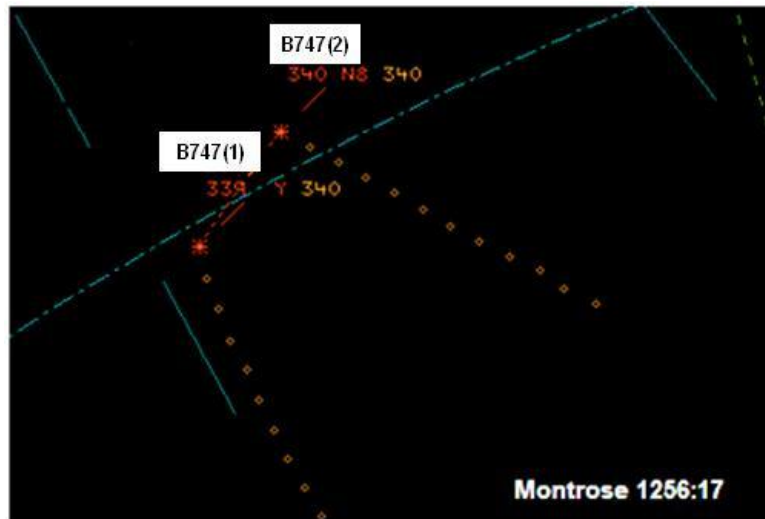
Figure 5.

ATCO(1) stated at interview that he was reluctant to give climb or descent to either ac due to his training, which discouraged it due to the possibility of giving instructions in conflict with TCAS. At 1256:17, high-level STCA alerted as separation was lost: the distance between the B747s had reduced to 4.9nm with both ac at FL340 on converging tracks (see Figure 5). The B747(1) appeared to have turned slightly R. By this time ATCO(2) had arrived on the sector to provide assistance to ATCO(1) and suggested that ATCO(1) give vertical instructions. At 1256:20, ATCO(1) instructed the B747(1) pilot to “descend now immediately”.
