This incident occurred 18.5nm NW of RAF Brize Norton (BZN), at about 1122:12 on 9 Aug 13, between a Merlin and a Tornado. The Merlin was transiting from RAF Shawbury to RAF Benson, in receipt of a Traffic Service from BZN RAD. The Tornado was descending into the Low-Flying System having exited the Daventry Radar Corridor, in receipt of a Traffic Service from LATCC(Mil) Central (CEN) Tac.

A Merlin helicopter and a Tornado GR4 flew into conflict at 1122 on 9<sup>th</sup> August 2013, 10nm east of Gloucestershire A/D. The Merlin crew were transiting under IFR in intermittent VMC, in receipt of a Traffic Service; the Tornado crew were descending to low level under VFR in VMC in receipt of a Traffic Service from another agency.

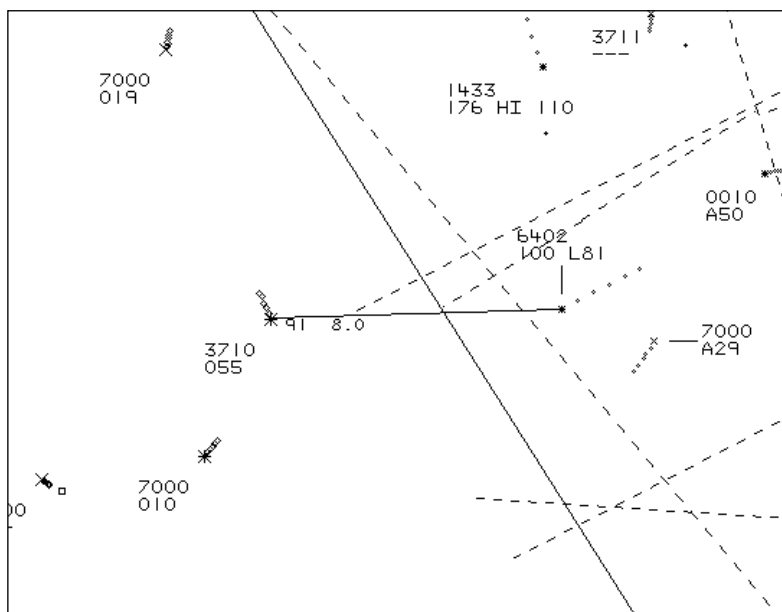
Figure 1: Incident Geometry at 1121:11

The incident sequence commenced at 1121:11 as, in response to a request from the GR4’s crew, CEN Tac instructed them to “descend flight level 4-5, report passing flight level 7-5”, which was acknowledged. Figure 1 depicts the incident geometry at this point, SSR 3A 6402 was the GR4 and SSR 3A 3710 was the Merlin.

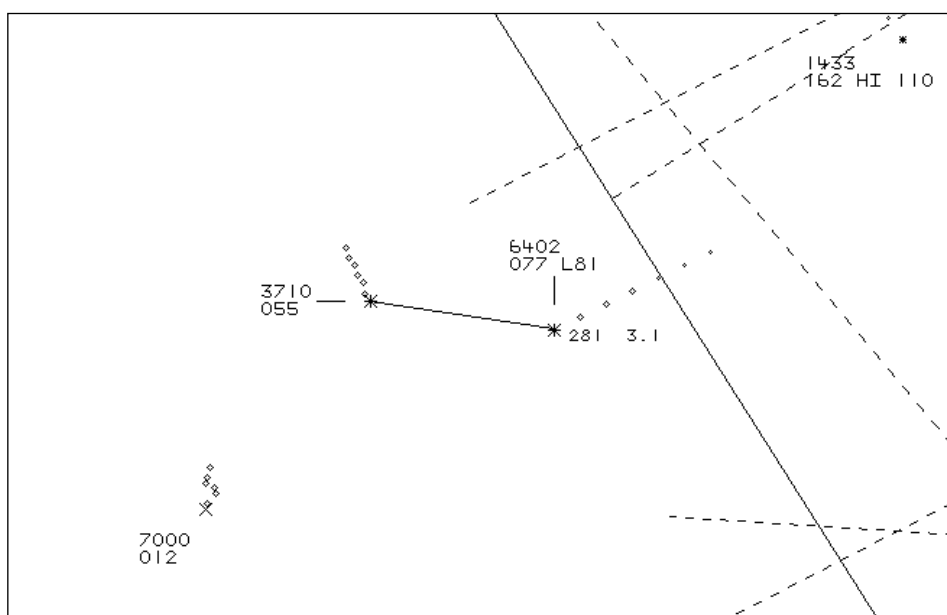
Figure 2: Incident Geometry at 1121:50

The RT exchange between BZN RAD and the unrelated Grob 109 was completed at 1121:37, with a further 7sec exchange of RT between 1122:00 and 1122:07. At 1121:45, the GR4 advised CEN Tac that they were “*passing flight level 7-5*”. CEN TAC acknowledged the call, advising the GR4, “*Cotswold 1-0-1-4, descend to altitude 4000 feet, report approaching, report V-M-C below.*” During this transmission, at 1121:55, the GR4 can be observed on the radar replay to have turned right by about 15°; at this point, the GR4 was indicating descent through FL74, 2.6nm ESE of the Merlin. Figure 2 depicts the incident geometry at the point that CEN Tac passed the Cotswold RPS. Extrapolation of the radar data determined that, had the GR4 maintained their WSW’ly track, they would have passed about 0.9nm ahead of the Merlin.

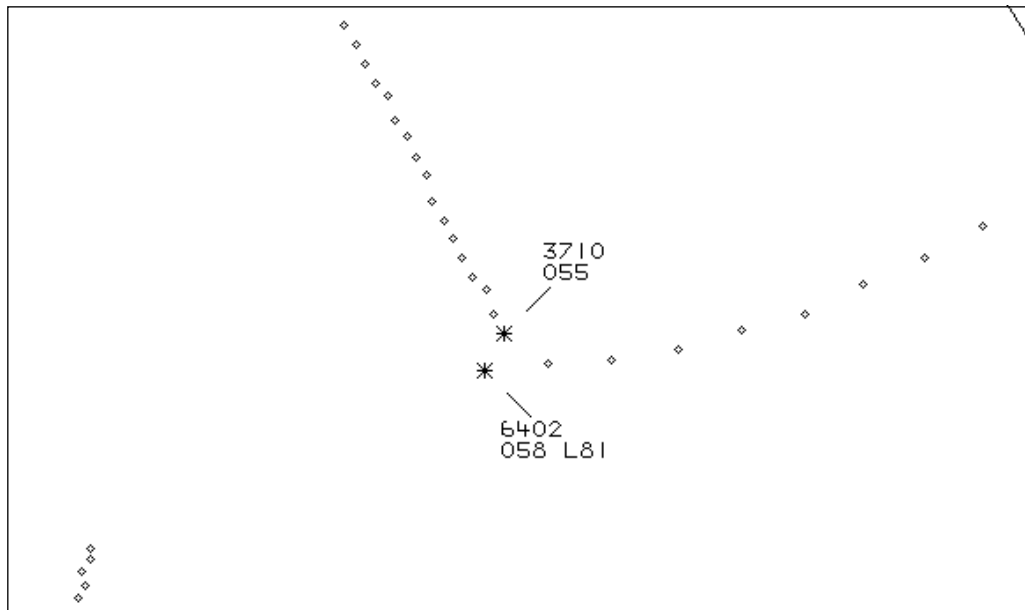
Figure 3: Incident Geometry at 1122:14

The CPA occurred during a VHF RT exchange with an unrelated Chipmunk, 41.9nm SSE of the Merlin and between sweeps of the radar at about 1122:12, as the GR4 passed 0.3nm ahead of the Merlin. The GR4’s SSR Mode C showed the ac descending through FL62 at 1122:10 and FL58 at 1122:14. The RT transcript is arguably a more accurate record as the GR4 pilot acknowledged his updated traffic information at 1122:12, reporting that they were “*through 5-5...[2sec pause] now [equating to 1122:16], [GR4 C/S] is victor mike and clear of that traffic and en-route, thanks*”. CEN Tac acknowledged this call, advising the GR4 to “*squawk as required and continue with Gloucester, 1-2-8 decimal 5-5-0*”. Figure 3 depicts the incident geometry at the first sweep of the radar after the CPA and shows the GR4’s earlier right turn at 1121:55.
