## **AIRPROX REPORT No 2013126**

Date/Time: 5 Sep 2013 1305Z

Position: 5055N 00027W  
(0.5nm NE Parham Glider site  
- elevation 110ft)

Type: DG505 BE 76

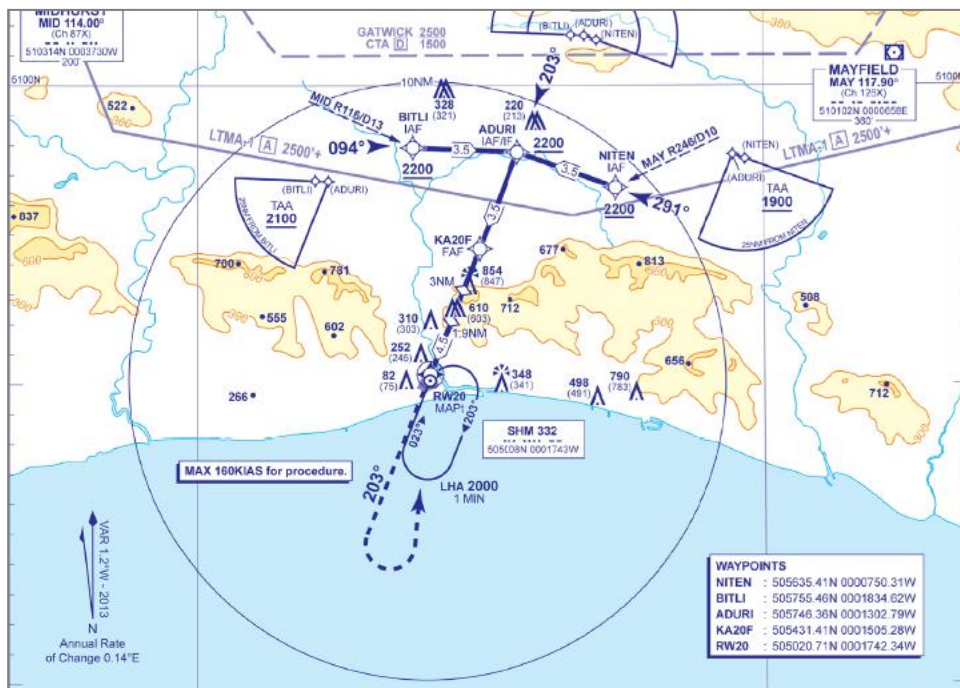
Figure 1 – extract from Shoreham Instrument Approach Chart RNAV (GNSS) RWY 20

The BE76 was operating from Bournemouth airport on an IFR training flight, inbound to Shoreham for an RNAV approach, missed approach followed by a hold then NDB approach. The BE76 was in receipt of a Procedural Service from Shoreham approach on frequency 123.150MHz. Figure 1 is an extract from the UK AIP page AD 2-EGKA-8-4 (RNAV procedure).

<u>Cause:</u>	A non-sighting by the BE76 pilot and, effectively, a non-sighting by the DG505 pilot.
<u>Degree of Risk:</u>	A
<u>ERC Score<sup>1</sup>:</u>	100
<u>Recommendation(s):</u>	Shoreham review their IFR approach procedure tracks with consideration for intensive gliding operations in the area.

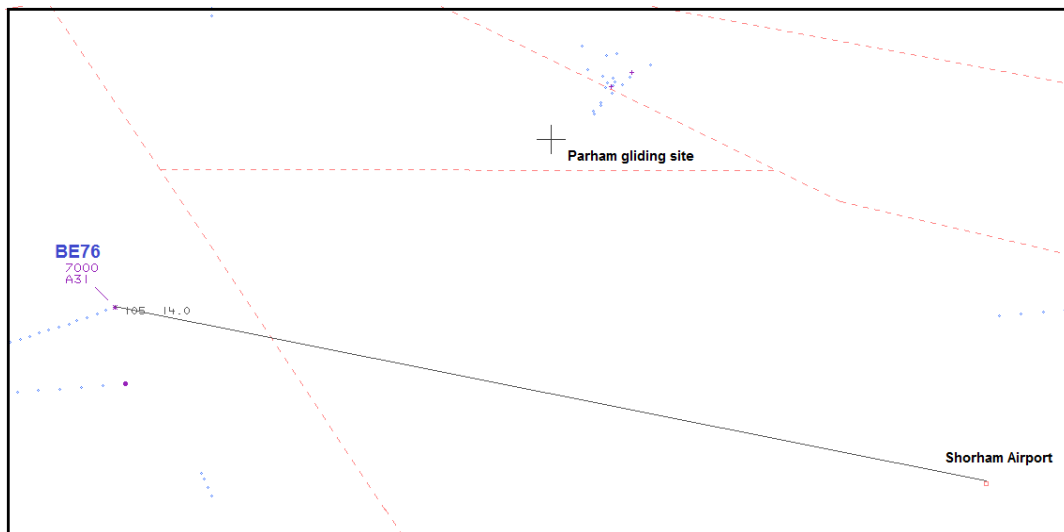
Figure 2 – Swanwick MRT at 1302:36

Area radar recording showed the BE76 14nm west-northwest of Shoreham and two likely glider contacts in the vicinity of Parham gliding site (1nm south of West Chiltington), see Figure 2 below.

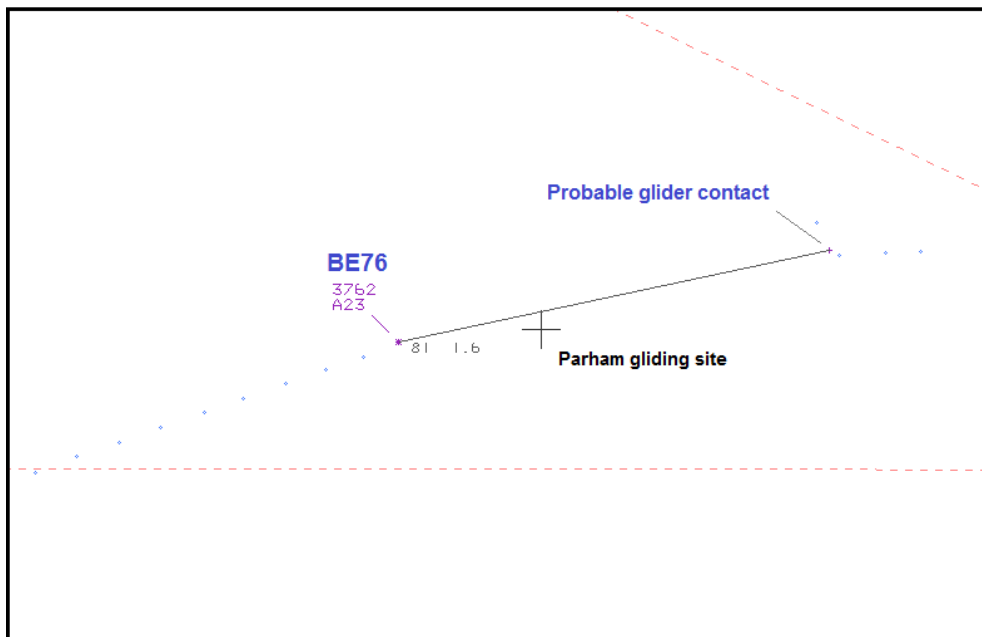
Figure 3 – Swanwick MRT at 1305:30

At 1305:30, the area radar recording showed the BE76, 0.5nm West of Parham gliding site at an altitude of 2300ft. A contact, most likely a glider, was shown manoeuvring 1nm northeast of Parham and in the BE76 pilot's half past twelve at a range of 1.6nm, see Figure 3 below.

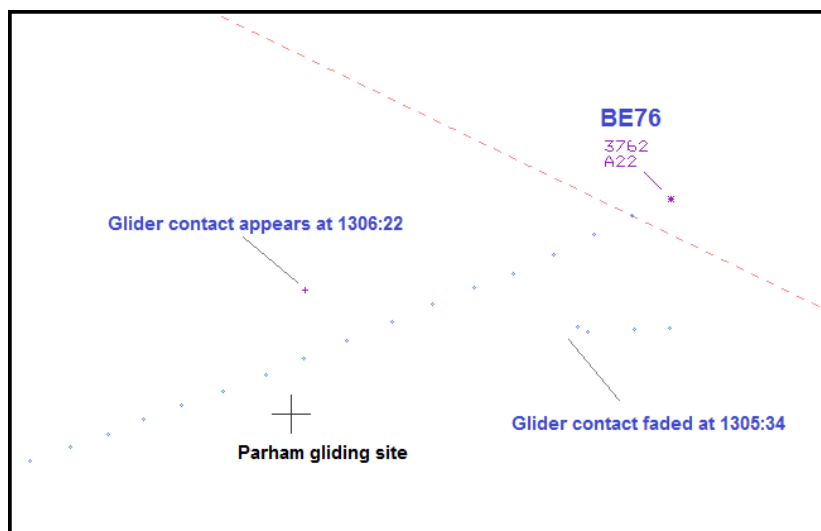
Figure 4 – Swanwick MRT at 1306:22

On the next radar update the glider contact faded from radar. At 1306:22 a probable glider contact appeared North of Parham tracking West, see Figure 4 below.

The geometry of the encounter was consistent with the track of the BE76 and the reported track indicated by the DG505 pilot's written report. However whilst both the unknown contacts were observed tracking west, there were also two other gliders in the vicinity and it was not possible to determine if the two unknown radar contacts were from the same aircraft. The BE76 pilot's written report indicated that he only descended to 2400ft whilst in the vicinity of Parham and did not observe any glider landing or departing from the airfield. The BE76 continued with the approach without further incident. No RTF reports were made to Shoreham by the BE76 pilot regarding the close proximity of a glider.
