AIRPROX REPORT No 2013141

Date/Time: 23 Sep 2013 1424Z

Position: 5712N 00212W
(Aberdeen Airport
-elevation 215ft)

Airspace: Aberdeen CTR (Class: D)

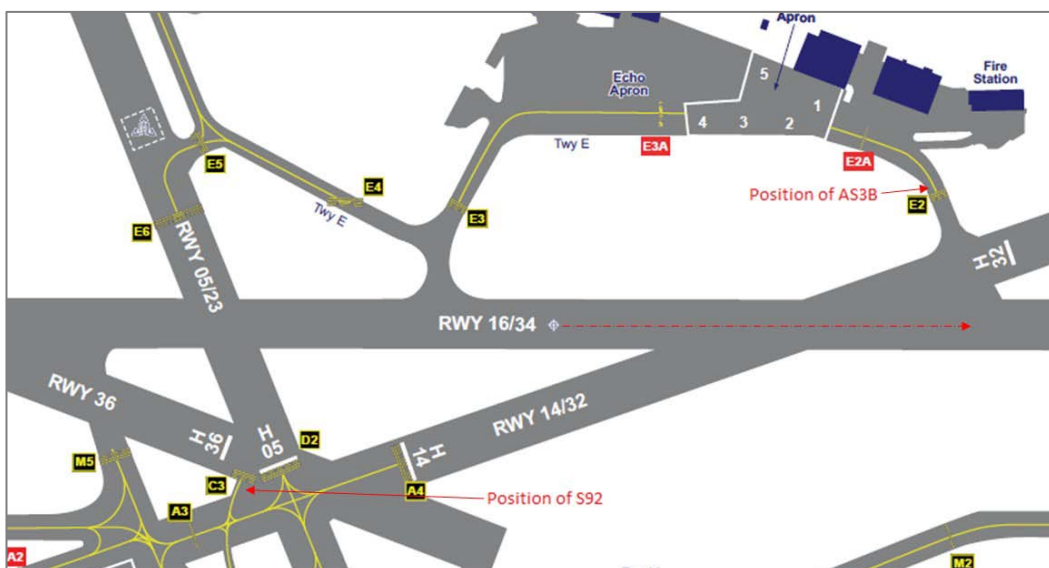
Figure 1 illustrates the layout of the holding points at ABZ with the positions of the Super Puma (AS3B) and the S92, prior to the Airprox, highlighted. At 1423:13 the Aerodrome controller asked the pilot of the Super Puma at holding point 'E2' if he could take an immediate take-off clearance. The pilot replied that he could, and he was instructed "[Super Puma C/S] *via echo two line up one six bring it to the hover be ready immediate*". The read-back from the Super Puma pilot was clear and correct but during the read-back there was a degree of background noise. Review of the RTF recordings revealed that another, crossed, transmission was made during the read-back from the Super Puma pilot but this was not detected by the Aerodrome controller. After analysis of the recording at full volume it is just possible to determine the words "*ready immediate*" in the background of the read-back; however, there was no other indication that might have alerted the Aerodrome controller to the crossed transmission such as a squeal, a significant difference in volume, or an unexpected additional word or phrase during the length of the transmission.
