AIRPROX REPORT No 2013157

Date/Time: 10 Nov 2013 1641Z (Sunday)
(Twilight)

Position: 5324N 00259W
(7nm NW of Liverpool Airport)

Type: EC135P2+ PA31 Chieftain

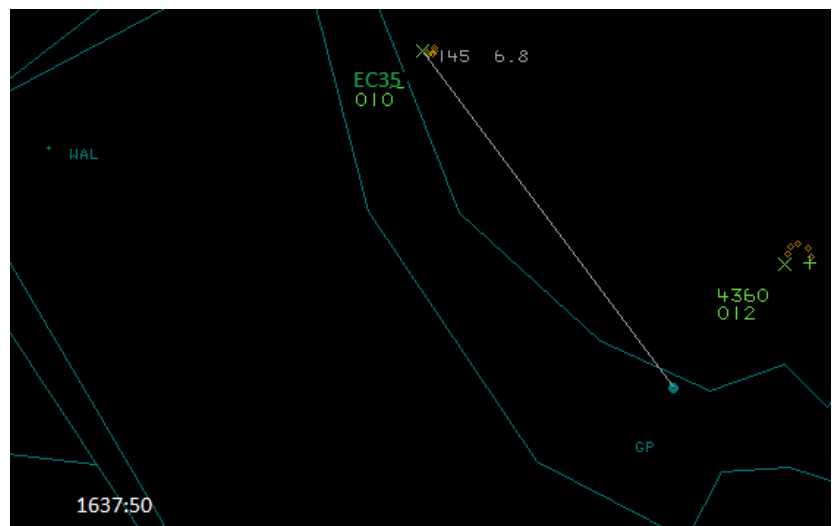
Figure 1 (EC35=EC135)

At 1637:00 the PA31 pilot reported ready for departure and the Tower controller instructed him to line-up and wait RW27; he was given take-off clearance at 1637:50 when the EC135 was 6.8nm northwest of Liverpool Airport (Figure 1).

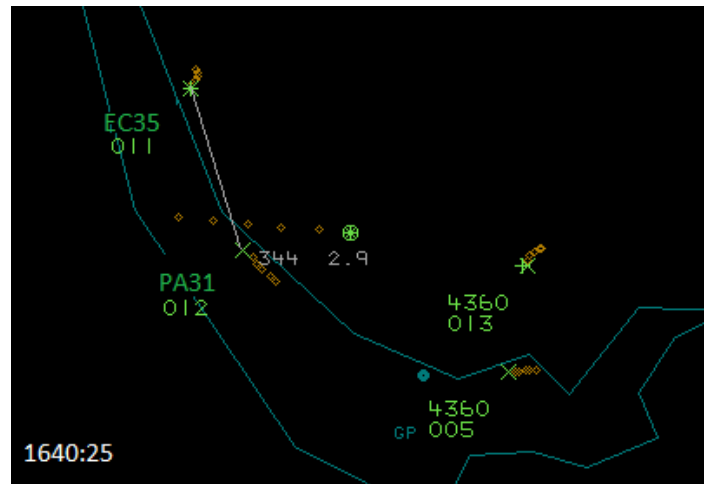
Figure 2 (EC35=EC135)

At 1640:25 the PA31 pilot was instructed to contact Liverpool Radar. The PA31 was 3.7nm northwest of Liverpool Airport, 2.9nm south of the EC135 (Figure 2).

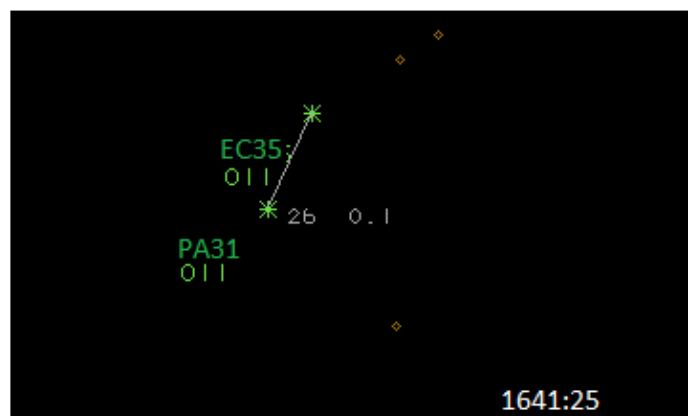
Figure 3 (EC35=EC135)

The two aircraft continued to converge until CPA at 1641:25, when the EC135 and the PA31 were 0.1nm apart at the same level (Figure 3).

The pilot of the EC135 reported that he saw the PA31 pass left to right at a distance of 100ft or less. Because the EC135 was in a right-hand turn the crew did not see the PA31 until it was passing just in front.
