## AIRPROX REPORT No 2013161

Date/Time: 21 Nov 2013 0815Z

Position: 5130N 00049W  
(10nm W Heathrow airport)

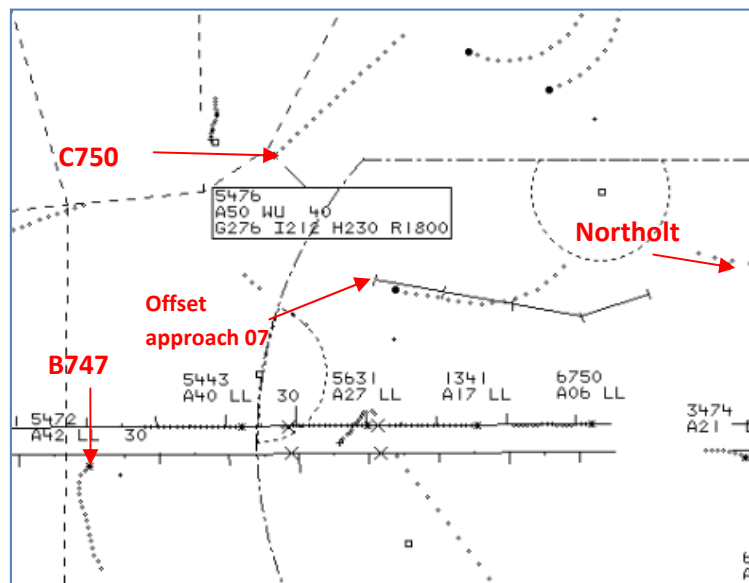
Figure 1: Swanwick MRT – 0815:00

The C750 pilot contacted NHT Approach at 0815:11 and the NHT controller instructed the C750 pilot, ‘...turn left immediately, 090 degrees, descend to altitude 3000 feet...’ [Analysis of the C750’s Mode S heading data indicated that the left turn was commenced approximately 19sec after the instruction was issued]. At 0815:52 NHT instructed the C750 pilot to turn left heading 080° (Figure 2). The C750 was now through the extended off-set centreline and its GS was 54kt greater than its IAS.

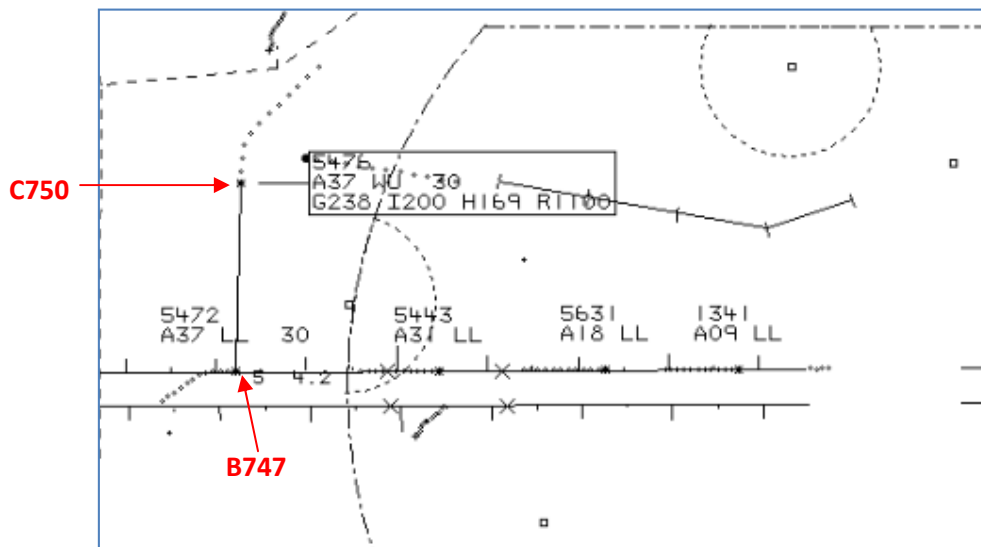
Figure 3: Swanwick MRT – 0816:04

At 0816:04 the LHR FIN DIR mentor took control of the frequency and instructed the B747 pilot, “avoiding action turn right now heading 150 degrees.” (Figure 3). Three sec later the NHT controller instructed the C750 pilot to turn further left heading 050°. The C750 was 4.2nm north of the B747 with both aircraft at altitude 3700ft. Mode S data showed the C750 turning through heading 169°, albeit that the aircraft’s track was southerly. After the B747 pilot’s read-back, the LHR FIN DIR passed Traffic Information on the C750.

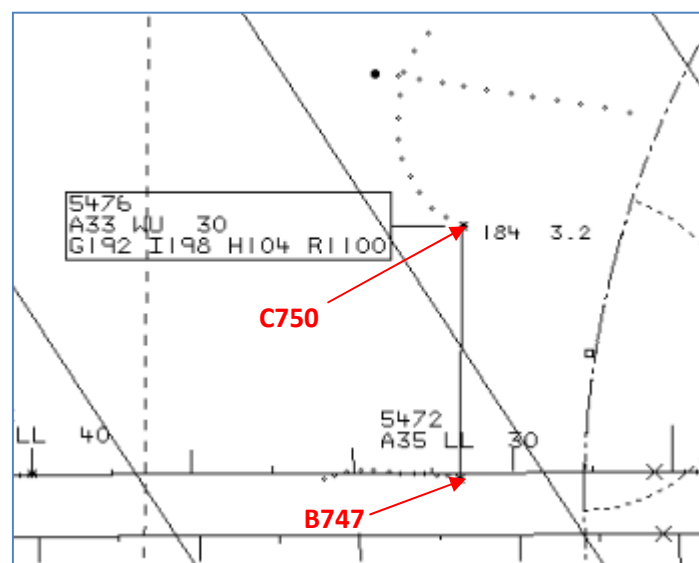
At 0816:28 the C750 was 200ft below and 3.2nm north of the B747 with the C750's Mode S indicating that the aircraft was turning through heading 104° (Figure 4). The B747 pilot's right turn was also beginning to take effect. On the next update of the situation display, 4 sec later, the distance between the two aircraft remained the same, after which the lateral distance began to increase. Neither pilot visually acquired the other aircraft.

Figure 4: Swanwick MRT – 0816:28. Note: diagonal cursor indicates 150/330°.

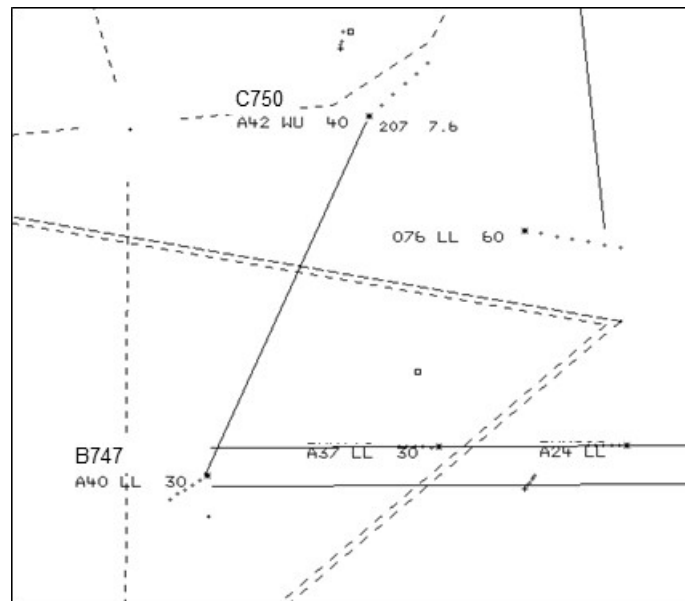
At 0814:58 LHR INT DIR N instructed the C750 pilot to report his heading to NHT. At 0815:12, the C750 pilot checked-in with NHT DIR descending to 4000ft, heading 230°. At 0815:23 the NHT DIR responded with quickly delivered RT, “[C750 C/S] *Northolt Director, identified, turn left immediately heading zero nine zero degrees, descend to altitude three thousand feet Northolt QNH one thousand, Radar Control.*” Figure 1 demonstrates the aspect and relative speed of the respective aircraft; the C750 was showing a GS of 272kt.

Figure 1: Aircraft geometry at 0815:23 when NHT DIR identified the C750 (7.6 nm separation from the B747).

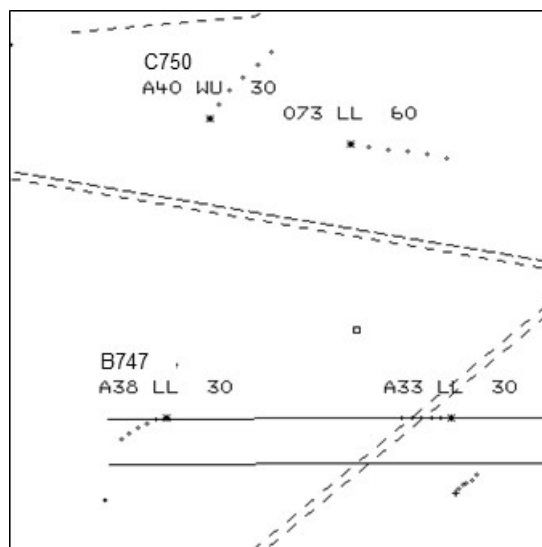
Figure 2: Aircraft geometry at 0815:52..

At 0815:52 NHT DIR updated the C750's heading turn to 080° (Figure 2).

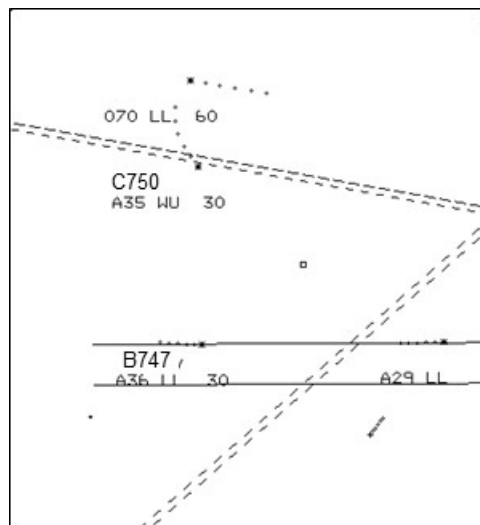
landline call, NHT DIR directed a further turn to 070° (at 0816:06) and this was updated with a turn to head 050° at 0816:20 (Figure 3).

Figure 3: Aircraft geometry at 0816:20 as left turn 050° is passed.
