AIRPROX REPORT No 2012020

Date/Time: 25 Feb 2012 1102Z (Saturday)

Position: 5135N 00146W (21nm
WNW CPT)

Airspace: UAR UL9 (Class: C)

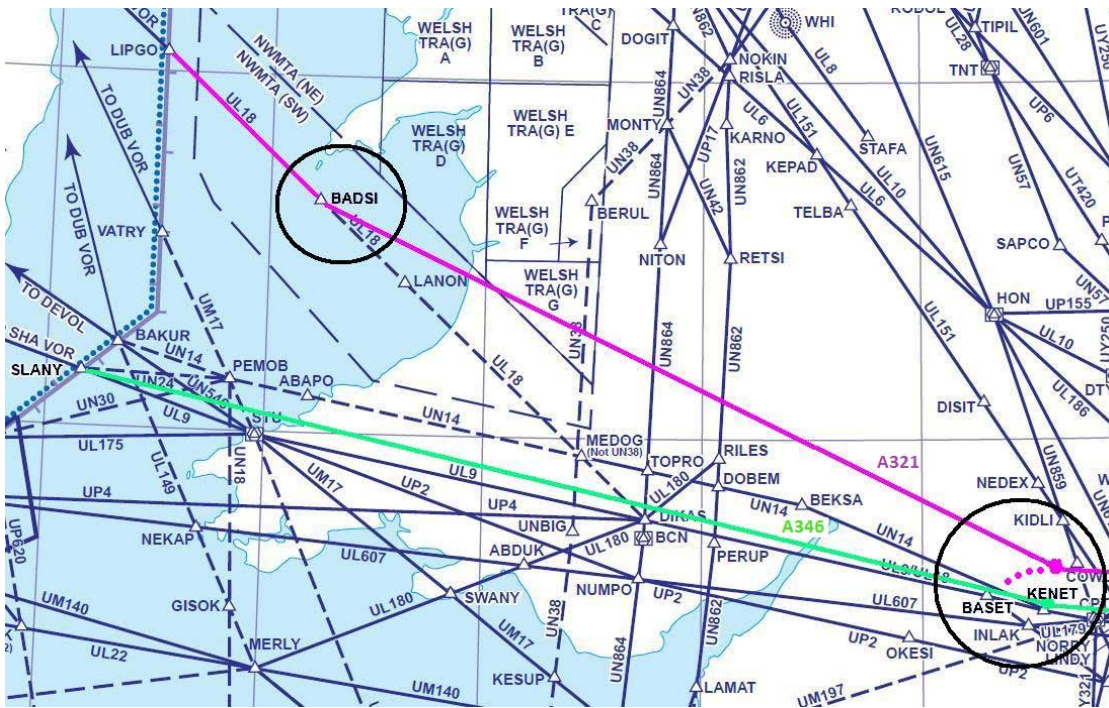
Fig 1

The A340 was operating IFR on a flight from Europe to N America and had flight planned to route UAR UL9 between CPT and SLANY (Fig 1).

The A321 was operating IFR on a flight from Europe to Dublin and had flight planned to route UAR UL9/UL18 between CPT and DIKAS then UL18 DIKAS to LIPGO (Fig 1). UL18 is classified as a conditional route which was available on the Saturday of the Airprox.

Within 2min of the ac coming on frequency the S35(T) controller had issued direct routings to both flights with an expectation that their tracks would diverge by approximately 20°. (Fig 1).
