AIRPROX REPORT No 2012026

Date/Time: 2 Mar 2012 1619Z

Position: 5116N 00050W (2nm WSW
Farnborough - elev 238ft)

Type: BA146 CL600

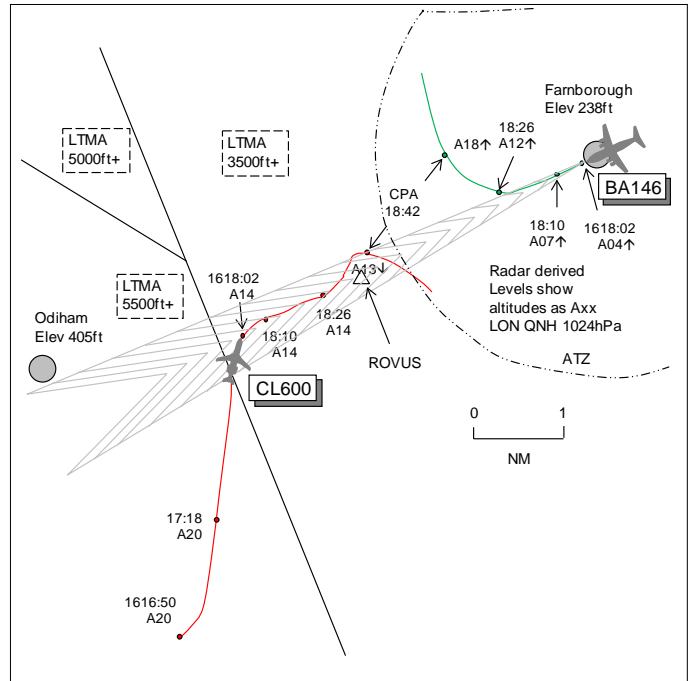
500ft V/1.4nm H

Following a brief conversation with ADC (B) the APR changed the avoiding action, at 1618:26, to the CL600 flight, to turn hard R onto 180°. The CL600 crew reported having the BA146 in sight. The CPA occurs at 1618:42, the BA146 turning R through heading 330° and climbing through altitude 1800ft with the CL600 1.4nm to its SW, having turned sharply R onto a SE'ly track descending through altitude 1300ft, 500ft below.

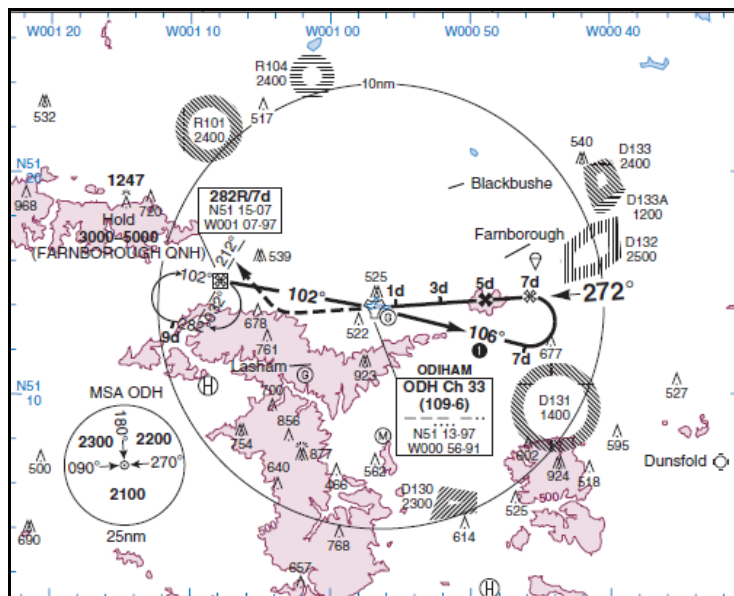
Figure 1. Odiham COPTER TAC 272 Procedure Plate

BM SAFETY MANAGEMENT reports this Airprox was between a BA146 outbound, IFR, from Farnborough (FBO) on RW24 and a CL600 inbound, IFR, to FBO on RW06. BM SM have been invited to investigate RAF ATM involvement in this incident after it was alleged that Odiham (ODI) APP had been “inflexible” in coordinating an IFR CH47 inbound to ODI with FBO’s IFR inbound. The CH47 was operating IFR, in receipt of a TS from ODI APP, conducting a COPTAC 272 approach (see Figure 1).
