## AIRPROX REPORT No 2012029

Date/Time: 5 Mar 2012 1821Z (Night)

Position: 5131N 00014E (6.5nm E  
London/City - elev 19ft)

Type: EMB170 FK50

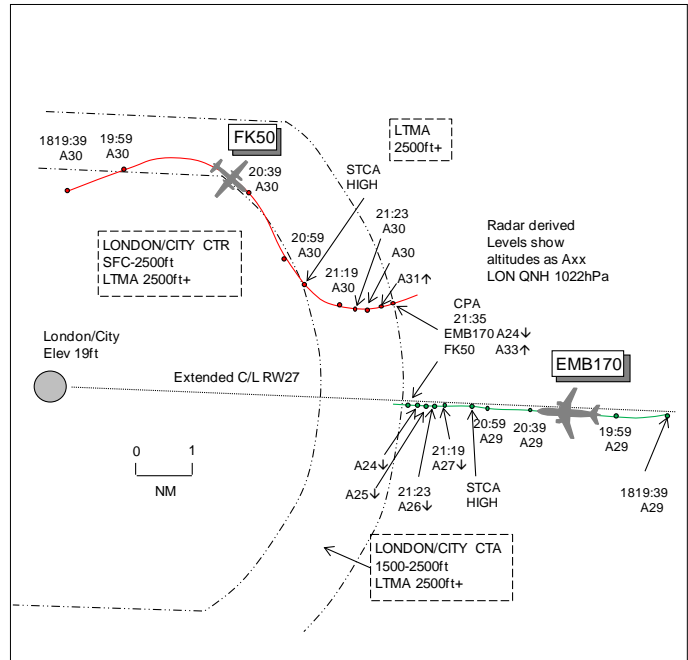
900ft V/1.8nm H

By 1820:59 the FK50 had turned further to the R and was tracking approximately 160°, at 3000ft, on a conflicting course with the EMB170 which was at 2900ft. The 2 ac were 4.6nm apart. The Thames radar controller again instructed the FK50 flight, "(FK50 c/s) avoiding action turn left immediately" which was read back as "Turn left immediately (FK50 c/s)".

The Thames radar controller then instructed the FK50 crew to, "...climb to altitude four thousand feet traffic one o'clock same level two miles". This transmission was not acknowledged so Thames Radar transmitted at 1821:20, "(FK50 c/s) traffic one one o'clock two miles same level climb to altitude four thousand feet". The FK50 crew replied, "Four thousand feet (FK50 c/s)". At this time the FK50 was in the L turn at 3000ft, 2.3nm from the EMB170 at 2600ft. At the CPA, 1821:35, the FK50 passed down the RHS of the EMB170 at a range of 1.8nm climbing through 3300ft while the EMB170 was descending through 2400ft.

The Thames Radar controller issued a heading of 080° to the crew of the FK50 which was read back correctly but not followed. The FK50 turned through the heading issued by the controller and flew into conflict with the EMB170. An avoiding action L turn was issued to the FK50 flight at 1820:40 but the FK50 continued to turn R until 1821:00.

Cause: The FK50 crew did not follow their assigned heading and were slow to respond to avoiding action, resulting in their flying into conflict with the EMB170.
