## **AIRPROX REPORT No 2012089**

Date/Time: 30 Jun 2012 1350Z (Saturday)

Position: 5210N 00007W  
(O/H Gransden Lodge  
Airfield - elev 254ft)

Type: Puchacz Glider Piper Arrow

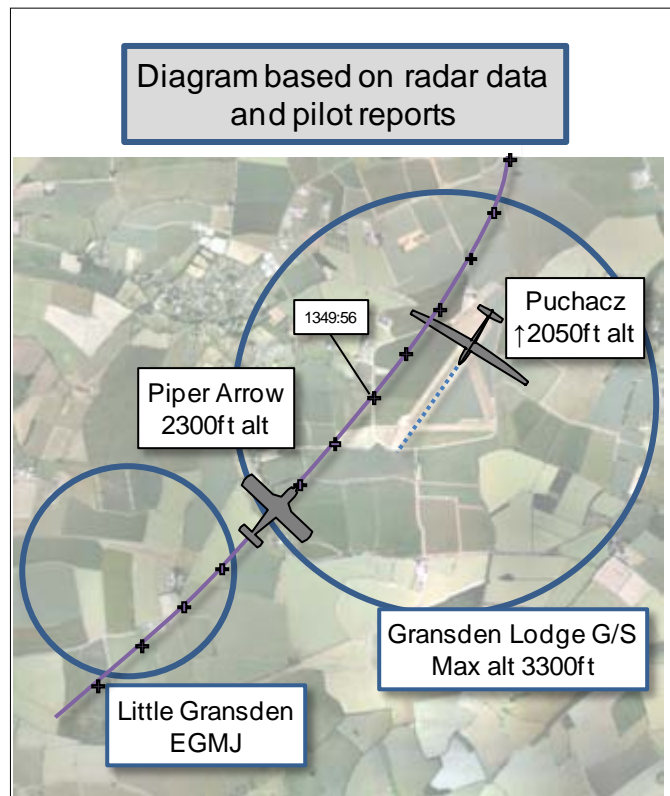
Cause: The Piper Arrow pilot flew overhead a promulgated and active glider site, below the vertical limit of the winch launch, and into conflict with the launching Puchacz glider, which he did not see.
