AIRPROX REPORT No 2012109

Date/Time: 21 July 2012 0847Z (Saturday)

Position: 5355N 00259W (2nm
E Fleetwood VRP)

Type: C150 Pilatus PC6

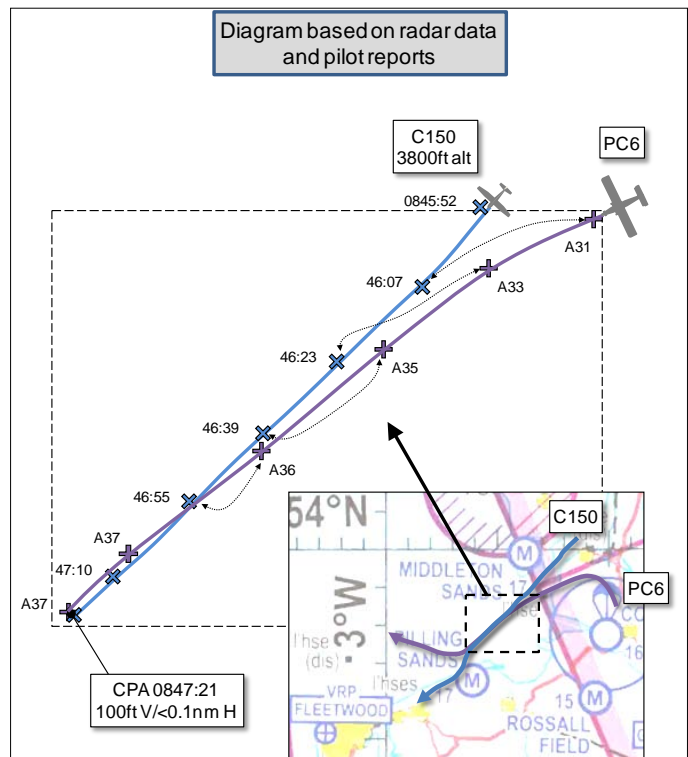
[UKAB Note(1): The C150 is reported as staying level at altitude 3800ft. The PC6 radar derived altitudes are shown as 'A<100's of feet>].

At 0847:21, the PC6 is shown passing less than 0.1nm to the R of the C150 (CPA). The PC6 was indicating FL034 (converts to 3697ft using QNH 1024 and 1hPa equal to 27ft). The C150 pilot's written report indicated flying at 3800ft and having sighted the PC6 within 100m to the R and below. The PC6 was shown to climb as the two ac continued on their slightly diverging tracks. Then at 0847:32 the PC6 made a R turn of 60° and the C150 made a L turn of 60°.

The PC6 departed from Cockerham drop zone and approached the C150 from behind, overtaking the C150 to the R, in close proximity, at a position 3.7nm WSW of the drop zone site.

The Airprox occurred when the PC6 departed from Cockerham Drop Zone and climbed on a W track approaching the C150 from behind, passing to the R of the C150, which caused the pilot of the C150 to be concerned about the relative position and proximity of the PC6.
