AIRPROX REPORT No 2012138

Date/Time: 29 Aug 2012 1003Z

Position: 5425N 00102W
(19nm ENE Leeming)

Airspace: Vale of York AIAA (Class: G)

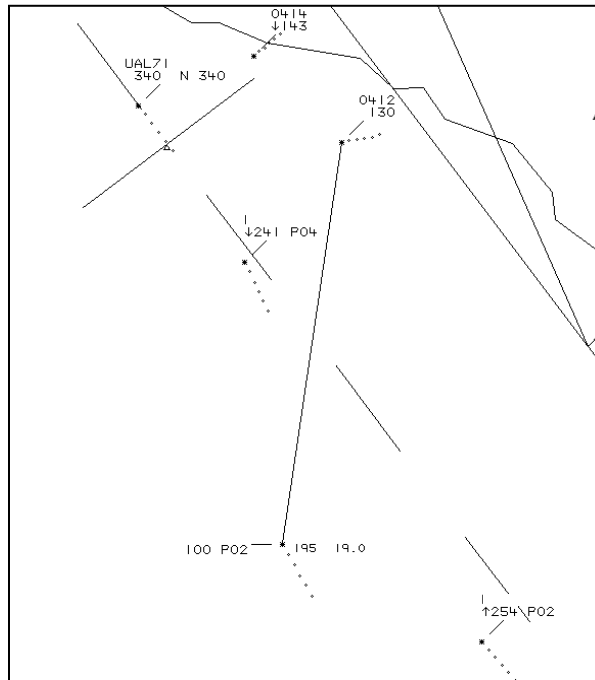
Figure 1: Radar Replay Screenshot at 1001:24

At 1001:24, DIR instructed the Hawk formation to, "*descend Flight Level 5-0*" which was acknowledged; at this point the GR4 was 19nm SSW of the Hawk formation (Figure 1 refers).

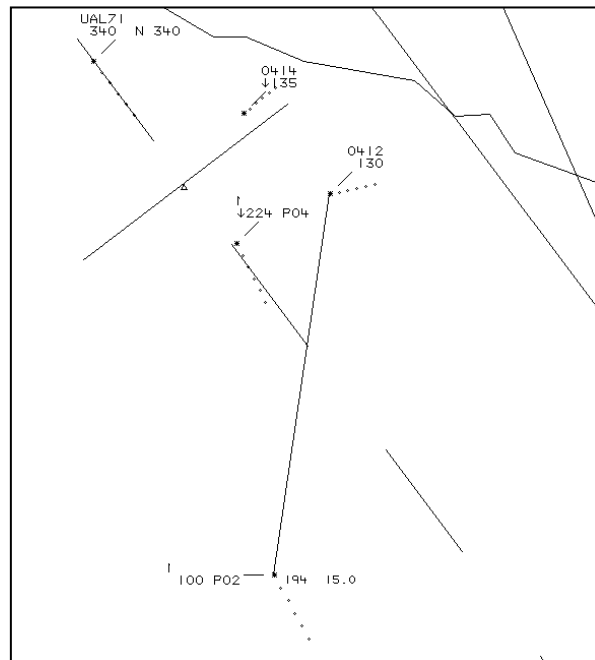
Figure 2: Radar Replay Screenshot at 1001:51

At 1001:51, DIR instructed the Hawk formation to, “turn left heading 2-3-0 degrees” which was acknowledged; at this point the GR4 was 15nm SSW of the Hawk formation (Figure 2 refers).

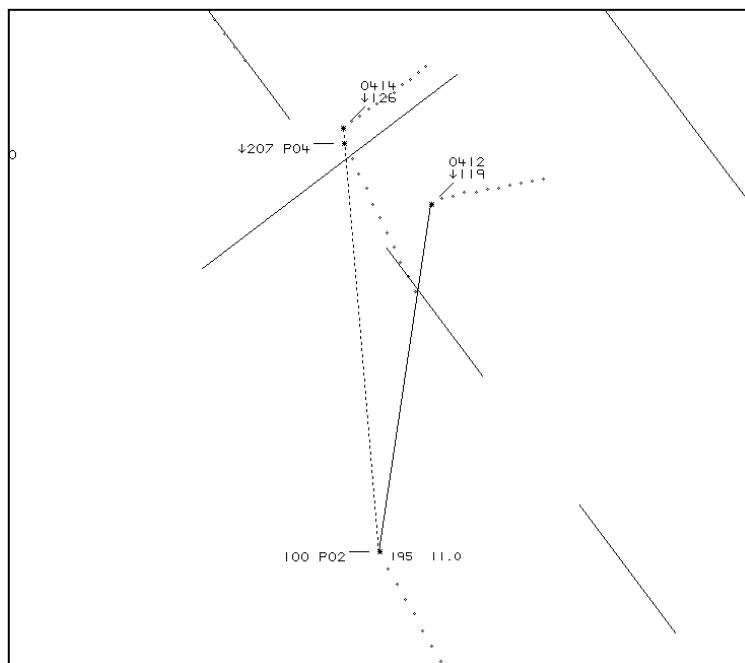
Figure 3: Radar Replay Screenshot at 1002:18

Whilst neither causal nor contributory to the incident, the delay of 29 secs between the passing of the descent instruction (1001:24) and the initiation of the Hawk formation's descent, was an aggravating factor in the magnitude of the subsequent loss of separation. Controller 2 first identified their traffic to the Leeming SUP, who replied, "Err, that's not our traffic." Controller 2 continued, "yeah, it's my traffic" and Leeming SUP asked, "what do you want coordination on?" As STCA white activated on the Controller 2's surveillance display at 1002:10, they replied, "he [the GR4] is maintaining Flight Level 100. Okay, your traffic, arr, 0-4-1-2, north-east of Leeming by 23 miles?" Leeming SUP replied, "roger, that traffic not above Flight Level 1-2-0." Although a discrepancy can be expected between the NATS Radar replay and the information presented to the Leeming SUP, at this point, the SSR Mode C of the Hawk formation leader could be observed on the NATS radar replay to be indicating descent through FL119. The statement made by the Leeming SUP suggests that they were monitoring the Hawk formation's descent. At 1002:18, the Hawk formation can be observed on radar to have commenced the L turn instructed by DIR at 1001:51 (Figure 3 refers).
