AIRPROX REPORT No 2012145

Date/Time: 9 Sep 2012 1427Z (Sunday)

Position: 5213N 00137W (1nm FIN APP
RW18 Wellesbourne Mountford
- elev 159ft)

Airspace: ATZ (Class: G)

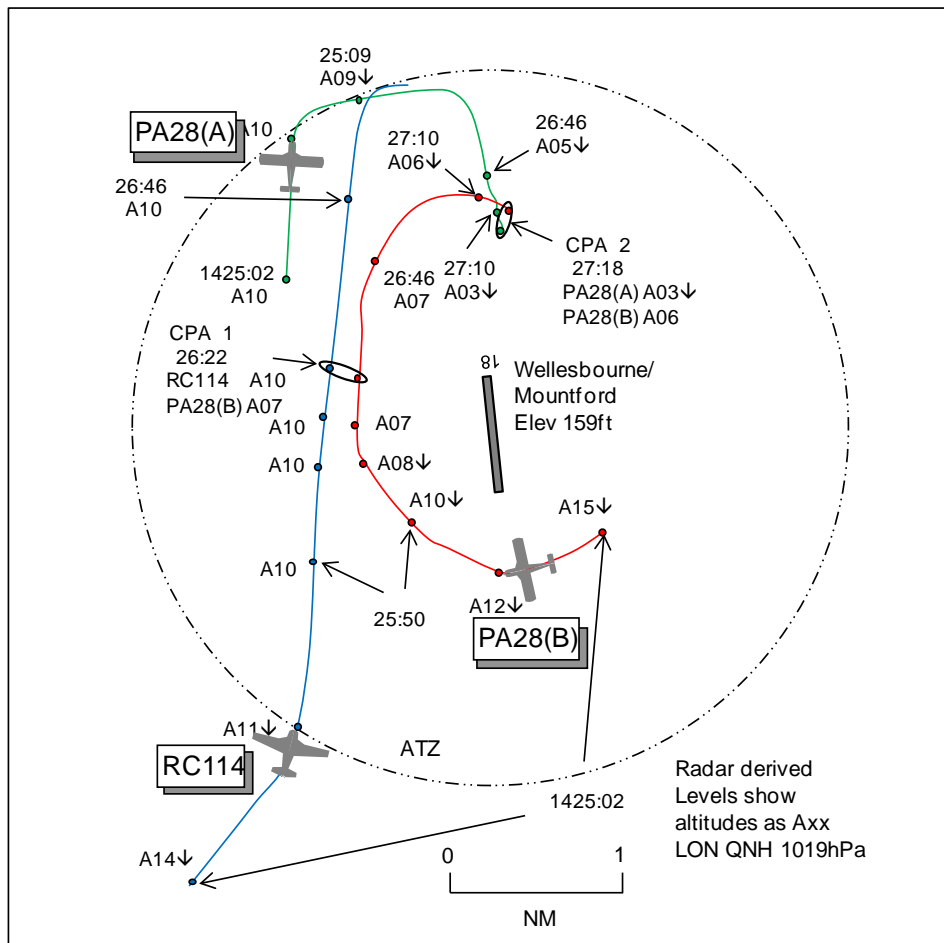
[UKAB Note (1): At 1425:50 PA28(B) is turning towards the downwind leg, inside the RC114. PA28(B) rolls out onto a parallel the track with that of the RC11, with the CPA (CPA 1) occurring at 1426:22 as the RC114, at altitude 1000ft, passes 0.1nm on the PA28(B)'s LHS, PA28(B) indicating 700ft. Twenty-four seconds later, at 1426:46, PA28(B) commences a R turn onto R base towards the PA28(A) which was on final. By 1427:10 PA28(B) is indicating 600ft and converging with PA28(A), which just R of its 12 o'clock range 0.2nm and 300 ft below. The next sweep at 1427:18 shows PA28(B) passing 0.1nm behind PA28(A) with vertical separation 300ft, CPA 2. PA28(A) continues the approach while PA28(B) breaks onto the deadside and later rejoins the cct.]
