AIRPROX REPORT No 2011122

Date/Time: 14 Sep 2011 1604Z

Position: 5118N 00025E
(16nm E Biggin Hill)

Airspace: Lon FIR (Class: G)

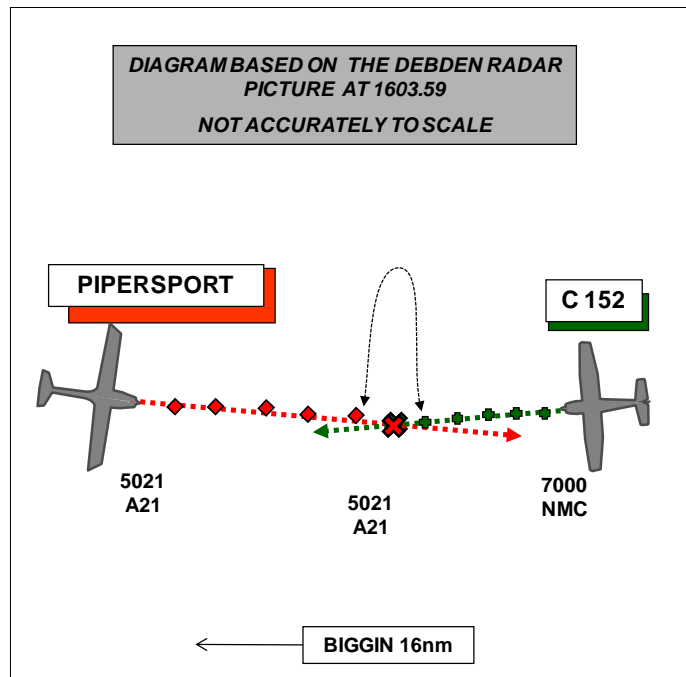
At 1603:12, radar recordings show the range between the two ac was 1.5nm, on reciprocal tracks.

At 1603:39 the distance between the two ac was 0.1nm, with the Pipersport indicating an alt of 2200ft. The next radar returns show that the two ac have passed abeam and the Pipersport has descended to 2100ft; the two ac then continued on their respective tracks.

UKAB Note (1): The recordings of several radars showed the incident. The geometry is as outlined in the ATSI report and depicted above. However the reported Pipersport passed 100ft directly below another C152 (tracking 180°) 2min before the CPA with the reporting C152.

The Board was informed that the radar recording showed another ac (identified as a second C152 and not shown on the diagram) transiting from NE to SW and crossing the Pipersport's track about 2 min before the CPA. Since the geometry of the incident as described by the Pipersport pilot did not match that described by the reporting pilot, but did match the earlier encounter, it was agreed that he had probably seen the first ac but not the one flown by the reporting pilot.
