AIRPROX REPORT No 2011126

Date/Time: 24 Sep 2011 1030Z (Saturday)

Position: 5052N 00018W (2.4nm
N of Shoreham Airport -
elev 7ft)

Type: R22B BE90

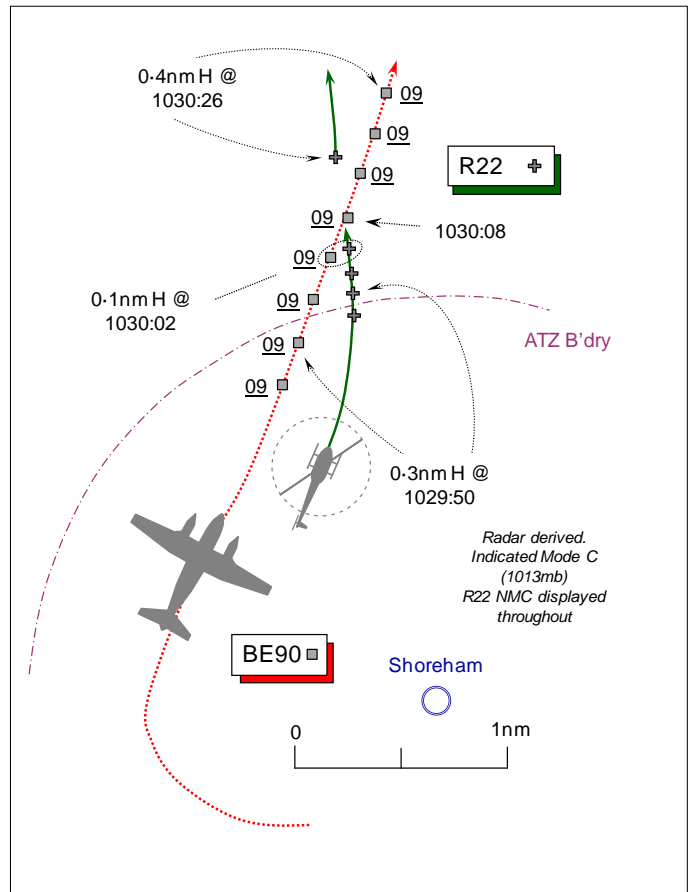
[At 1029:50, radar recordings show the R22 tracking NNW and leaving the ATZ with no Mode C level reporting evident. The BE90 was in the R22 helicopter’s 8 o’clock position at a range of 0.3nm and converging maintaining 900ft (1013hPa) – about 930ft QFE.]

At 1030:08, radar recordings show the BE90, crossing ahead of the R22 from L - R at a range of less than 0.1nm. The BE90 was indicating 900ft Mode C - about 930ft QFE 1014. No report has been received from the BE90 pilot and it is not clear if the pilot had acquired the R22 visually as the BE90 extended downwind.

Cause: In the absence of TI the BE90 pilot overtook the R22 causing its pilot concern.

- a. It is recommended that the ATSU in consultation with SRG, review the levels of staffing and service provision, to ensure that Aerodrome and Approach control services can be provided from separate position when warranted.
- b. It is recommended that the ATSU in consultation with SRG, ensure that the controller is suitably apprised of the issues raised by this Airprox.

c. It is recommended that the ATSU review the guidance for operational staff in predicting, managing and limiting traffic levels, with an emphasis on the human factor effects of overload and highlighting the need for early planning and preventative measures.

d. It is recommended that the ATSU remind controllers of the requirement to pass TI to ac flying in and in the vicinity of the ATZ to achieve a safe, orderly and expeditious flow of air traffic and to assist pilots in preventing collisions.
