**AIRPROX REPORT No 2011129**

Date/Time: 26 Sep 2011 1007Z

Position: 5141N 00058W  
(6nm NE Benson)

Airspace: Benson MATZ (Class: G)  
Reporting Ac Reported Ac

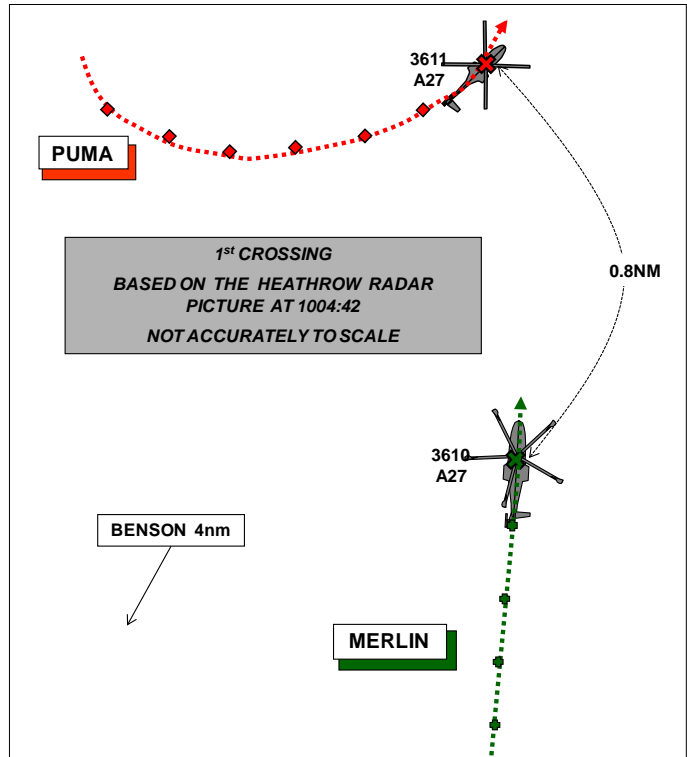
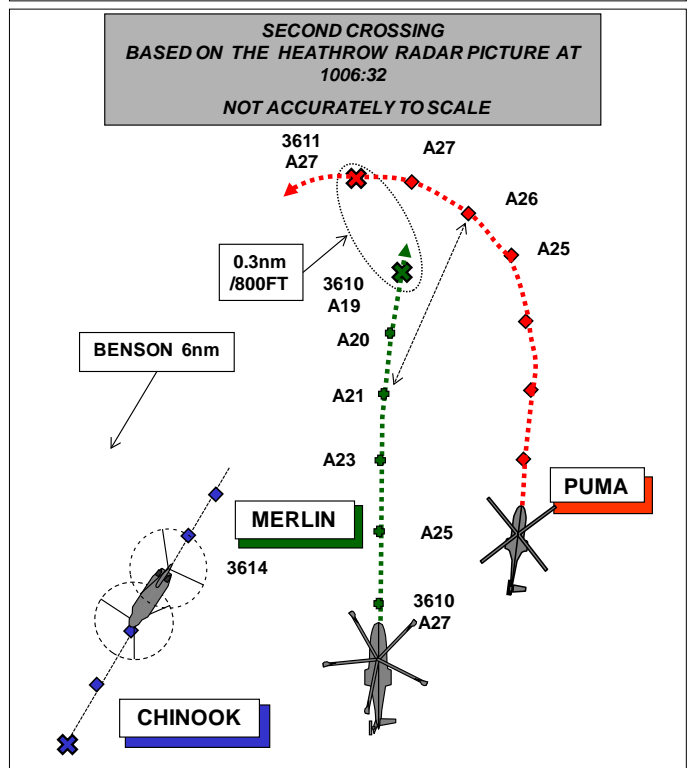
UKAB Note (1): The recording of the Heathrow 10cm Radar shows the incident clearly as depicted in the diagram(s) above. All contacts suffer from track jitter and have been adjusted accordingly.

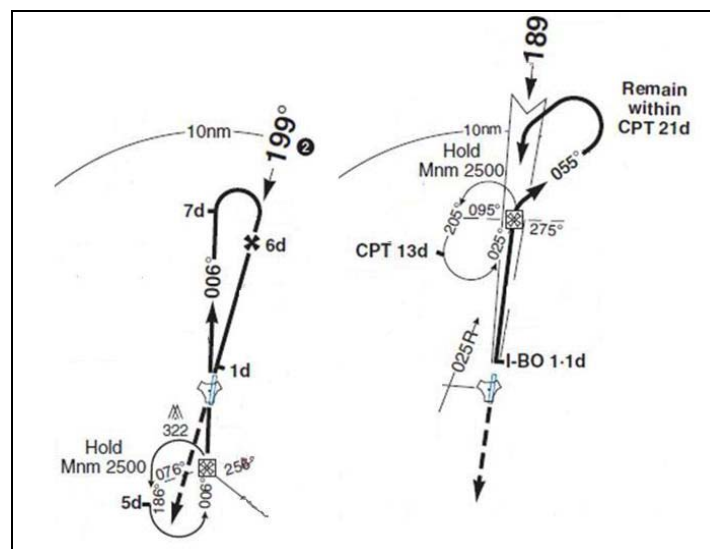
Figure 1: RAF Benson COPTAC (left) and VOR ILS/DME Procedure (right) RW19.

Figure 1 above depicts the COPTAC and VOR ILS/DME procedures to RW19; the base height for the hold for both procedures is 2500ft QFE. The COPTAC approach requires aircrew to maintain 2500ft QFE from the IAF to 7d on the outbound leg of 006°. The VOR ILS/DME approach requires aircrew to maintain from 2500ft QFE until they pass the IAF on the outbound leg of 055°.

Given the height of the outbound leg of the COPTAC procedure and the base height of the VOR ILS/DME hold, there is no procedural deconfliction between these procedures. RAF Benson ATC has confirmed that there is a local procedure to deconflict level allocation between the two holds. The specific scenario encountered in this Airprox is covered in local training material and Benson controllers receive synthetic based training and consolidation on IFR hold deconfliction.

The design of the COPTAC and VOR ILS/DME procedures, specifically the confliction between an ac on the outbound leg of the COPTAC and an ac at the base of the VOR ILS/DME hold, provides no element of procedural deconfliction. Although there is a local procedure to manage this confliction, it is wholly down to the ability and/or capacity of the DIR to identify this issue and to take corrective action; this means that the procedure is susceptible to ATM human error. In this instance, for a number of reasons, DIR specifically and ATC generally did not perceive the confliction.

Although not as a result of this Airprox, RAF Benson ATC, in association with AIDU, has undertaken a review of IFR procedures with the aim of reducing the current level of complexity by reducing the number of IFR holds, in accordance with PANSOPS procedure design guidelines.

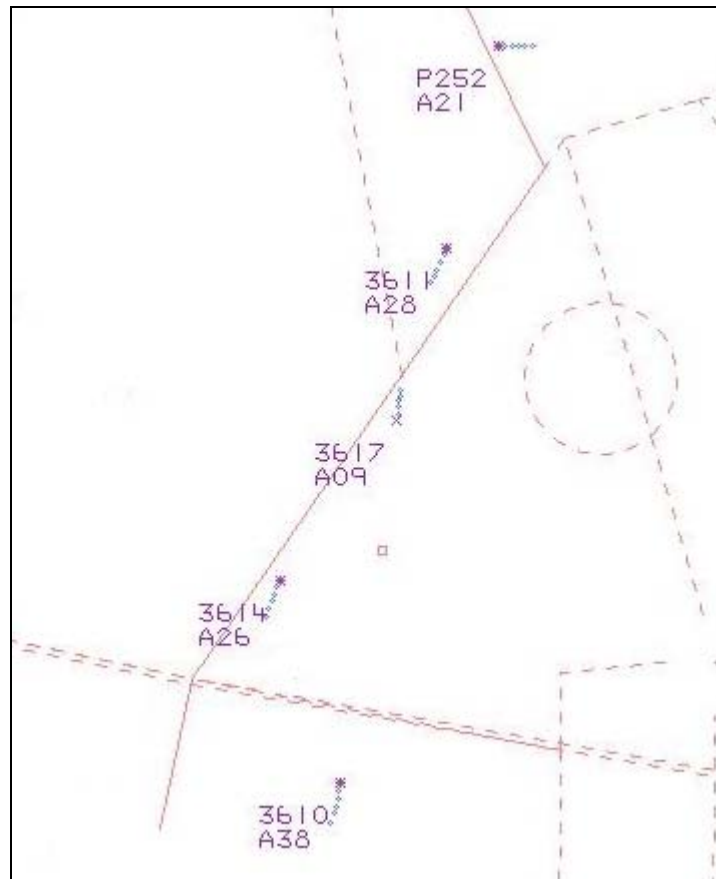
Figure 3. Position of DIRs Traffic at 1001:20.

At 1001:20, DIR had five ac on freq in the positions at Figure 3 and described their workload and task complexity as high. The incident ac were a Puma in the VOR ILS/DME hold at 2500ft QFE, SSR 3A 3611, and a Merlin departing the COPTAC hold at 3500 ft QFE, SSR 3A 3610. There were three further unconnected ac: a Chinook flying towards the VOR ILS/DME hold at 2500ft QFE, SSR 3A 3614; a Squirrel in the RTC, SSR 3A 3617 and a Police helicopter, SSR 3A code-callsign converted to P252.
