AIRPROX REPORT No 2011152

Date/Time: 27 Oct 2011 1831Z (Night)

Position: 5439N 00614W (0.5nm SW
Belfast/Aldergrove - elev 268ft)

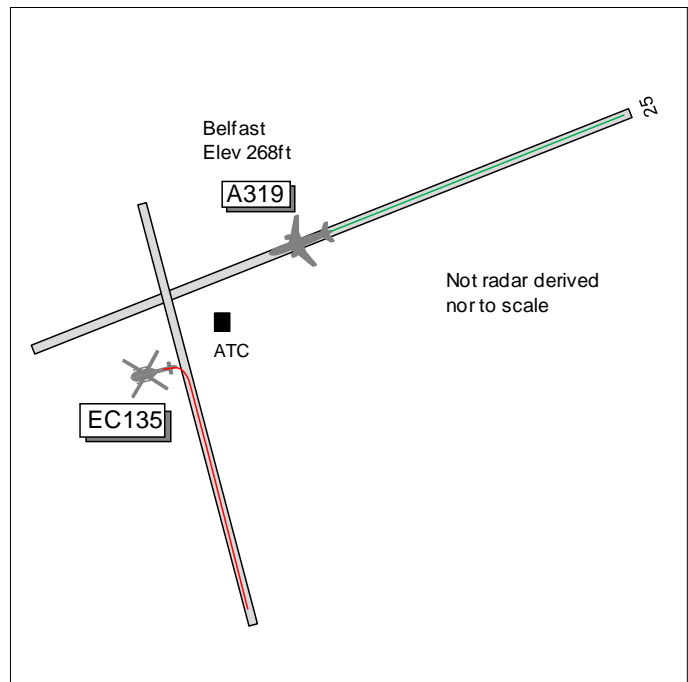
The controller mistakenly assumed that the EC135 would route from the RW35 threshold directly to the S. However the EC135 pilot's expectation was to depart into a visual cct from RW35 threshold in a similar manner to that previously approved (remaining S of the Tower line and RW25). This resulted in the A319 and EC135 departing from crossing RWs at the same time.

In the absence of any TI, the A319 pilot departed, unaware that the EC135 helicopter was approaching, at night, from the S. The A319 crew perceived that there was a conflict and the pilot took action to ensure that separation was maintained, by turning R 30° immediately after departure.

Cause: In the absence of TI, the A319 crew was concerned by the proximity of the EC135.

As a result of the incident and in consultation with CAA SRG appropriate unit action has been taken with additional training for the controller and with lessons learned material disseminated within the unit.
