## AIRPROX REPORT No 2010027

Date/Time: 25 Mar 1115

Position: 5212N 00137W  
(Wellesbourne - elev  
159ft)

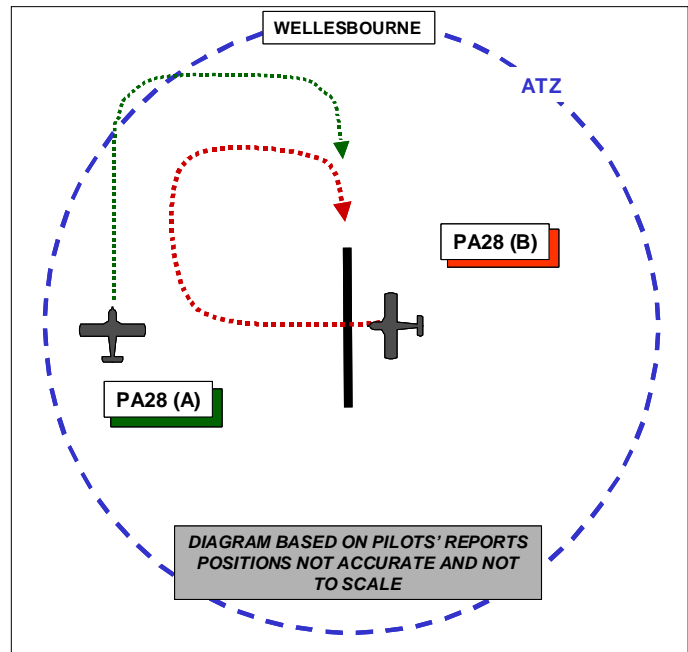
They established their ac on a 3-degree glidepath but when they were at about 500ft they saw the front of the other ac immediately below them on a very shallow glidepath at a distance estimated as less than 100ft. He immediately took control and initiated a missed approach and reported the Airprox on the frequency; the FISO confirmed this with a time check. He considered that there was a risk of collision on final approach and, had PA28 (B) corrected its shallow glidepath, he would have climbed up into their ac having not been seen. He assessed the risk as medium.

**The FISO** reports that the RW18 was in use with a RH cct, which was busy with around 5 ac. The pilot of PA28 (A) reported downwind and shortly afterwards he watched PA28 (B) turn downwind; PA28 (B) was 'closer in' than PA28 (A) and slightly behind. As he thought that there was a risk of the ac getting closer round the base-leg turn, he confirmed over the RT that both pilots were aware of each other. PA28 (A) reported 'final' followed shortly afterwards by PA28 (B) also reporting 'final'. Because it appeared to be very close behind PA28 (A), he asked PA28 (B) pilot if he would be going around; the pilot replied that he had the other ac in sight, but did not immediately go around. About 10sec later PA28 (B) initiated a go-around and shortly afterwards PA28 (A) also initiated a go-around; the ac appeared to get quite close, he estimated less than 150ft.

UKAB Note (1): The recording of the Clee hill radar shows the incident. There are 5 ac in the Wellesbourne cct, all squawking 7000 with Mode C so it is not possible to identify specific ac with any degree of certainty. At 1112 one contact appears to cut inside another in the cct, but this also happens some 2min later. It is not possible, therefore, to determine which incident is the one reported.

Cause: The pilot of PA28 (B) did not integrate into the circuit pattern established by PA28 (A) ahead.
