AIRPROX REPORT No 2010039

Date/Time: 30 Apr 2010 1434Z

Position: 5137N 00105W (Benson
Circuit - elev 203ft)

Airspace: ATZ (Class: G)

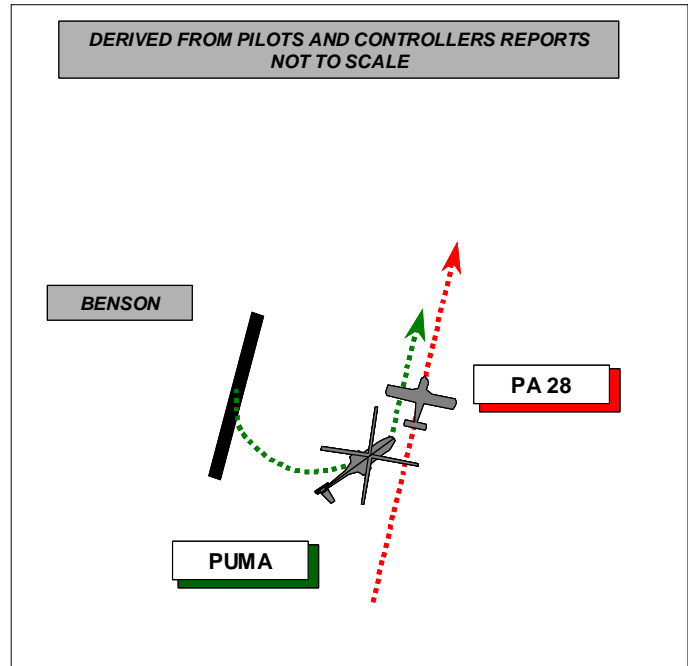
UKAB Note (1): The recording of the Heathrow radar shows the PA28 throughout and the Puma intermittently. The PA28 joins the circuit as described by its pilot, descending to be at 1000ft at the beginning of the downwind leg. The Puma appears as a primary only contact almost abeam the ARP converging with the PA28 and closing to 0.1nm (the minimum radar resolution) before the separation increases as the Puma decelerates in the PA28's 6 o'clock.
