## **AIRPROX REPORT No 2010057**

Date/Time: 26 May 2010 1352Z

Position: 5025N 00458W (1½nm  
SE of Newquay Cornwall  
Airport - elev 390ft)

Airspace: Newquay ATZ (Class: G)

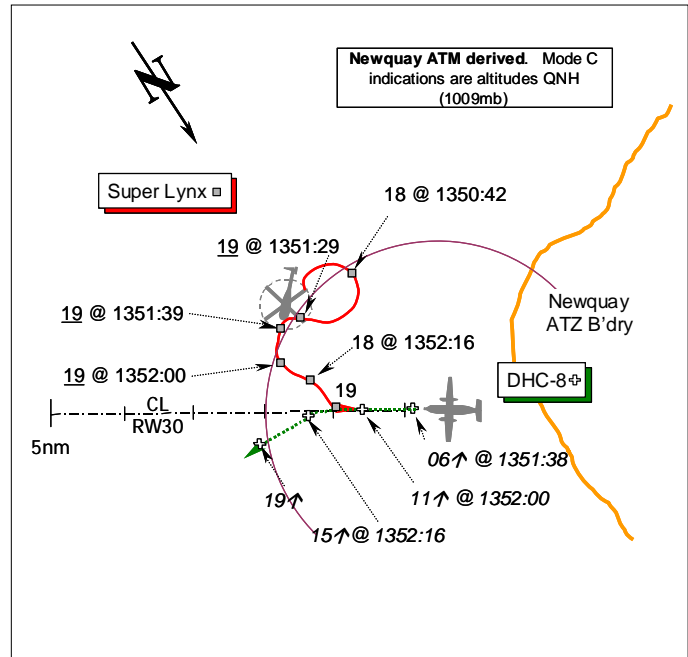
200ft V/500m H

300ft V/0.5nm H

the radar recording shows the DHC-8 commencing a L turn to the E indicating 1500ft ALT, with the Lynx 0.5nm S of the centreline indicating 1800ft ALT at the CPA. It was noted that the DHC-8 pilot's use of the wrong callsign was probably a slip due to the urgency of the transmission and this was repeated by TOWER. The DHC-8 was transferred to the radar frequency immediately after the L turn was approved and before the Lynx had passed abeam. Because the DHC-8 was no longer following noise abatement the ADC considered it important to transfer the flight early so that the APR could deal with the non-standard turn. This was co-ordinated with the APR, the ADC being satisfied at this stage that the Lynx would pass S of the DHC-8.
