AIRPROX REPORT No 2010111

Date/Time: 17 Aug 2010 1443

Position: 5353N 00122W (6.5nm WNW Church Fenton - elev 29ft)

Airspace: Vale of York AIAA (Class: G)

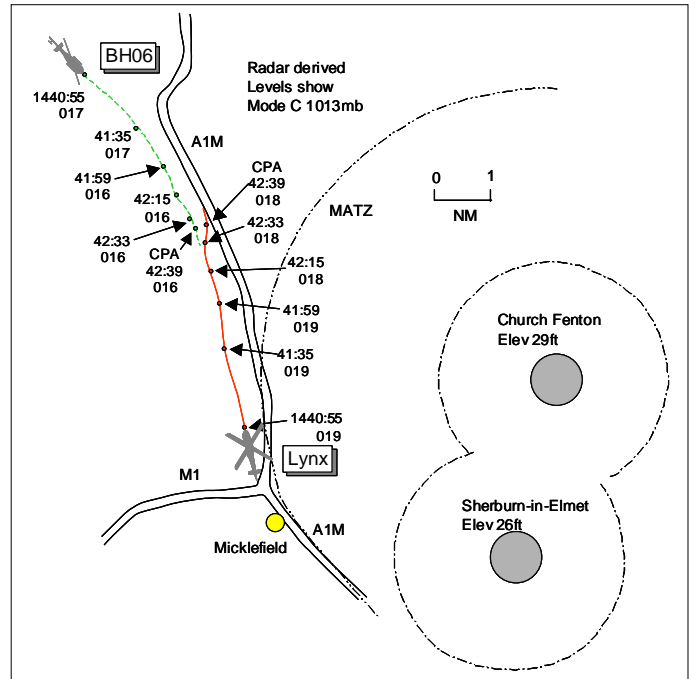
[UKAB Note (1): The radar recording at 1440:55, when the JetRanger pilot makes initial contact with CFN APP, shows the JetRanger 9.7nm NW of Church Fenton tracking 135° indicating FL017 (1370ft RPS 1002). At the same time the Lynx is 5.4nm WSW of Church Fenton tracking 350° indicating FL019 (1670ft RPS), in the JetRanger’s 1 o’clock range 6.7nm. Just over 1min later at 1441:59 the JetRanger has descended 100ft and turned R about 25° head-on to the Lynx in its 12 o’clock range 2.6nm. Both helicopters converge and by 1442:15 the Lynx is indicating FL018 (1470ft RPS) 1.5nm ahead of the JetRanger.]

At the point when the Lynx’s avoiding turn to the R becomes evident at 1442:33, the JetRanger has entered a slight turn to the L, bringing it further into conflict with the Lynx, separation 0.5nm and 200ft. At 1442:37, CFN APP passes TI to the JetRanger flight and the CPA occurs 2sec later at 1442:39, with just under 0.2nm lateral separation existing - at this point the JetRanger has appeared to turn back to the R, away from the Lynx.
