**AIRPROX REPORT No 2010132**

Date/Time: 5 Aug 2010 (Thursday) 1147Z

Position: 5134N 00102W (5nm  
S Benson)

Type: Lynx GLIDER

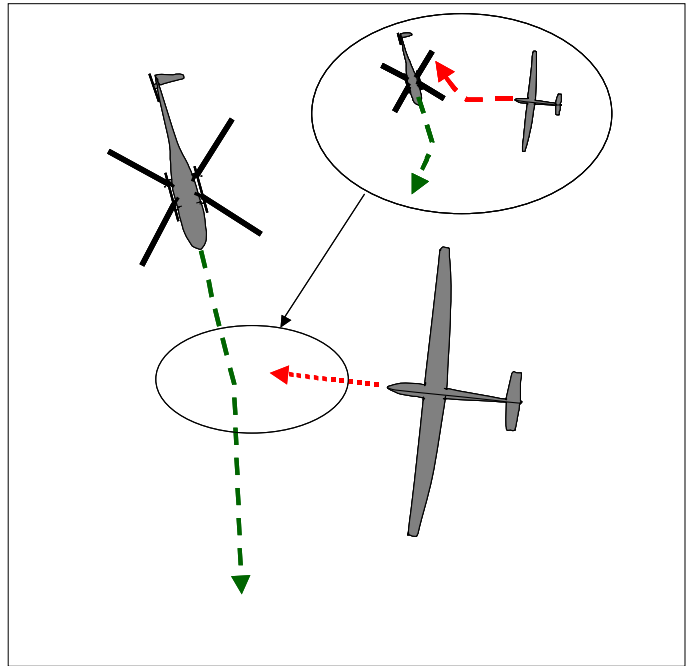
UKAB Note (1): The recording of the Heathrow 23cm radar shows the Lynx throughout, squawking 3615, tracking 175° at FL031. At 1145:21, an intermittent primary only contact, presumed to be the glider, pops up at 3nm in the Lynx's 11 o'clock. The Lynx continues to close with the primary contact which tracks 280° until 1146:46 when it disappears from radar when under ½nm away in the Lynx's 1030 position. The CPA is not recorded but the Lynx can be seen to turn right at 1146:55.

APP updated the TI on the glider at 1146:44 saying, “*previously called traffic twelve o’clock, half a mile crossing left right, no height information;*” however, the glider’s primary contact had disappeared from the radar recording [not necessarily APP’s display] as it was being called. While the CPA is not captured on the replay, there is no reason to believe that the loss of data occurred on the Watchman display at the unit. It is possible to extrapolate from the replay that at the point that the TI was updated, the glider was actually in the 11 o’clock position at ½ nm, rather than 12 o’clock, with the glider moving towards the 10 o’clock position given the ac’s relative speeds, in keeping with the Lynx pilot’s description. The CPA probably occurred at around 1146:51 immediately prior to the Lynx pilot’s sighting report, with the Lynx’s avoiding action turn to the right becoming apparent on radar at the next sweep at 1146:56.
