AIRPROX REPORT No 2022004

Date: 20 Jan 2022 Time: 1052Z Position: 5247N 00246W Location: 4NM west of Shawbury

PART A: SUMMARY OF INFORMATION REPORTED TO UKAB

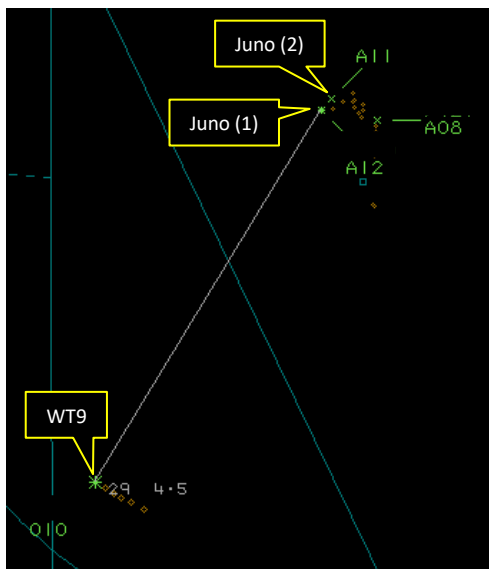
Figure 1

The WT9 pilot was routing towards Sleaf whilst maintaining outside the Shawbury ATZ (see Figure 1). The Juno pilots appeared to be transiting westerly. The Aerodrome and Approach controllers had both had Traffic Information passed to them by either the Zone controller or Supervisor regarding the WT9 transit. The WT9 pilot reported visual with Sleaf and requested to change frequency. The separation decreased to 3.3NM (see Figure 2).

WT9 routing as expected and Junos transiting towards westerly departure

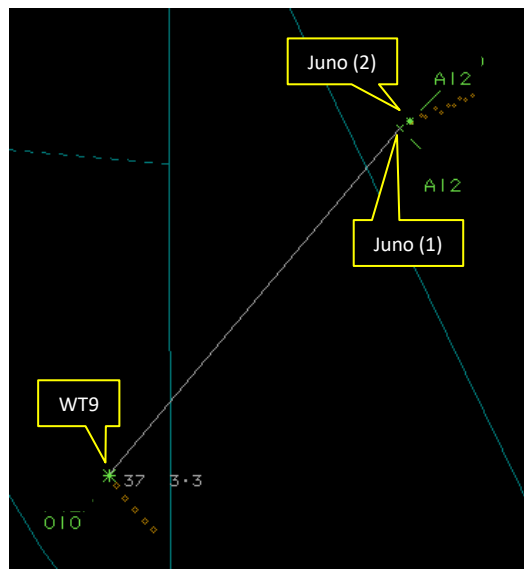
Figure 2

WT9 pilot reported visual with destination

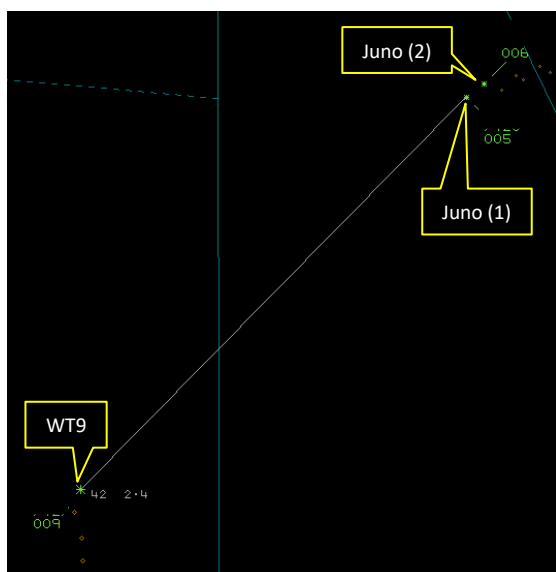
Figure 3

Twenty-one seconds later, Traffic Information was passed highlighting that there was a formation of helicopters northeast, 3NM indicating three hundred feet below. They were then advised to squawk 7000 and change to their en-route frequency. This is not acknowledged by the WT9 pilot. Separation decreased to 2.4NM and 400ft from the lead aircraft (see Figure 3). Twenty-three seconds later, the lead Juno pilot reported switching to stud 4 following their departure from the airfield. Separation decreased to 1.5NM and 400ft. The Aerodrome controller did not pass Traffic Information to the Juno pilot (see Figure 4).

Traffic Information passed to the WT9 pilot

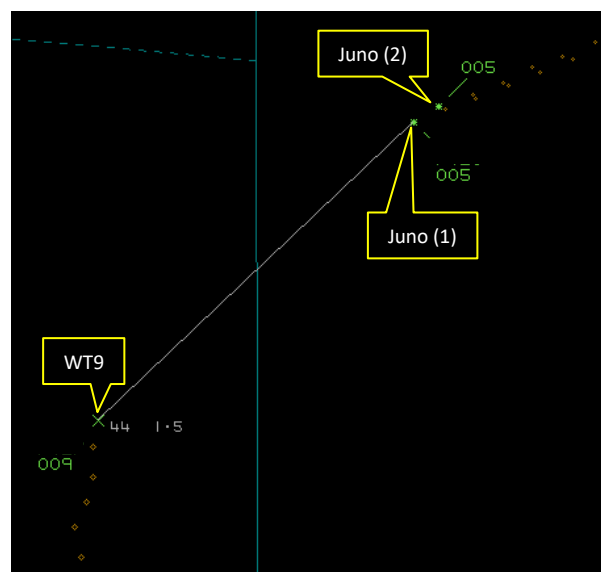
Figure 4

Lead Juno pilot reported changing to stud 4

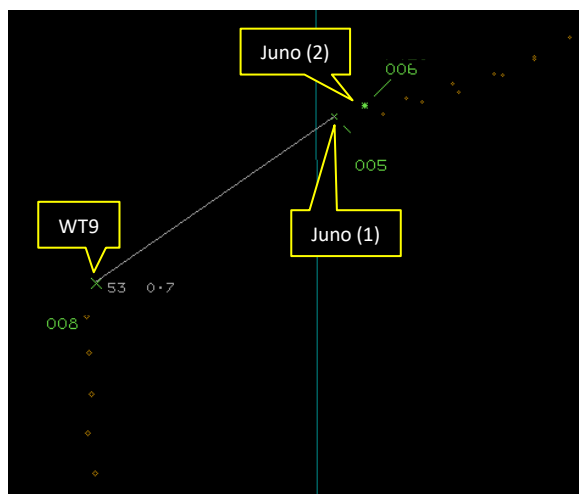
Figure 5

Eighteen seconds later, the Juno pilots began their check in on the Low Level frequency, however, this was not complete. The Approach controller opted to not pass Traffic Information to the Juno pilot. Separation decreased to 0.7NM and 300ft from the lead aircraft (see Figure 5). CPA occurred 20 seconds later. Separation was measured at 0.0NM and 100ft for what is believed to be the Juno formation lead and the WT9 and 0.1NM and 0ft between the WT9 and the formation trail See Figure 6).

Juno pilots begin to check-in on LL frequency

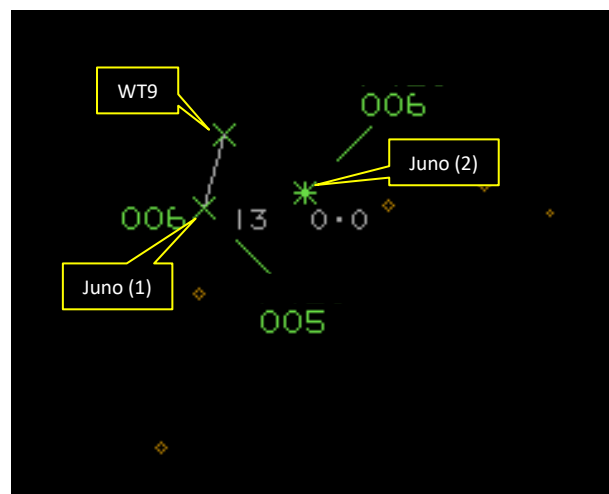
Figure 6

CPA
