AIRPROX REPORT No 2022002

Date: 12 Jan 2022 Time: 1120Z Position: 5155N 00211W Location: Gloucestershire

PART A: SUMMARY OF INFORMATION REPORTED TO UKAB

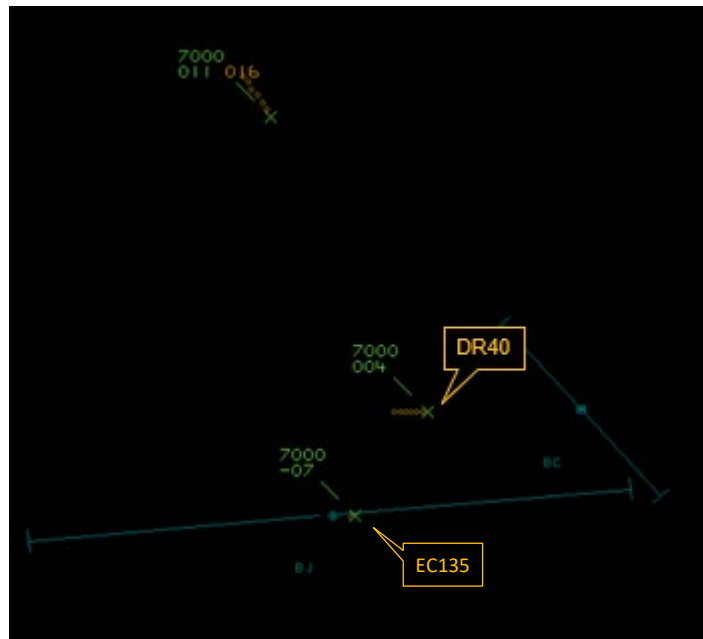
Figure 1 – 1115:48 – add 750ft for aircraft altitude

The EC135 pilot replied: “*visual with the Robinson and clear cross 27, standard helicopter departure to the north – cleared take-off*”. At this time the EC135 briefly became visible on the radar replay but then disappeared at 1116:20 until some 5 minutes later (Figure 1).

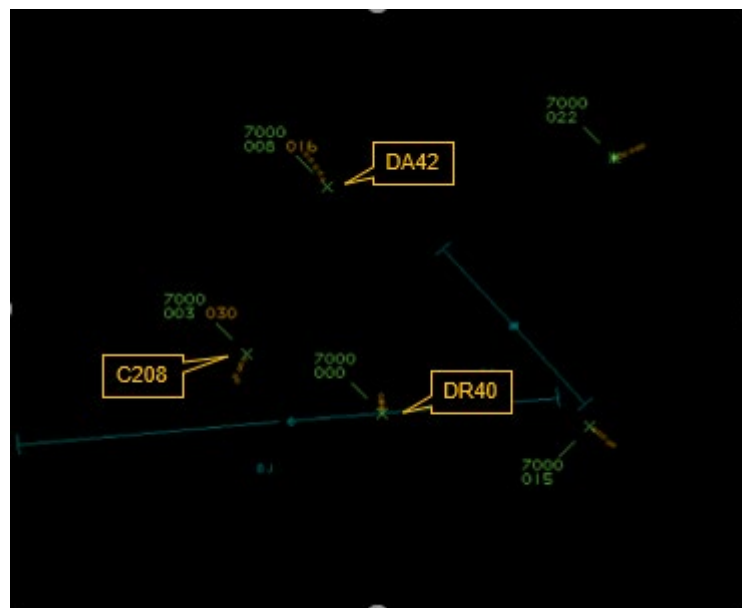
Figure 2 – 1117:18

At 1116:48 the controller cleared a vehicle to cross the runway which was followed by a “*finals*” call from the pilot of the DR40. Before the controller replied, the pilot of another aircraft, a DA42 inbound from the north, made their initial call to the Tower controller at 1117:18 reporting that they were joining right base (Figure 2).

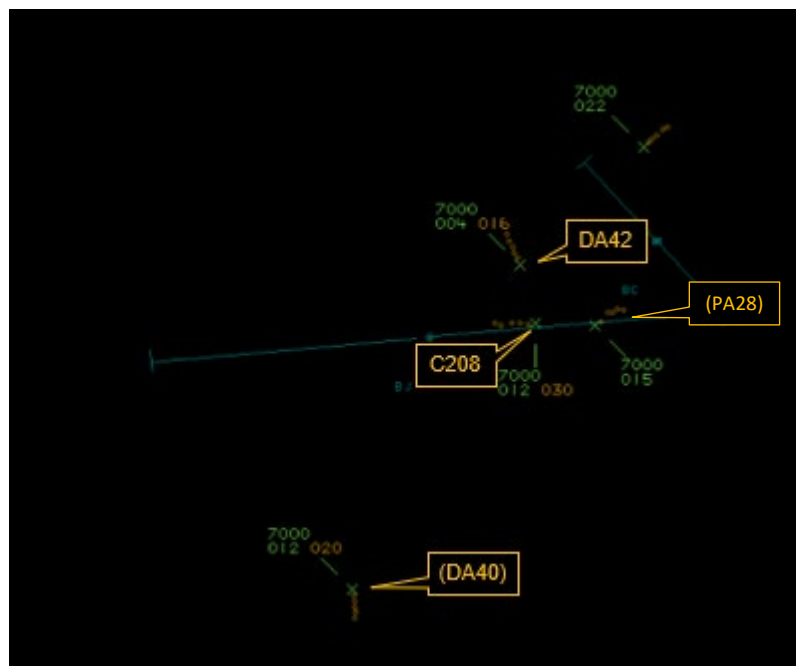
Figure 3 – 1118:52

At 1118:52 the inbound DA42 pilot called but again this transmission crossed with a refuelling vehicle (Figure 3).

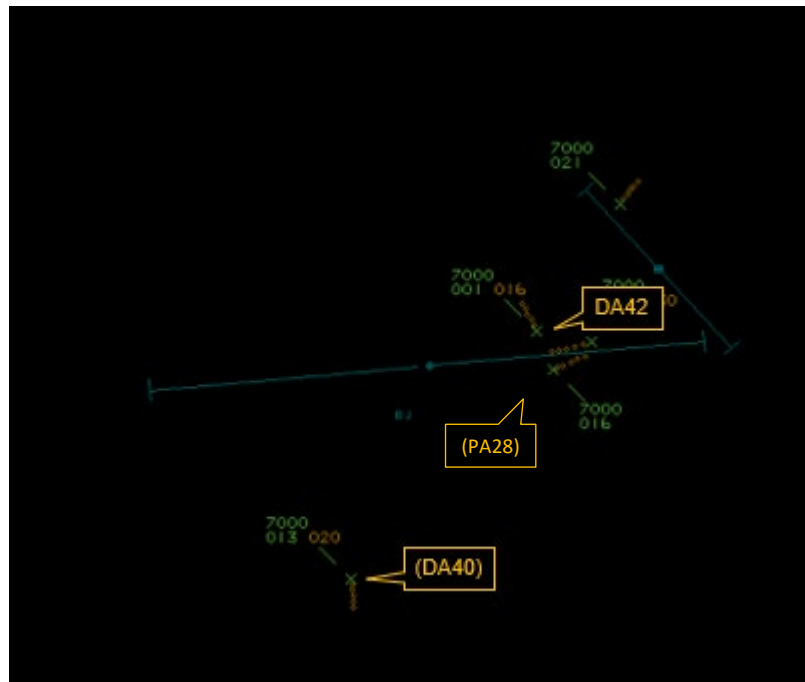
Figure 4 – 1119:20

The controller then, at 1119:20 asked the pilot of the PA24 if they would prefer a left or a right turnout. Although again this transmission crossed with another pilot's, the pilot of the PA24 advised that they could take either, but that they were following the previously departed C208. The OJTI then took the frequency and replied: "Ok yeah, please if you don't go straight up final approach track like the last one - right turn to the east, Runway 27 - cleared for take-off (surface wind)" (Figure 4).

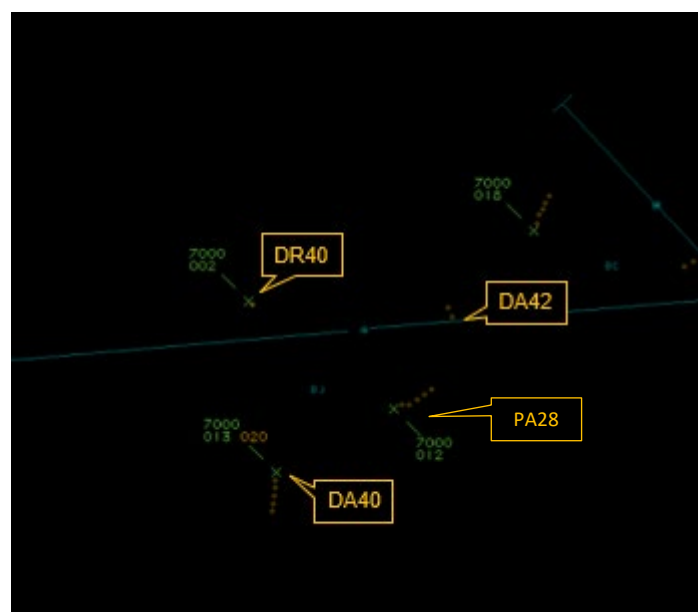
Figure 5 – 1120:30

There were again two simultaneous transmissions from pilots at 1120:30 (Figure 5).

It is considered that CPA between the PA24 and the EC135 would likely have occurred at some point during this period.

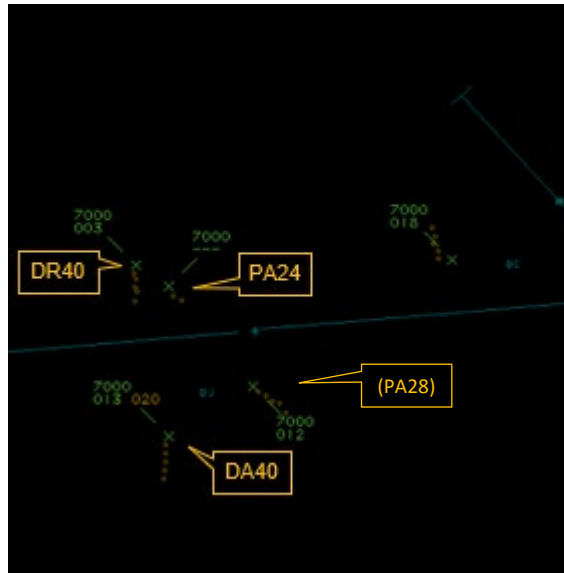
Figure 6 – 1120:48 – PA24 visible on radar replay

The controller then called the pilot of the DA40 inbound from the south and requested they report their position. However, the pilot of the DR40 in the circuit took the call instead and replied “*we’re just outside turning aircraft, just about to turn downwind. We’re visual with him*”. (Figure 6).

The controller then asked the pilot of the DA40 inbound from the south for their position. However, the pilot of the DR40 in the circuit replied instead and reported their position as being *“just outside turning aircraft, just about to turn downwind. We’re visual with him”*. (The DR40 pilot was likely visual with the previously departing PA24). Apparently not noticing that this was the pilot of the DR40, the controller instructed them to follow the PA28, possibly in the belief they were speaking to the pilot of the DA40. The pilot of the DA40 did not subsequently respond either. The radar replay (Figure 6) illustrates that this plan might have been sound.

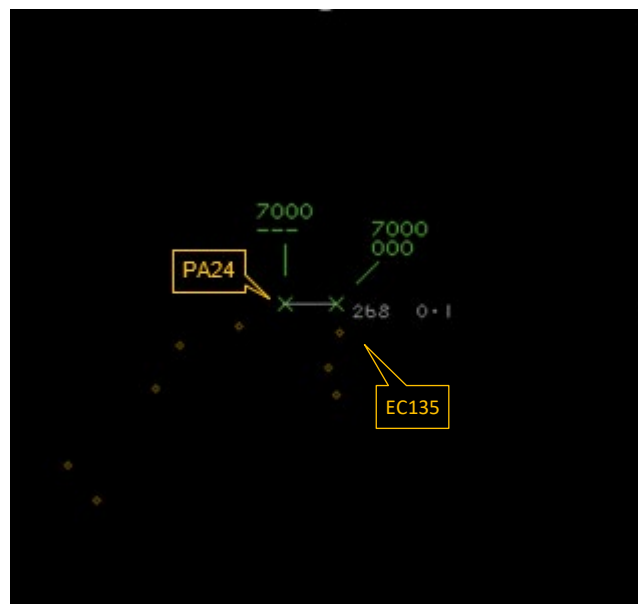
Figure 7 – 1121:15

The CPA reported by the RAC was at 1121:15 (Figure 7).

This has been discounted as CPA by ATSI as the report from the pilot of the PA24 stated that after the Airprox in the climb-out they turned downwind and saw the helicopter again, well below them.
