AIRPROX REPORT No 2022009

Date: 05 Feb 2022 Time: 1328Z Position: 5058N 00000E Location: 3.5NM W of Uckfield

PART A: SUMMARY OF INFORMATION REPORTED TO UKAB

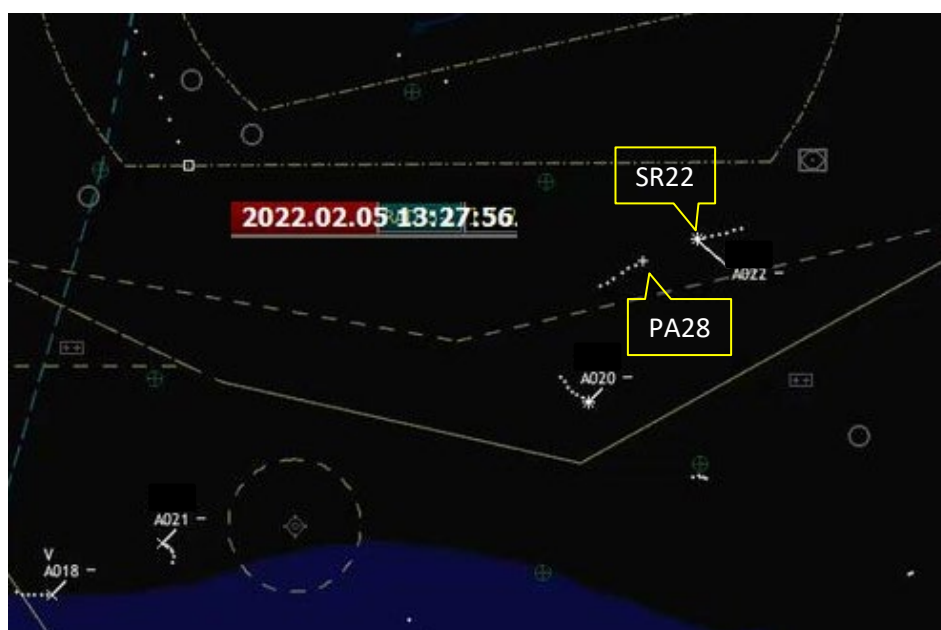
Figure 1 – 1327:56

[The SR22 pilot] then called to report that they climbed to 2550ft to avoid the conflicting traffic and that they were descending back to 2300ft. The base of CAS is 2500ft (TMA Class A). They confirmed that they had the traffic in sight and that they would report an Airprox when on the ground. [The SR22 pilot] reported that the other aircraft was at the same level and then left the frequency. The radar recording showed the contacts merging, but the conflicting aircraft had no Mode C (see Figures 1 and 2).

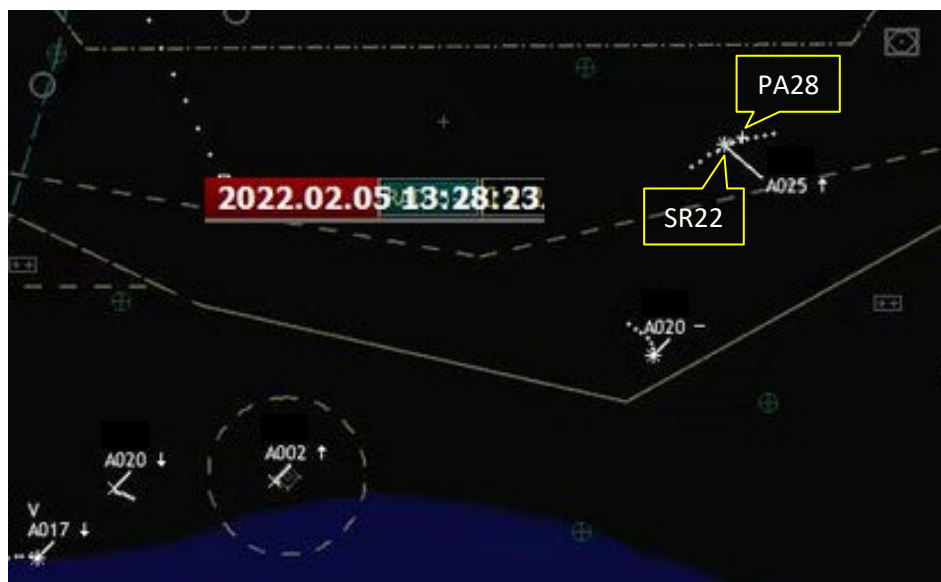
Figure 2 – 1328:23

13:28 [The SR22 pilot] acknowledged the warning of traffic. The contacts could then be seen to merge and [the SR22 c/s] could be seen climbing from 2200ft to 2500ft.
