## AIRPROX REPORT No 2022010

Date: 10 Feb 2022 Time: 1344Z Position: 5416N 00113W Location: 2.5NM N Sutton Bank

### PART A: SUMMARY OF INFORMATION REPORTED TO UKAB

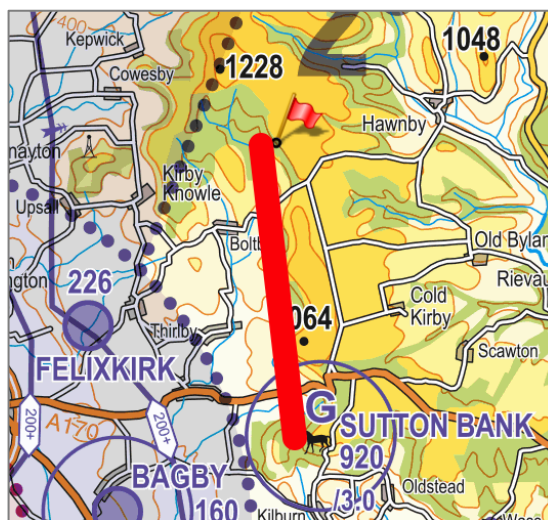
Figure 1

When westerly winds exceed 15kts, the western edge of the North York Moors between Sutton Bank Airfield and Boltby Forest becomes very busy with gliders exploiting "ridge lift" (see red line on Figure 1). At these times up to 15 gliders continuously fly along this 4NM ridge line, typically below 1500ft agl; other traffic transiting the area can greatly reduce the chance of conflict with gliders by diverting around it, or passing over above 1500ft agl.

The high wind speeds, narrow band of rising air and ridge-soaring gliders' low flying height constrain the manoeuvres they can make to avoid other traffic if they are to remain airborne. In this incident the glider pilot sighted the Puma well before CPA, but the glider's height and position behind the ridge prevented its pilot taking early avoiding action. The Puma pilot's late sighting of the glider, coupled with the glider pilot's manoeuvre to both remain in rising air and keep the Puma in sight, caused the Puma pilot some anxiety. Mutually-compatible Electronic Conspicuity equipment in both aircraft could have given the helicopter pilot earlier warning of the glider's presence, and the opportunity to take the early avoiding action that the glider pilot could not.
