AIRPROX REPORT No 2022012

Date: 10 Feb 2022 Time: 1447Z Position: 5052N 00043W Location: Chichester/Goodwood circuit

PART A: SUMMARY OF INFORMATION REPORTED TO UKAB

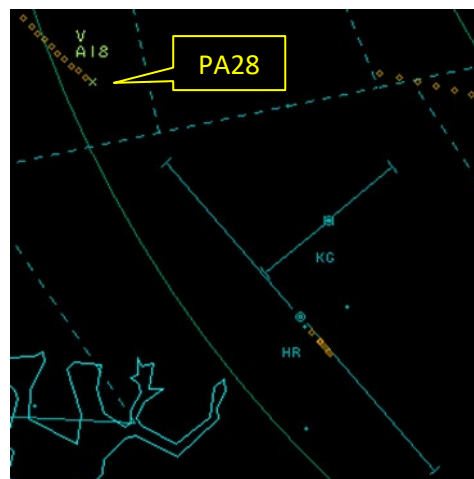
Figure 1 – **1442:50**

At **1442:50** the PA28 pilot reported downwind for RW32 and the FISO passed Traffic Information on an aircraft ahead that was joining on base leg. The pilot responded that they had copied the traffic (Figure 1).

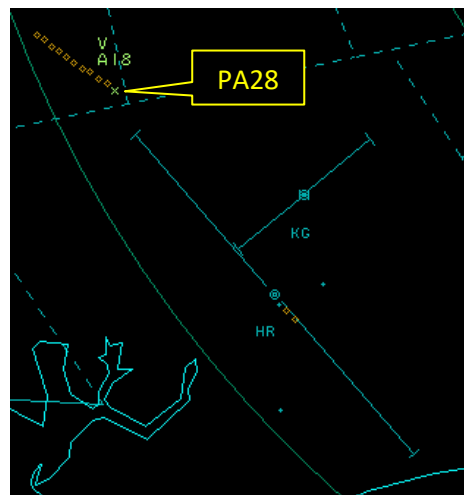
Figure 2 – 1443:30

At **1443:30** The G2 pilot requested to *"circuit right."* The FISO responded, *"triangle, take off at your discretion, the wind is 290/12."* The pilot responded, *"roger"* (Figure 2).

When the G2 pilot was given take-off at their discretion for the right-hand circuit, the PA28 had only just reached the start of the downwind leg.

Traffic Information was not passed to the G2 pilot on the PA28 when the G2 pilot was getting airborne into the circuit.

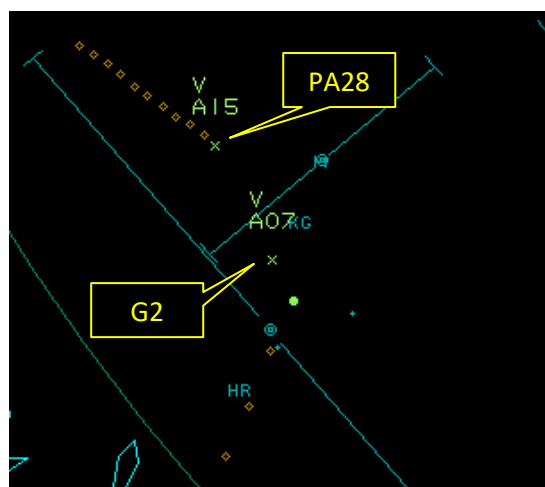
Figure 3 – 1445:10

At **1445:10** the G2 first appeared on the radar replay (Figure 3).

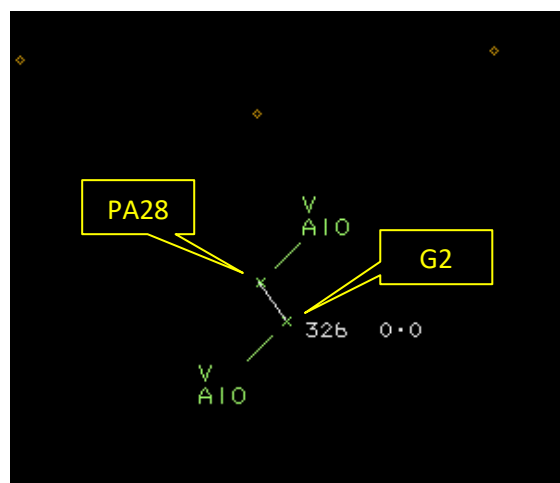
Figure 6 – 1446:33 CPA

At **1446:32** CPA occurred, with the aircraft separated by <math><0.1\text{NM}</math> laterally and an indicated 0ft vertically (Figure 6).

The PA28 pilot was observed on the radar replay to have descended below the published fixed-wing circuit height while on the downwind leg of the circuit. The pilot confirmed in their report, that distraction had played a part in the unintended descent.

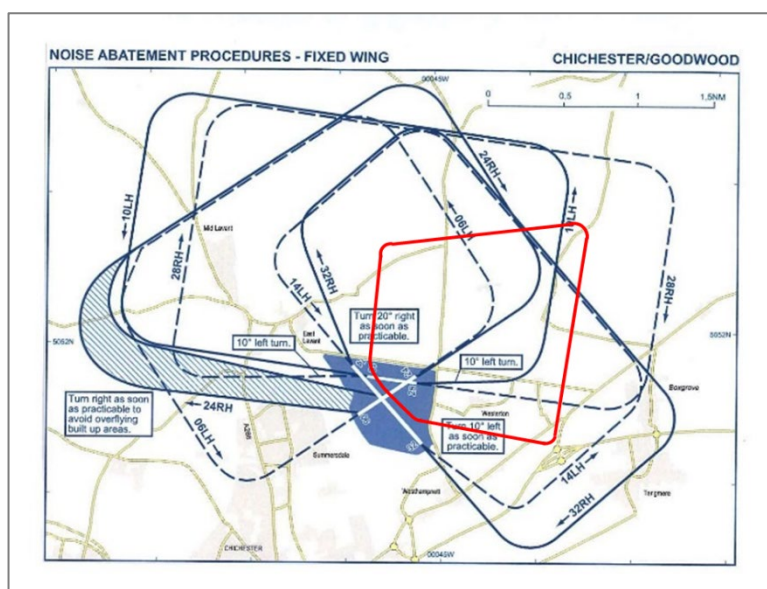
Figure 7 – Chichester/Goodwood circuit patterns for fixed-wing aircraft, overlaid with the (Northern) helicopter pattern for when RW14/32 is in use¹

A schematic of the fixed-wing and rotary-wing circuits at Goodwood is at Figure 7. It should be noted that in the AIP the fixed-wing and rotary-wing circuit patterns are represented independently and are not overlaid as in this schematic. The airfield elevation at Goodwood is 109ft; therefore, the published fixed-wing circuit height of 1200ft equates to an altitude of 1300ft and the published rotary-wing circuit height of 900ft equates to an altitude of 1000ft.

The runway in use was RW32 for fixed-wing, with a corresponding 'Northern' circuit for helicopter training traffic. The circuit for RW14/32 and helicopter 'northern' circuit intersect at two points, but there is sufficient vertical separation (300ft) if both circuits are flown at an accurate height. The helicopter circuit patterns were introduced in 1991 and the fixed-wing circuits were established and optimised (for noise reduction) in 1978 as part of a legal (Section 52) review of Aerodrome operational limitations. The northern helicopter circuit is largely contained within the fixed-wing circuit, with traffic in both circuits moving clockwise for RW32, and anti-clockwise for RW14.

- The Northern helicopter circuit requires review. ACTION: The Northern circuit has been withdrawn from operational use pending completion of the review.
