AIRPROX REPORT No 2022013

Date: 05 Jan 2022 Time: ~1302Z Position: 5215N 00253W Location: Shobdon circuit

PART A: SUMMARY OF INFORMATION REPORTED TO UKAB

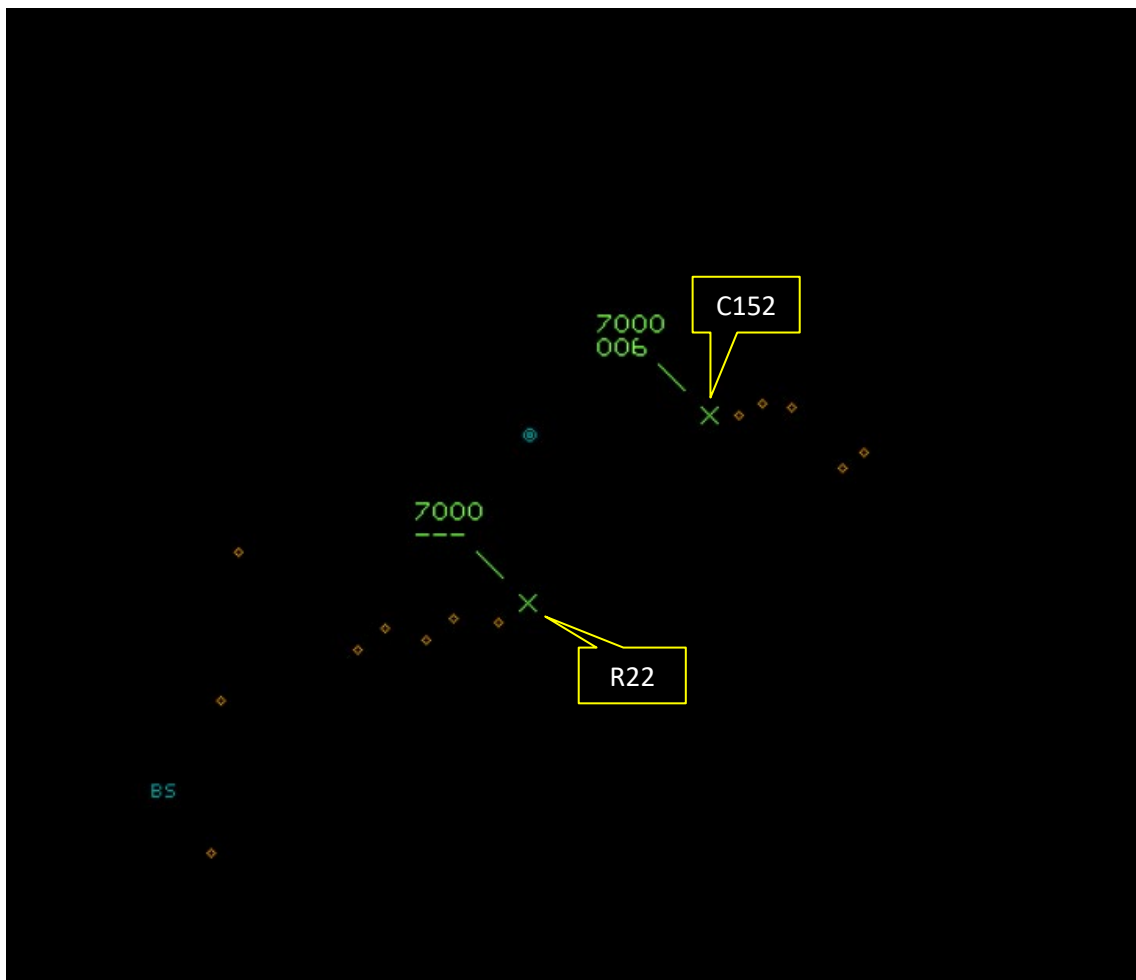
Figure 3 – 1259:36

Then at **1259:22** the pilot of the PA28 reported “er visual with the one that’s er just appeared inside on base”. The AFISO replied “thanks – report final”, although the end of the transmission crossed with the driver of the gliding vehicle. Another aircraft on the ground called up but the AFISO ignored that call and gave the pilot of the C152 the RW (see Figure 3).

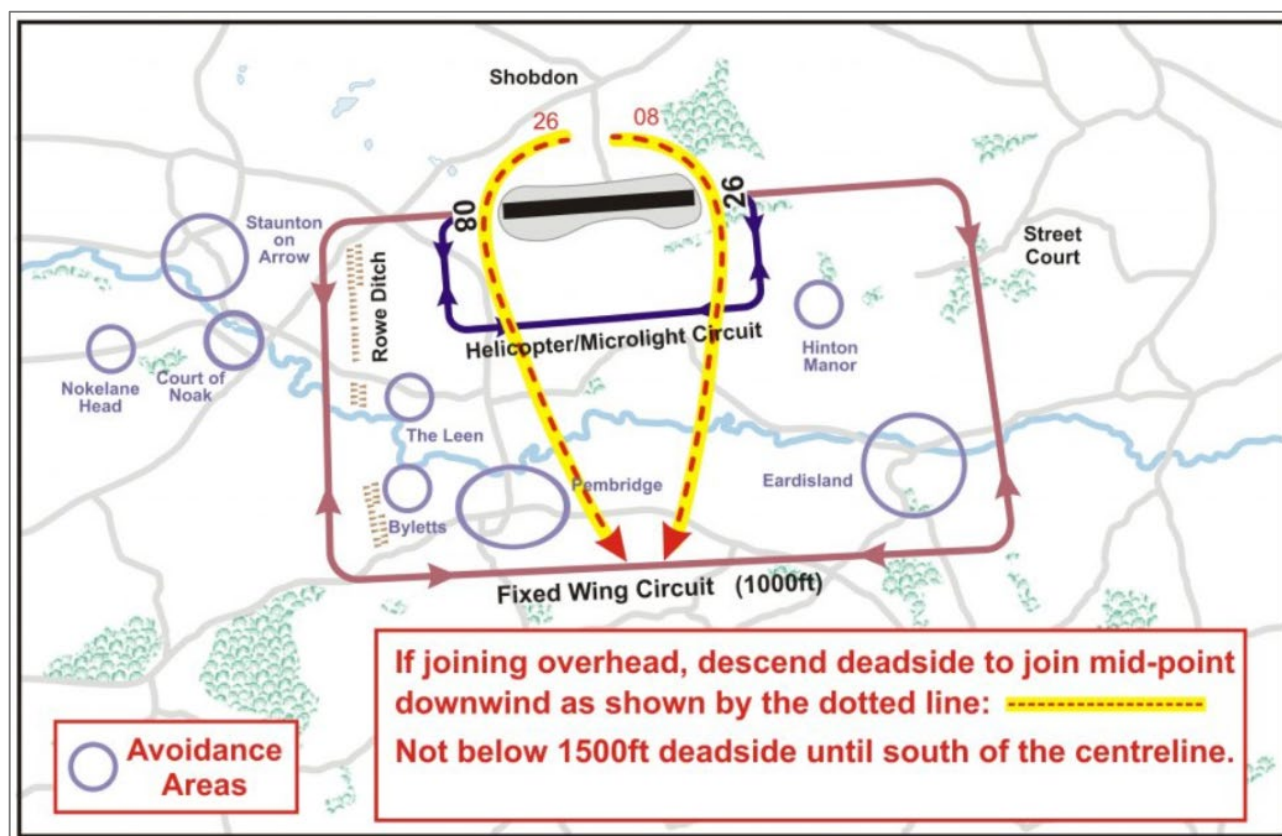
However, there is no description within the UK AIP of the relationship between the fixed-wing and helicopter circuits with respect to the significantly shorter track distance of the helicopter circuit when compared to the fixed-wing circuit. This information can be found on the Shobdon Airfield website (see Figure 4).

Figure 4 – Shobdon published circuit patterns¹

Regulations, Processes, Procedures and Compliance were assessed as **partially effective** because the published Shobdon circuit procedures for the integration of rotary and fixed-wing traffic flying different circuit patterns to the same RW are not sufficiently descriptive, which could lead to uncertainty amongst pilots as to the sequencing of aircraft in the 2 circuits.
