AIRPROX REPORT No 2022028

Date: 07 Mar 2022 Time: 0821Z Position: 5137N 00041W Location: High Wycombe

PART A: SUMMARY OF INFORMATION REPORTED TO UKAB

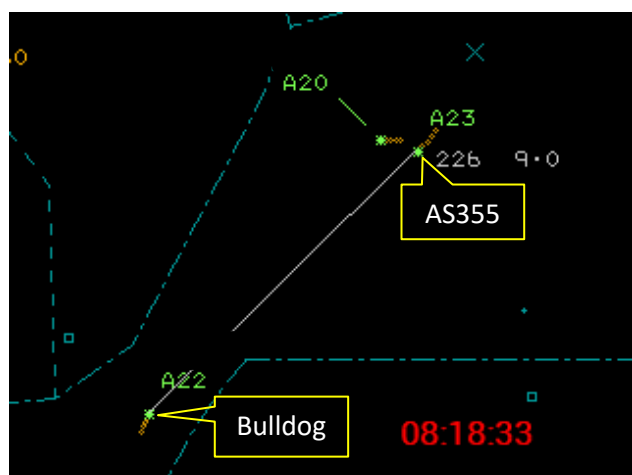
Figure 1 – 0818:33

At **0818:33** the Luton controller advised the pilot of [the AS355] "clear of the previously mentioned traffic. New Traffic, twelve o'clock, seven miles, opposite direction, indicating two thousand two hundred feet" (see Figure 1). The pilot of [the AS355] acknowledged the information and stated they were looking for the traffic.

The referenced traffic was [a Bulldog], displaying Mode-A code 4572 (Farnborough LARS West Monitoring Code) heading northeast 2.6NM south-east of Booker Airfield at an indicated 2200ft. [The Bulldog pilot] was listening out on Farnborough LARS frequency with no service agreed.

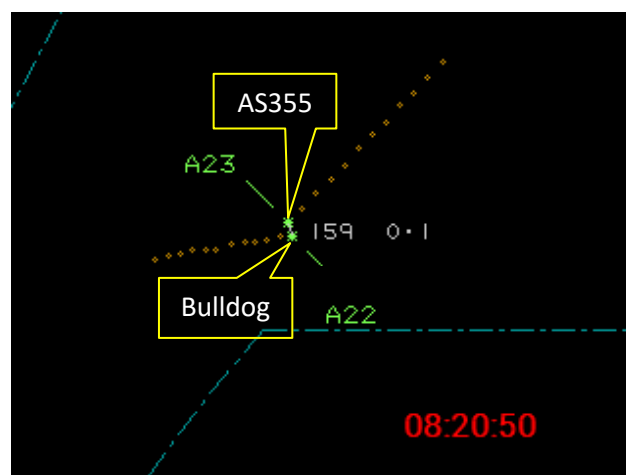
Figure 2 – 0820:50 - CPA

At **0820:50** [the Bulldog] crossed underneath [the AS355], approximately 4.3NM east of Booker Airfield (see Figure 2).

The Airprox occurred outside controlled airspace, when [the AS355] on a Traffic Service from Luton Radar and [the Bulldog] displaying a Farnborough listening code flew into proximity, approximately 4.3NM east of Booker. Closest Point of Approach occurred at **0820:50** and was recorded on Multi-Track Radar as 0.1NM and 100ft.
