AIRPROX REPORT No 2022025

Date: 08 Mar 2022 Time: 1052Z Position: 5217N 00016W Location: 4.5NM SW Huntingdon

PART A: SUMMARY OF INFORMATION REPORTED TO UKAB

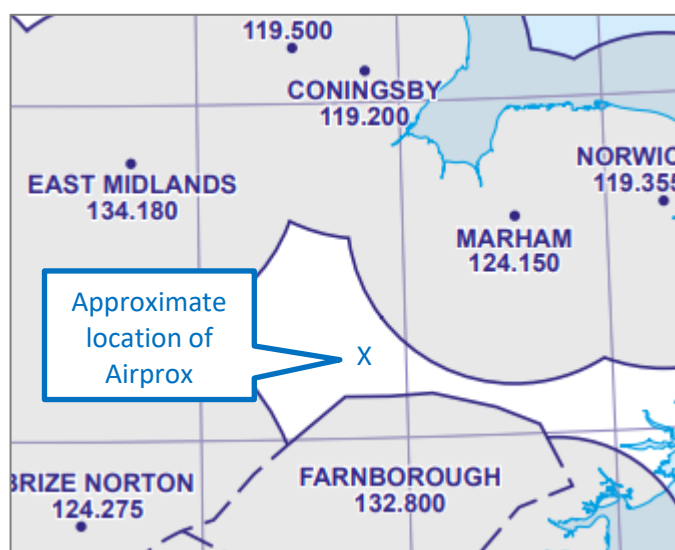
Figure 1. UK LARS provision.

- The Duxford AFISO would not have been aware of the presence of the PA28 as its pilot was not on their frequency.
- ATSI noted that in this area, there is no published LARS available, see Figure 1.

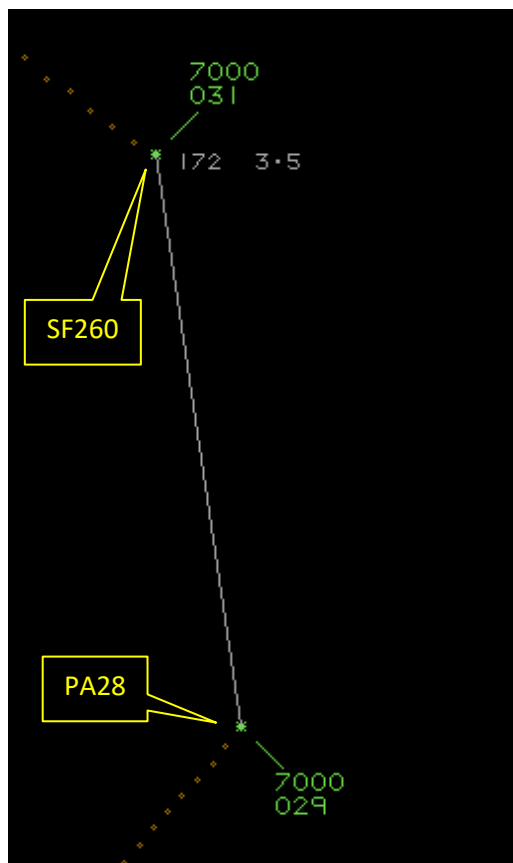
Figure 2 - **1050:30**

Both pilots had been maintaining a relatively straight course however the pilot of the SF260 had been in a slow descent whereas the pilot of the PA28 had been in a slow climb. Figure 2 shows the aircraft at **1050:30**, 1min 4sec before CPA when the SF260 was 200ft above the PA28, separation was 3.5NM. The SF260 pilot then flew level and, 48sec later at **1051:18**, the aircraft were co-alt and separated by 0.9NM, Figure 3.

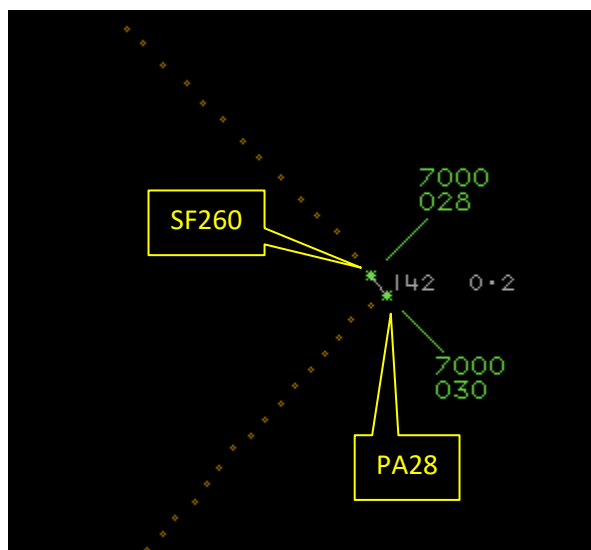
Figure 4 – 1051:34

The pilots maintained their trajectory and the aircraft continued to converge until at **1051:34** when the PA28 crossed ahead of the SF260, with a separation of 0.2NM and 200ft, Figure 4.

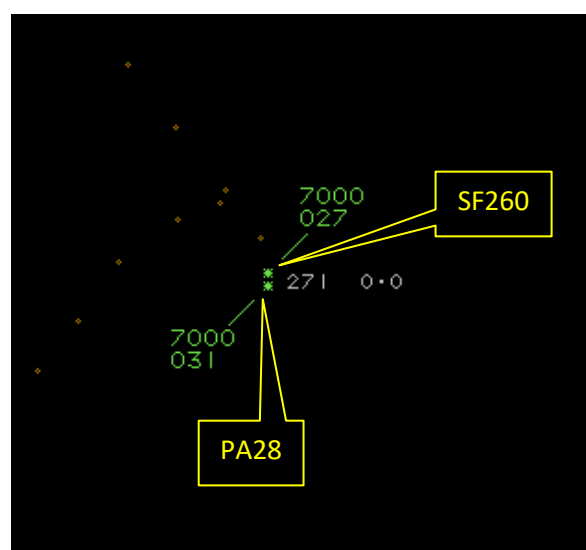
Figure 5 – CPA

On the next sweep, the radar recorded the right turn and climb as reported by the PA28 pilot. Although the SF260 pilot reported taking no avoiding action, the Mode C readout from the radar showed rate of descent for the SF260 of 450fpm increasing to 1000fpm. CPA occurred at **1051:42**, Figure 5. After CPA the PA28 pilot maintained their level and continued enroute and the SF260 pilot's rate of descent reduced to approximately 300fpm.
