**AIRPROX REPORT No 2022022**

Date: 06 Mar 2022 Time: 1247Z Position: 5216N 00015W Location: Grafham Water

**PART A: SUMMARY OF INFORMATION REPORTED TO UKAB**

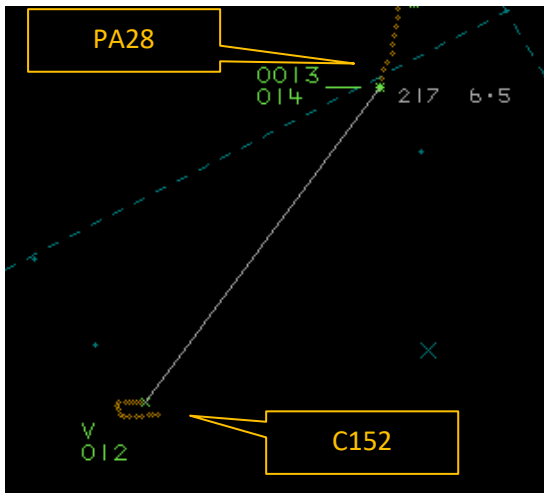
Figure 1 - 1244:07

An analysis of the NATS radar replay was undertaken. Neither pilot was receiving an ATS, the C152 was squawking 7000 (converted to 'V' on the radar replay) and the PA28 pilot was listening out on the Luton frequently and was therefore displaying the Luton frequency monitoring code of 0013. At Figure 1 the two aircraft were 6.5NM apart, the C152 was heading east and indicating FL012, and the PA28 was on a southerly heading, indicating FL014. The two tracks continued to close until 1245:31 (Figure 2) when the C152 turned onto a south-easterly heading at FL015.

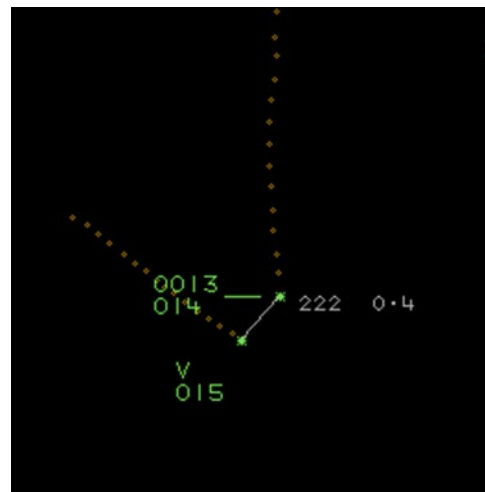
Figure 4 - 1246:53

Again the two aircraft continued and at 1246:53 (Figure 4) were 0.4NM apart with an indicated 100ft separation. The PA28 descended to FL013 shortly afterwards and CPA occurred at 1247:10 (Figure 5) with a radar indicated 100ft and <0.1NM separation.

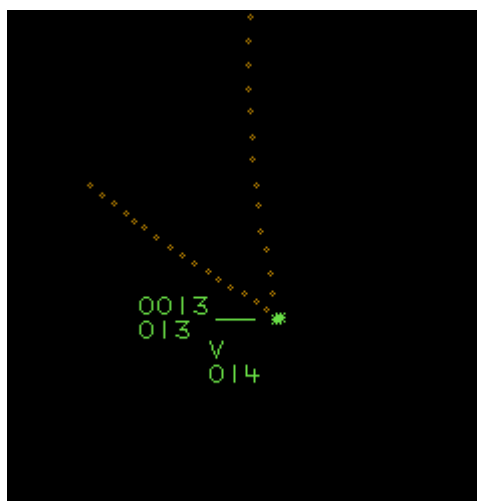
Figure 5 – CPA 1247:10

In determining the risk, members took into consideration the radar screenshots together with the reports from both pilots. They agreed that because the PA28 pilot had been visual with the C152, there had been no risk of collision, however, they felt that the separation was such that safety had been degraded and accordingly assessed the Airprox as Risk Category C.
