## **AIRPROX REPORT No 2022024**

Date: 07 Mar 2022 Time: ~1220Z Position: 5229N 00326W Location: Llandinam

### **PART A: SUMMARY OF INFORMATION REPORTED TO UKAB**

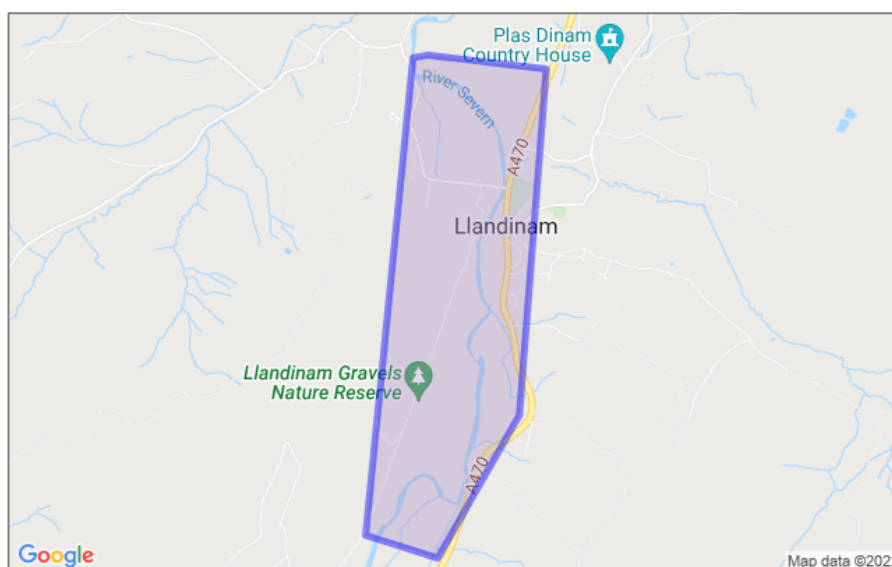
Figure 1 – Drone Assist UK depiction of DJI Mavic 2 operating area

An analysis of the NATS area radar replay was undertaken and, unfortunately, the event took place below the coverage of the NATS radars available at that time (the Clee Hill radar was unavailable on the day of the Airprox). However, the DJI Mavic operator supplied details of their notified (via Drone Assist UK) activity (see Figure 1) and the Texan II pilot report included a trace of the actual track flown by the Texan II see Figure 2). It has not been possible to measure a CPA due to the absence of GPS positional data at the time of the reported Airprox.
