AIRPROX REPORT No 2022033

Date: 20 Mar 2022 Time: 1545Z Position: 5030N 00139W Location: IVO THRED

PART A: SUMMARY OF INFORMATION REPORTED TO UKAB

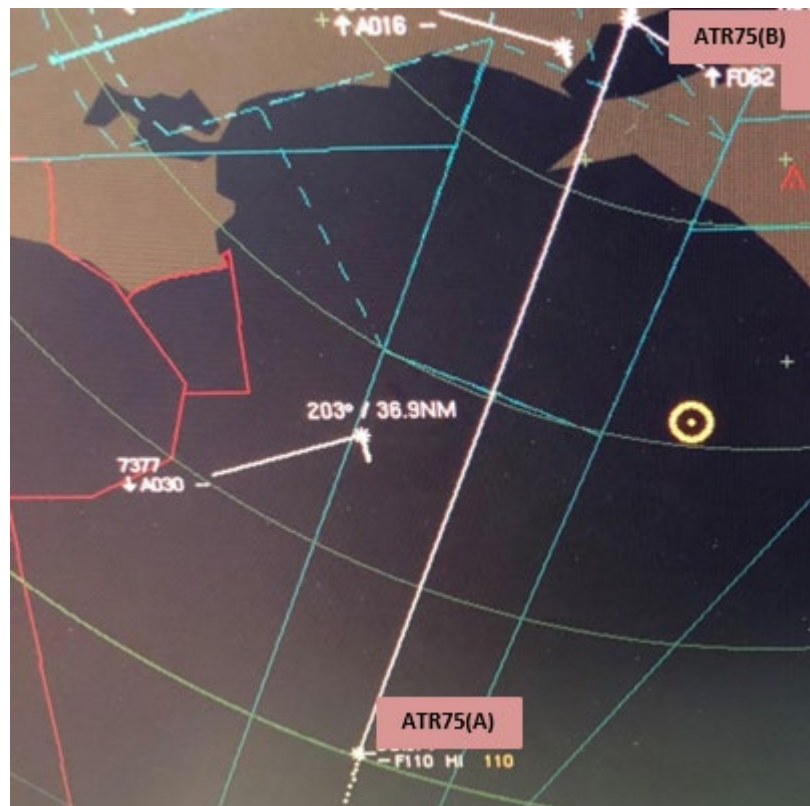
Figure 1 – Radar replay screenshot

1540:48 ATR75(B) transferred to London: Solent Controller- *'[ATR75(B) C/S] contact London control on one two nine decimal two three zero goodbye'*.

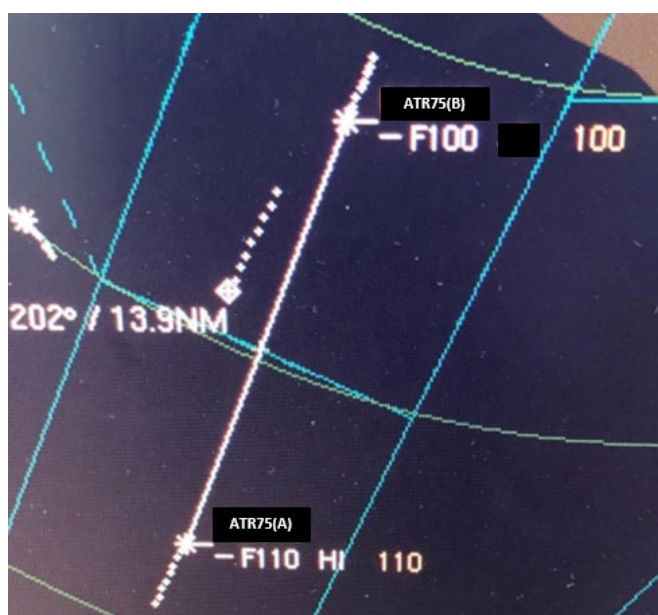
Figure 2

1543:43 Solent Radar issued descent to *[ATR75(A) C/S] '[ATR75(A) C/S] descend flight level seven zero'* and the instruction was readback by the pilot.

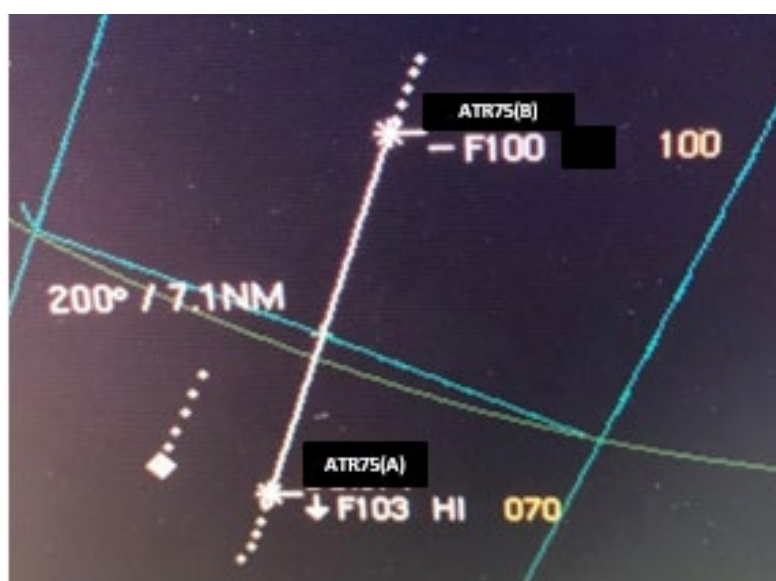
Figure 3

1544:32 The Planner called Solent and as the Solent controller answered the call, this alerted them to the situation and the Solent controller issued avoiding action '[ATR75(A) C/S] fly heading zero nine zero avoiding action'

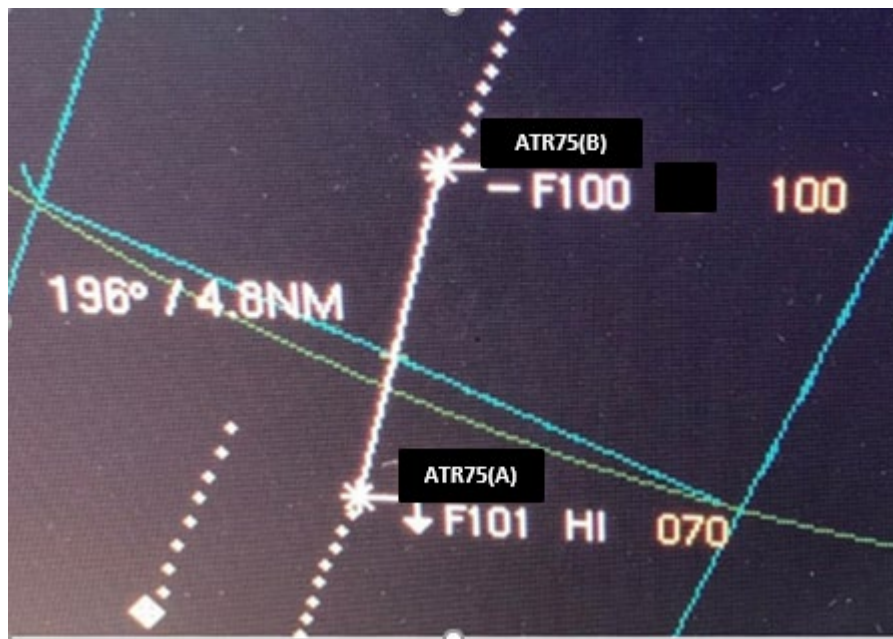
Figure 4 – Separation below 5NM

1544:47 Standard separation between the two aircraft was lost (5NM required), Figure 4.

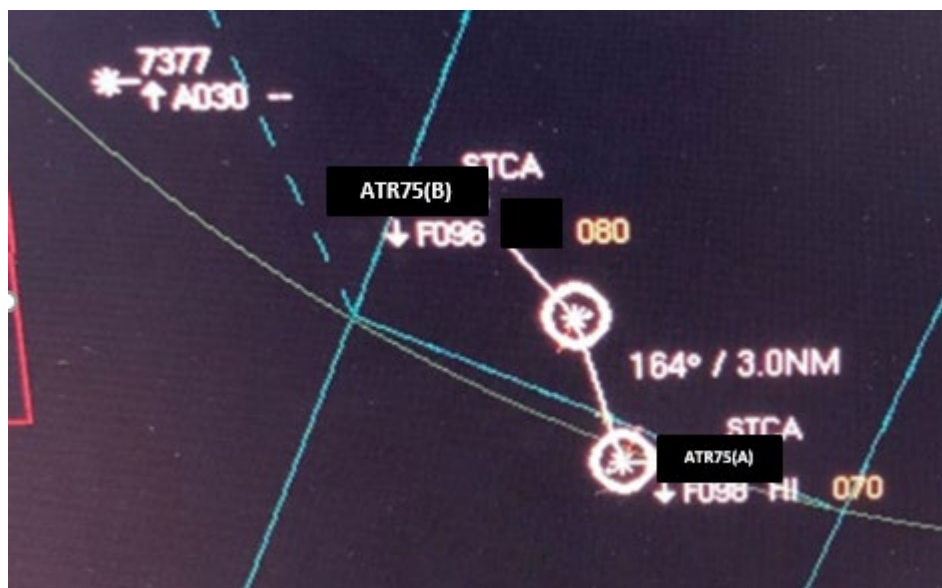
Figure 5

1545:07 Minimum separation between the two aircraft occurred with 3NM and 200ft.

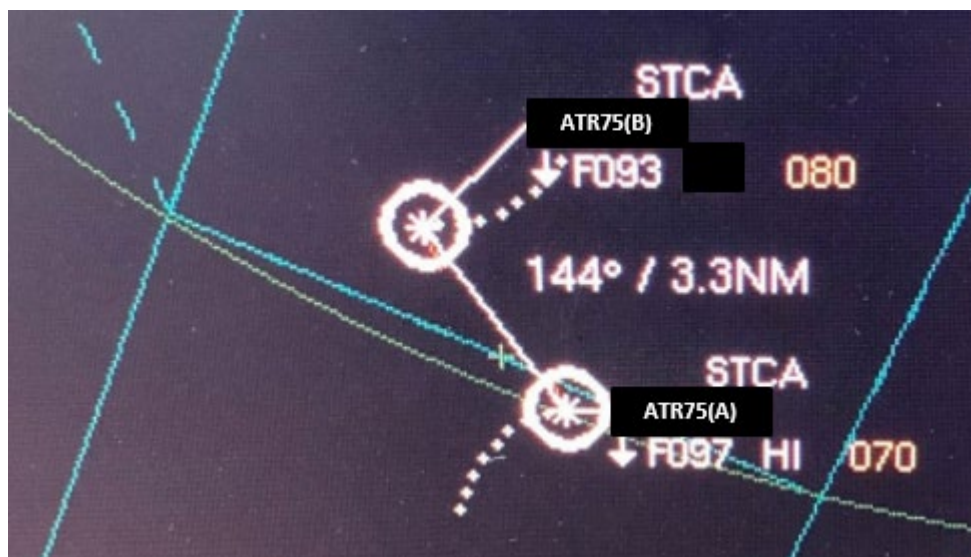
Figure 6

1545:15 [ATR75(A) C/S] reported clear of traffic.

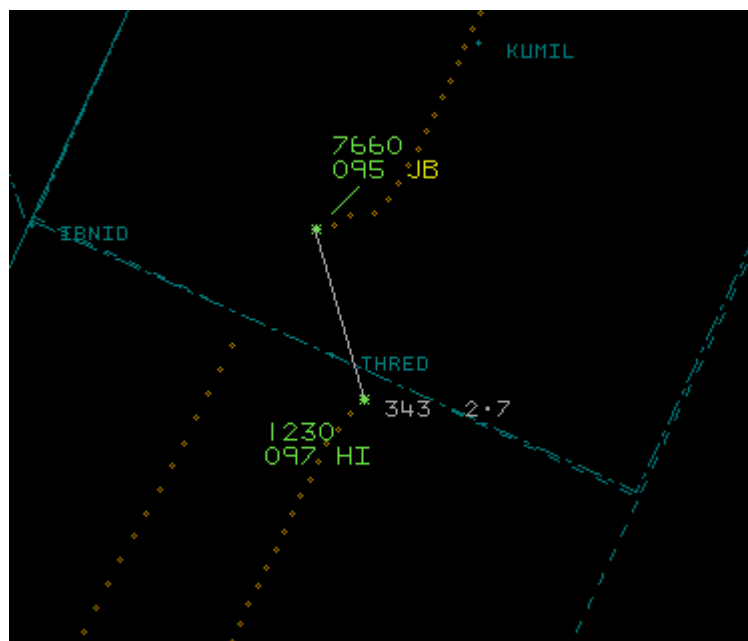
Figure 7 1545:10

[UKAB Secretariat Note: At 1545:10 radar separation had reduced further to 200ft and 2.7NM see Figure 7]

Continuing the radar replay to 1545:10 gave a radar separation of 200ft and 2.7NM, see Figure 7.
