AIRPROX REPORT No 2022042

Date: 28 Mar 2022 Time: 1502Z Position: 5351N 00109W Location: Leeds East ATZ

PART A: SUMMARY OF INFORMATION REPORTED TO UKAB

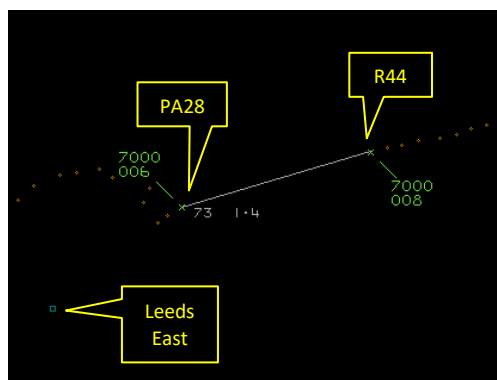
Figure 1 - R44 crossed into ATZ

An analysis of the NATS radars was undertaken and both of the aircraft were detected in the lead up to the Airprox. The R44, identifiable from the Mode S transponder, can be seen to have been inbound from the east, as reported by the pilot. The PA28, identifiable by cross reference with the pilot report, was first detected as it passed 600ft climbing out on runway heading. Shortly after this, at **1501:18** the R44 entered the ATZ and the aircraft were separated by 1.4NM horizontally and 200ft vertically, Figure 1. The PA28 pilot continued their climb-out and the R44 commenced a slight climb whilst the two aircraft converged, CPA occurred at **1501:46** with a separation measured at 0.1NM horizontally and 100ft vertically, Figure 2.
