AIRPROX REPORT No 2022038

Date: 26 Jan 2022 Time: ~1103Z Position: 5009N 00503W Location: Pendennis Point

PART A: SUMMARY OF INFORMATION REPORTED TO UKAB

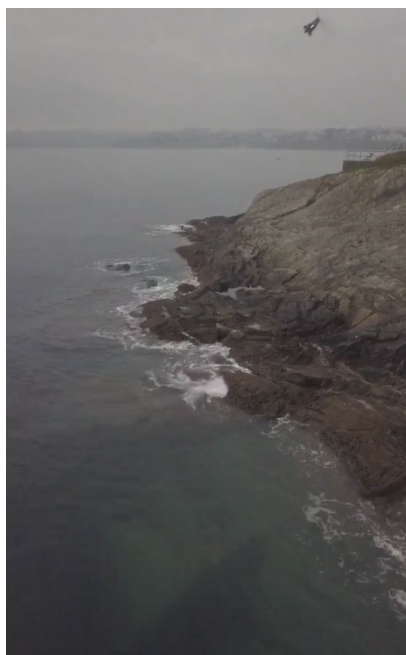
Figure 1 -
Puma flying towards drone

Due to the low-level nature of this event the aircraft were not detected on the NATS radar system. The Mavic Pro pilot has supplied the UKAB secretariat with GPS data and video information relating to the Airprox however, as the GPS elevation of the drone had been referenced to the TOLP, no altitude information is available. Track and altitude data for the Puma is not available. Figure 1 below is a still taken from the video supplied by the Mavic Pro pilot, taken from on-board the drone, in which the approach of the Puma can be seen to be above the level of the drone and inland of it. Figure 2 has been extracted from the same video and shows the Puma departing the location shortly afterwards. Although the Mavic Pro pilot contacted the local ATC unit in advance with details of their flight, OC Low Flying confirms that the information was not entered in to CADS and therefore would not have been available to the Puma crew through that system.
