AIRPROX REPORT No 2022036

Date: 24 Mar 2022 Time: ~1922Z Position: 5149N 00121W Location: Oxford visual circuit

PART A: SUMMARY OF INFORMATION REPORTED TO UKAB

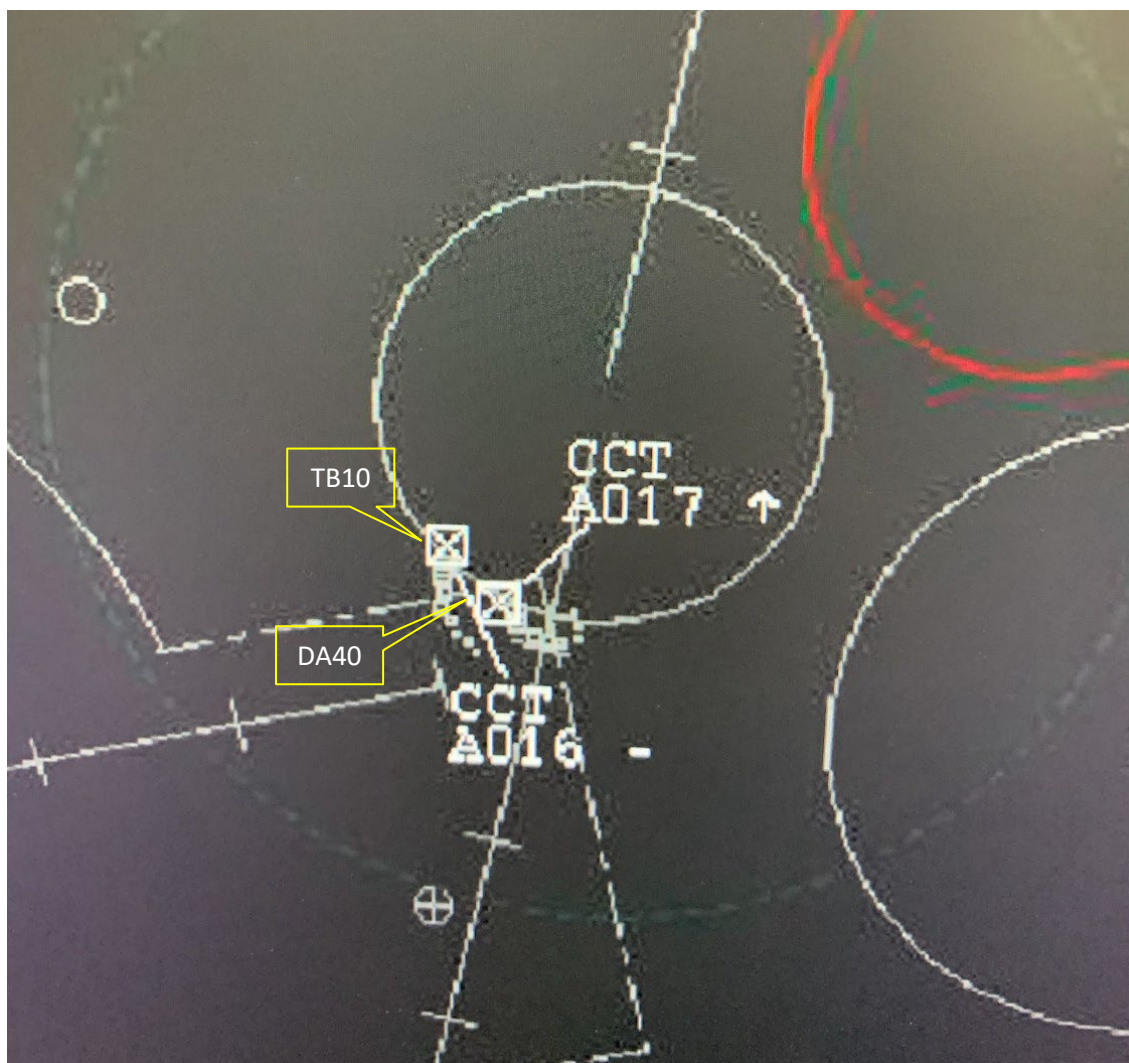
Figure 1 – CPA

The radar replay shows the CPA as approximately half a mile (see Figure 1). The pilot of the following DA40 seemingly had the [TB10] in sight at all times and therefore the risk of collision was deemed to be none. It's clear that the pilot of the DA40 was very concerned with the proximity of the Brize Norton CTR and was aware that, by complying with the controller's instructions, they would need to infringe this CTR; this was reported to the controller when downwind as, "*you might want to call Brize, we just infringed trying to keep out the way of that aircraft*".
