## AIRPROX REPORT No 2022047

Date: 09 Apr 2022 Time: 1128Z Position: 5134N 00119W Location: Harwell

### PART A: SUMMARY OF INFORMATION REPORTED TO UKAB

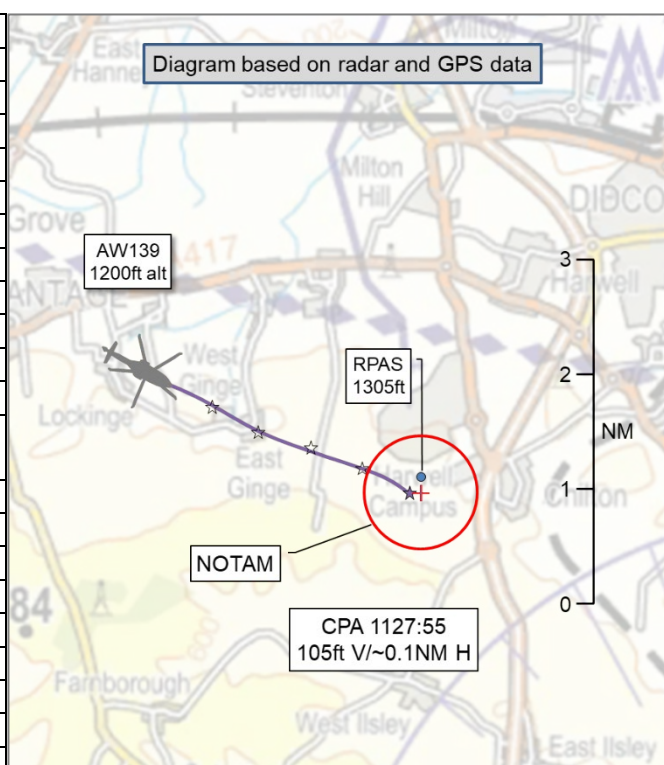
Recorded	Aircraft 1	Aircraft 2
Aircraft	RPAS	AW139
Operator	Civ UAS	Civ Comm
Airspace	London FIR	London FIR
Class	G	G
Rules	VLOS	VFR
Service	N/A	None <sup>1</sup>
Provider	N/A	N/A
Altitude/FL	1305ft	1200ft
Transponder	Not fitted	A, C, S+
Reported		
Colours	Black	Grey
Lighting	Green/red position lights	Anti-col
Conditions	VMC	VMC
Visibility	>10km	>10km
Altitude/FL	1300ft	1300ft
Altimeter	QNH (1016hPa)	QNH (NK hPa)
Heading	N/A	090°
Speed	0kt	140kt
ACAS/TAS	Not fitted	TCAS II
Alert	N/A	None
Separation at CPA		
Reported	~250ft V/200m H	Not seen
Recorded	105ft V/~0.1NM H

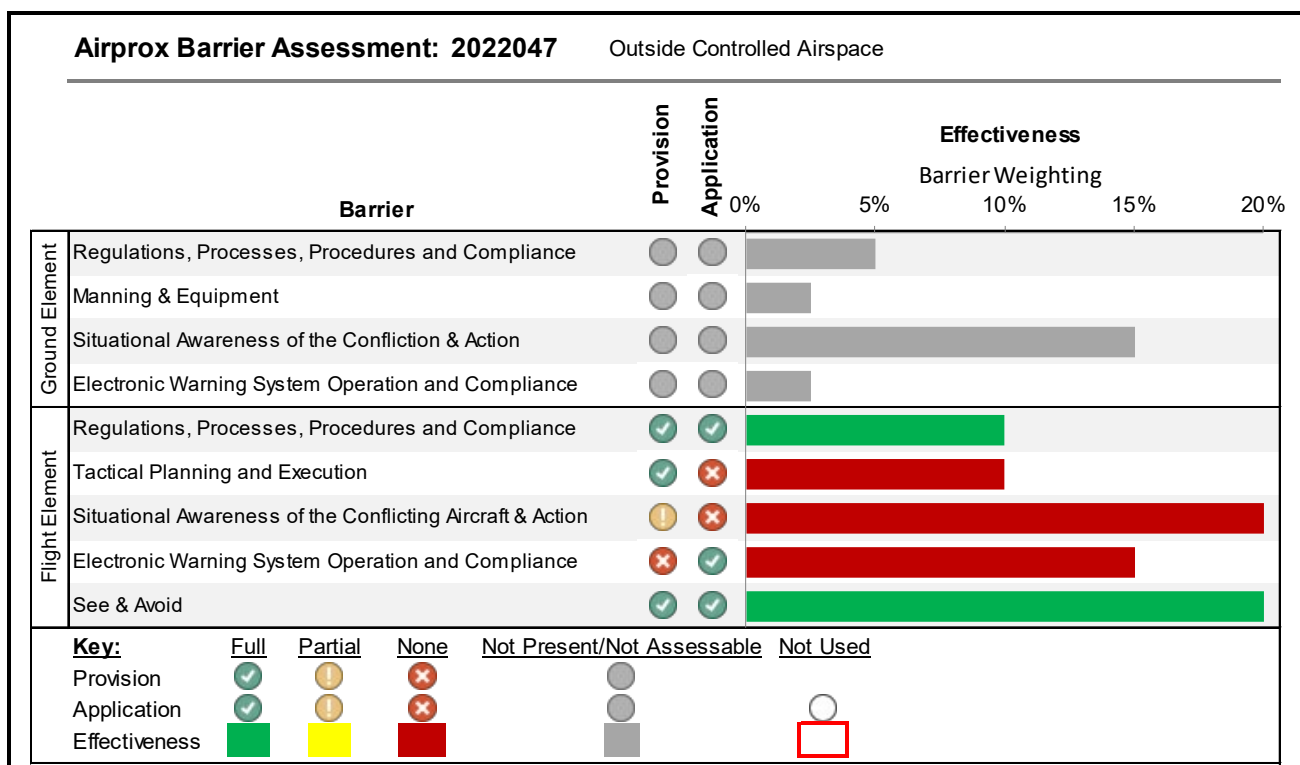
Safety Barrier Assessment<sup>4</sup>

**Tactical Planning and Execution** was assessed as **ineffective** because the AW139 pilot's flight path bisected the NOTAM'd area.

**Situational Awareness of the Conflicting Aircraft and Action** were assessed as **ineffective** because the AW139 pilot likely had no situational awareness of the RPAS presence.

**Electronic Warning System Operation and Compliance** were assessed as **ineffective** because the RPAS was not equipped with electronic conspicuity equipment.
