AIRPROX REPORT No 2022045

Date: 01 Apr 2022 Time: 1130Z Position: 5552N 00426W Location: Glasgow airport

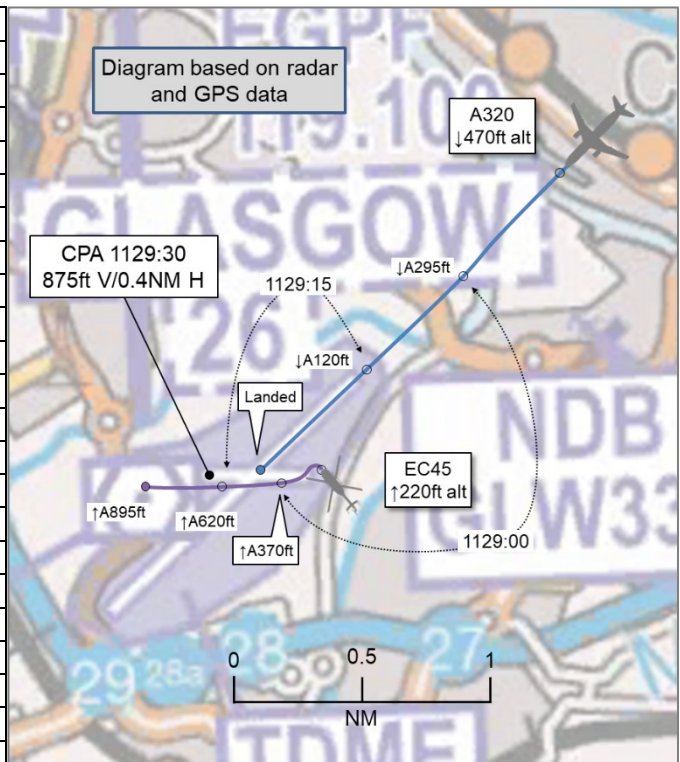
An analysis of the NATS radar replay was undertaken and, although both aircraft had been detected, the A320 disappeared in the final stages of the approach and the EC45 only became visible as it passed 700ft in the climb. Fortunately, the UKAB secretariat has been able to obtain GPS data that displays both aircraft throughout the event and this has been used to measure the CPA. The A320 pilot reported the Airprox to have occurred whilst they were making their final approach and the EC45 was in the vicinity of the runway however, the separation between the two aircraft continued to decrease after this point and CPA occurred when helicopter had cleared the runway and departed to the west and the A320 had been on the ground. In the vicinity of aerodromes, the standard separation minima may be reduced if adequate separation can be provided by the aerodrome controller when each aircraft is continuously visible to this controller.²

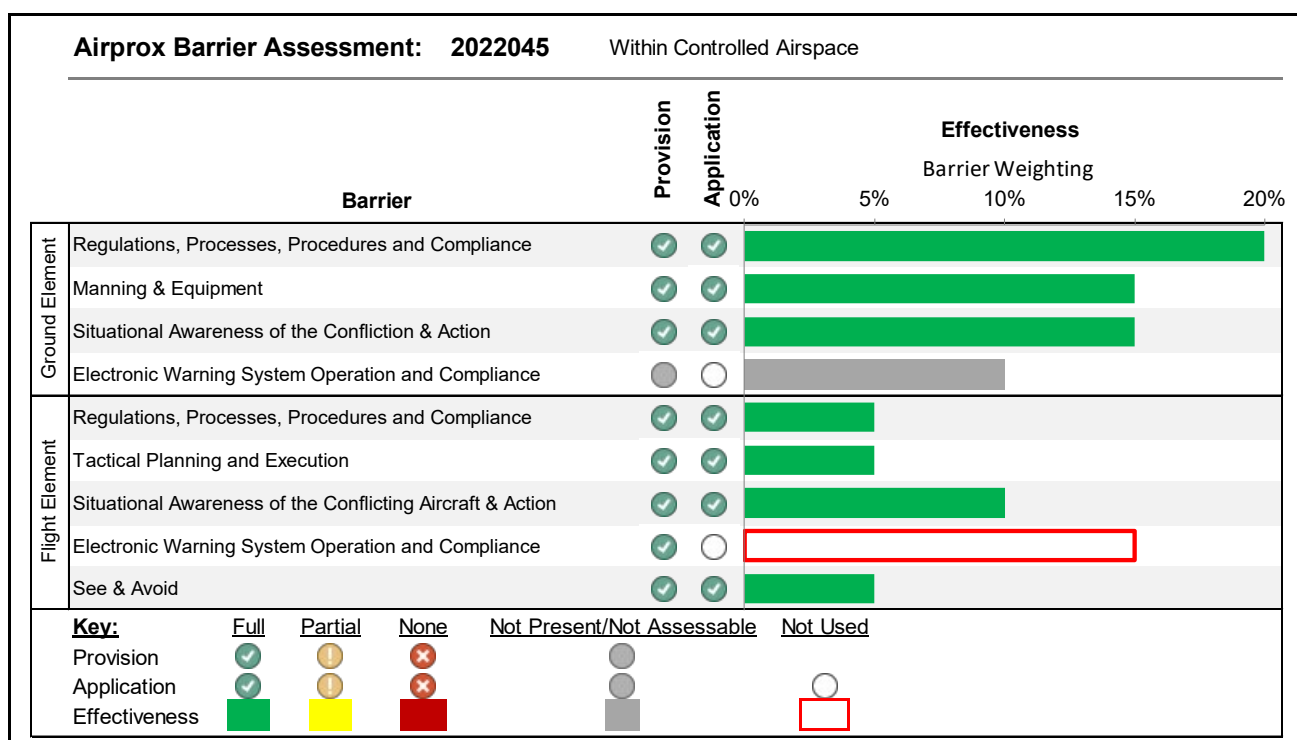
In assessing the effectiveness of the safety barriers associated with this incident, the Board concluded that the key factors had been that:

Electronic Warning System Operation and Compliance were assessed as **not used** because the proximity and geometry of the aircraft had been such that they had not met the alert criteria of the system
