AIRPROX REPORT No 2022056

Date: 08 Mar 2022 Time: 1529Z Position: 5132N 00038E Location: Southend

PART A: SUMMARY OF INFORMATION REPORTED TO UKAB

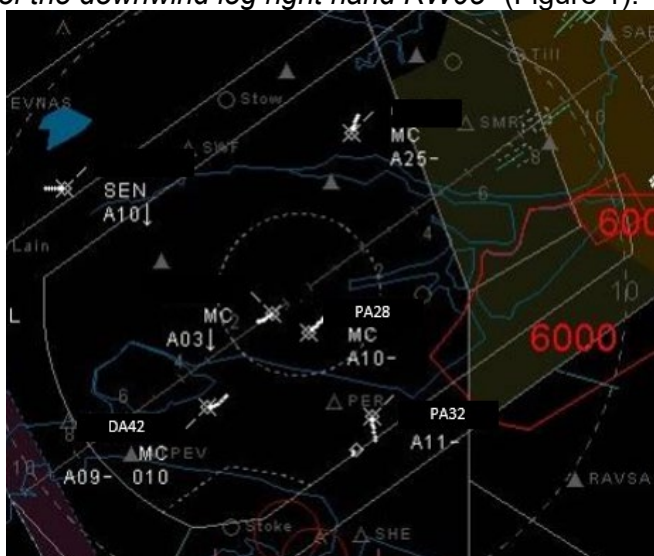
Figure 1

1525.40 [PA32 C/S] contacted TWR and was instructed: "[PA32 C/S] report, correction, join and report at the beginning of the downwind leg right hand RW05" (Figure 1).

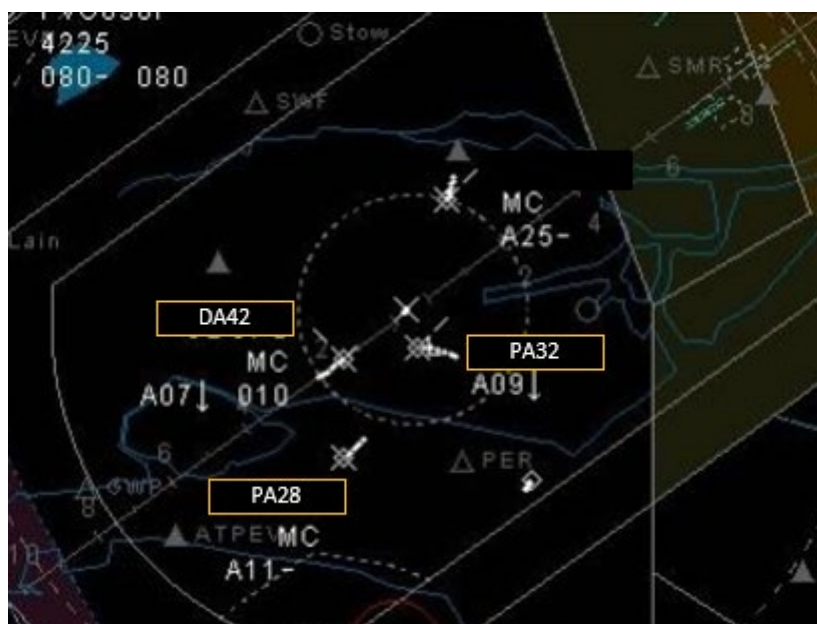
Figure 2

1527.36 TWR: "[PA28 C/S] you can turn base when you are ready"
 PA28: "[C/S] roger"
 PA32: "[C/S] late downwind"
 1527.53: "[PA32 C/S] roger continue downwind and you are very close to final approach, traffic on a 1 mile final is a DA42". (Figure 2)

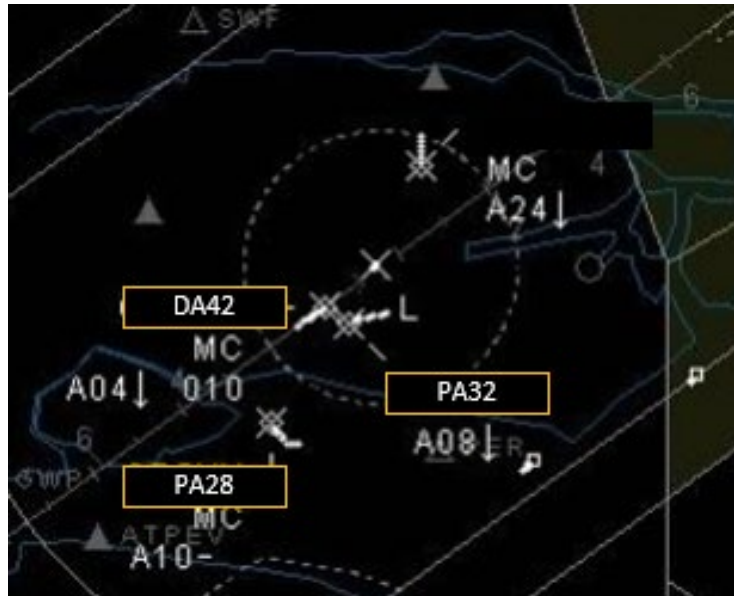
Figure 3

PA32: "Copy the traffic continue downwind [C/S]"
 TWR: "[DA42 C/S], surface wind 13011KT, RWY05 cleared touch and go"
 1528.10. TWR pre-noted [DA42 C/S]'s departure with RAD.
 [PA32 C/S] passed just south of DA42 opposite direction. (Figure 3).

[PA32 C/S] (indicating A08) passed approx 0.5NM south of [DA42 C/S] (indicating A04) in an opposite direction on a 1NM final RW05. (Fig 3). Based on initial Mode C verifications the aircraft were likely to have been approx 600ft apart.

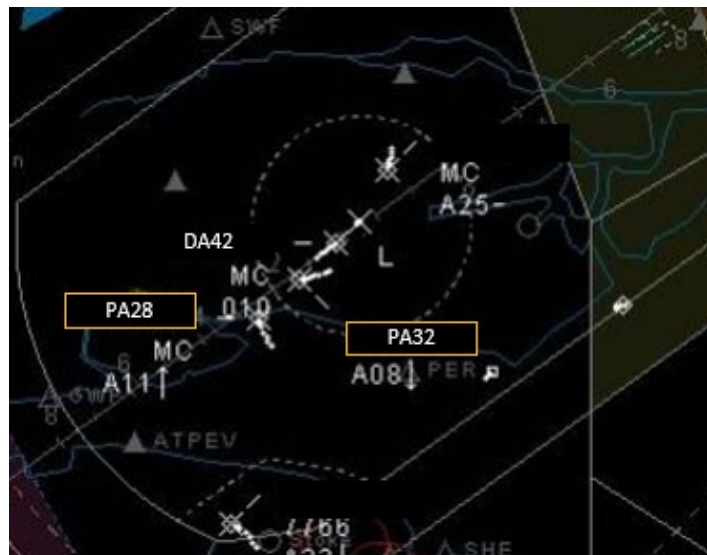
Figure 4

1528.35. TWR: "[PA32 C/S] turn southbound immediately you're on final approach".
 [PA32 C/S] indicating A08 passed 1.5NM final opposite direction to [PA28 C/S] indicating A11.
 (Figure 4)

It was about this time that the TWR controller got distracted with a conversation with the ATCA about the VCR blinds. The TWR controller then noticed how close [PA32 C/S] was to final approach and converging with [PA28 C/S]. (Fig 4). At this stage [PA32 C/S] had not been given their landing order or specific Traffic Information on [PA28 C/S]. Based on relative positions it would have been appropriate to have passed this information. The TWR controller told [PA32 C/S] that they were on final approach and instructed [PA32 C/S] to turn southbound immediately. The term "avoiding action" would also have been appropriate but was not used. Traffic Information was passed to [PA28 C/S] about [PA32 C/S] ("*1NM east of you at 800ft*"). (Fig 5). Despite reading back the instruction to turn southbound, [PA32 C/S] did not follow the instructions and then asked for them to be repeated. [PA32 C/S] was given Traffic Information about the PA28 ("*[PA32 C/S] essential traffic 1/2 mile west of you at 11 hundred feet*"). This resulted in [PA32 C/S] continuing on their track and flying through final approach in front of [PA28 C/S] in close proximity. [PA32 C/S] was indicating A08 and [PA28 C/S] indicating A11. (Fig 6). The pilot of [PA32 C/S] said they had traffic in sight. Again, based on initial Mode C verifications the aircraft were both likely to have been at the same (similar) level of 1000ft as [PA32 C/S] Mode C was under reading by 200 ft and [PA28 C/S] Mode C was over reading by 100ft. It is not known if the pilot of [PA28 C/S] ever visually acquired the PA32.

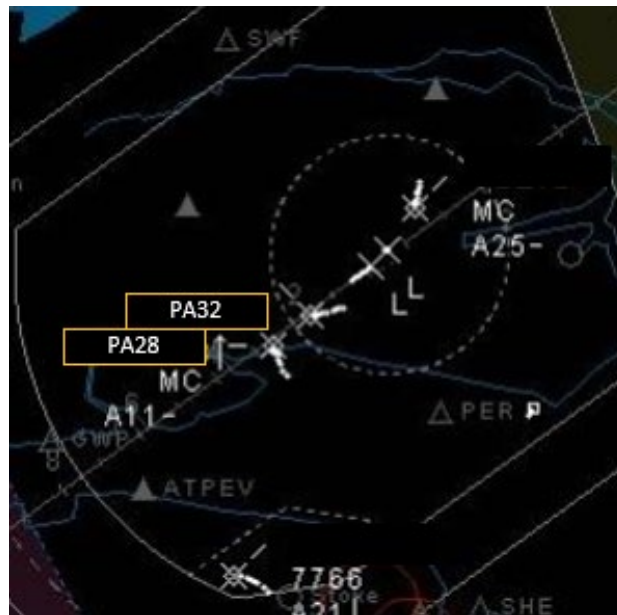
Figure 5

PA32: "turn southbound immediately [C/S]"
 1528.42. TWR: "[PA28 C/S] there is traffic 1 mile east of you at 800ft, he should be downwind right hand"
 PA28: "[C/S]"
 PA32: "Can you repeat instructions for [PA32 C/S]"
 1529.46 [PA32 C/S] indicating A08 passing 1.75NM final opposite direction to [PA28 C/S] indicating A11. (Fig 5).

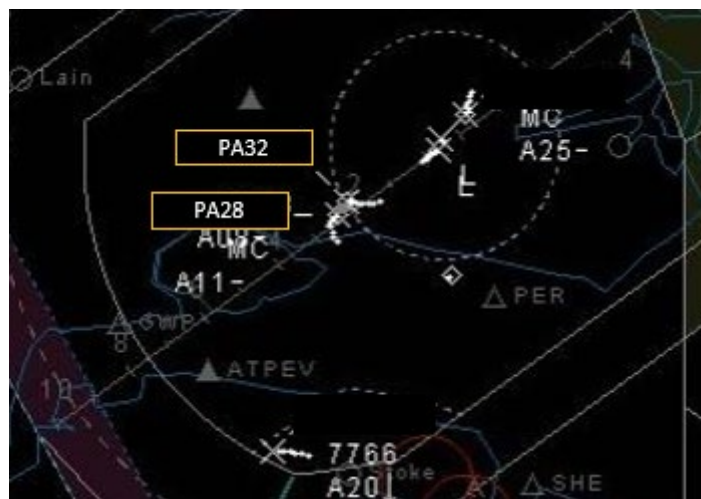
Figure 6

1529.01. TWR: "[PA32 C/S] essential traffic 1/2 mile west of you at 11 hundred feet".
 [PA32 C/S] indicating A08, [PA28 C/S] indicating A11 merge on a 2NM final (Figure 6).

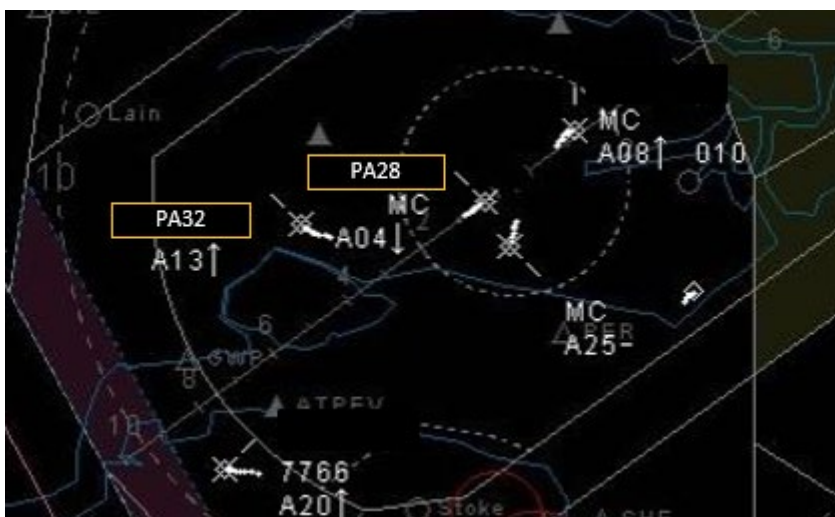
Figure 8

1530.19 [PA32 C/S] approx 4.5NM west of the airfield starting a right turn. Figure 8.

[PA32 C/S] continued on the westerly track and continued 'downwind'. When [PA32 C/S] was approx 3NM west of the airfield they were told to turn final when ready (Fig 7). Radar then co-ordinated a further inbound ([C/S redacted] 10NM range check on ILS approach) with TWR. TWR advised the radar controller "*I have no idea of what the 5053 is really doing, just be careful, I'll let you know if he goes weird again*". At this stage no positive control or plan had been formulated to ensure that [PA32 C/S] would not conflict with the ILS traffic. [PA32 C/S] subsequently made a right turn back to the airfield approx 5NM west indicating A13. (Fig 8)

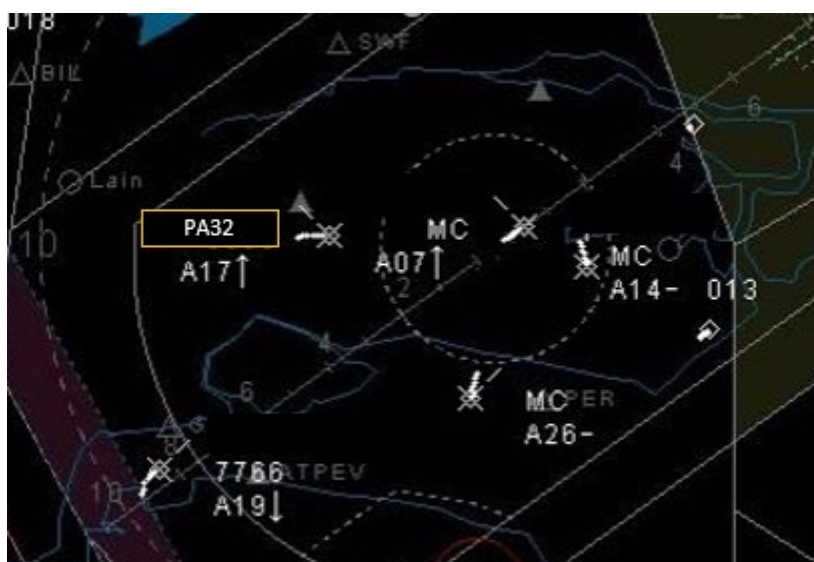
Figure 9

1531.39 [PA32 C/S] 3NM west of airfield indicating A17 tracking eastbound. (Figure 9).

TWR then advised: "*[PA32 C/S] your current position is now 4 miles west of the airfield, report final*". [PA32 C/S] then positioned towards a right base and at 3NM west indicating A17 on Mode C (Fig 9). [PA32 C/S] was cleared to land whilst on right base approx 1.2NM from the airfield indicating A07. The pilot subsequently initiated a missed approach and continued for a left-hand circuit and landed without incident.
