## AIRPROX REPORT No 2022052

Date: 15 Apr 2022 Time: 1131Z Position: 5113N 00104W Location: 1.5NM NW of Lasham

### PART A: SUMMARY OF INFORMATION REPORTED TO UKAB

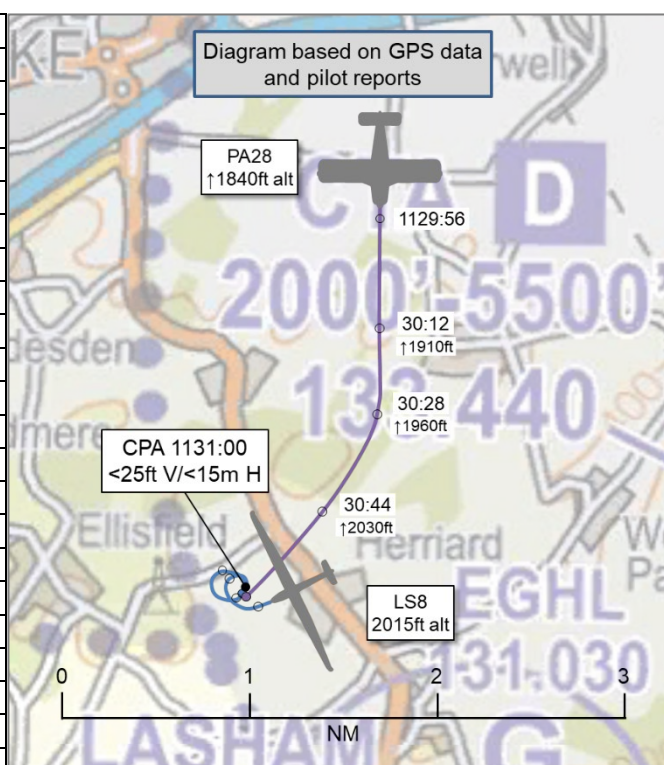
Recorded	Aircraft 1	Aircraft 2
Aircraft	LS8	PA28
Operator	Civ Glid	Civ FW
Airspace	Odiham MATZ	Odiham MATZ
Class	G	G
Rules	VFR	VFR
Service	Listening Out	Basic
Provider	Lasham Gliders	Farnborough
Altitude/FL	2015ft	2030ft
Transponder	Off	A
Reported		
Colours	White	White, green
Lighting	Nil	Beacon
Conditions	VMC	VMC
Visibility	>10km	>10km
Altitude/FL	2020ft	2100ft
Altimeter	QNH (1027hPa)	QNH (NK hPa)
Heading	180°	180°
Speed	50kt	130kt
ACAS/TAS	PowerFLARM	Not fitted
Alert	None	N/A
Separation at CPA		
Reported	50ft V/0m H	NK V/NK H
Recorded	<25ft V/<15m H <sup>1</sup>

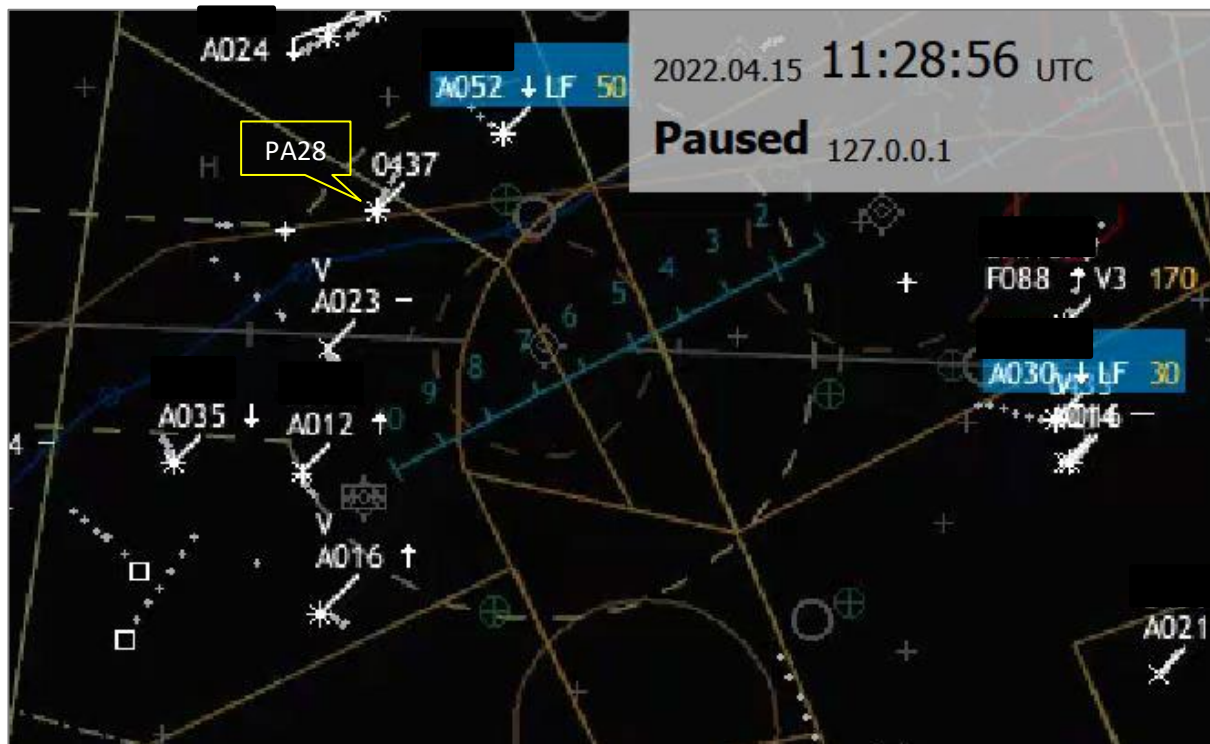
At 1128 [the PA28] could be seen inside the Odiham MATZ squawking 0437. At this time, the track of [the PA28] appeared to be SW and would track west of Lasham (see Figure 1).

Figure 1 – PA28 inside Odiham MATZ on a south-westerly track

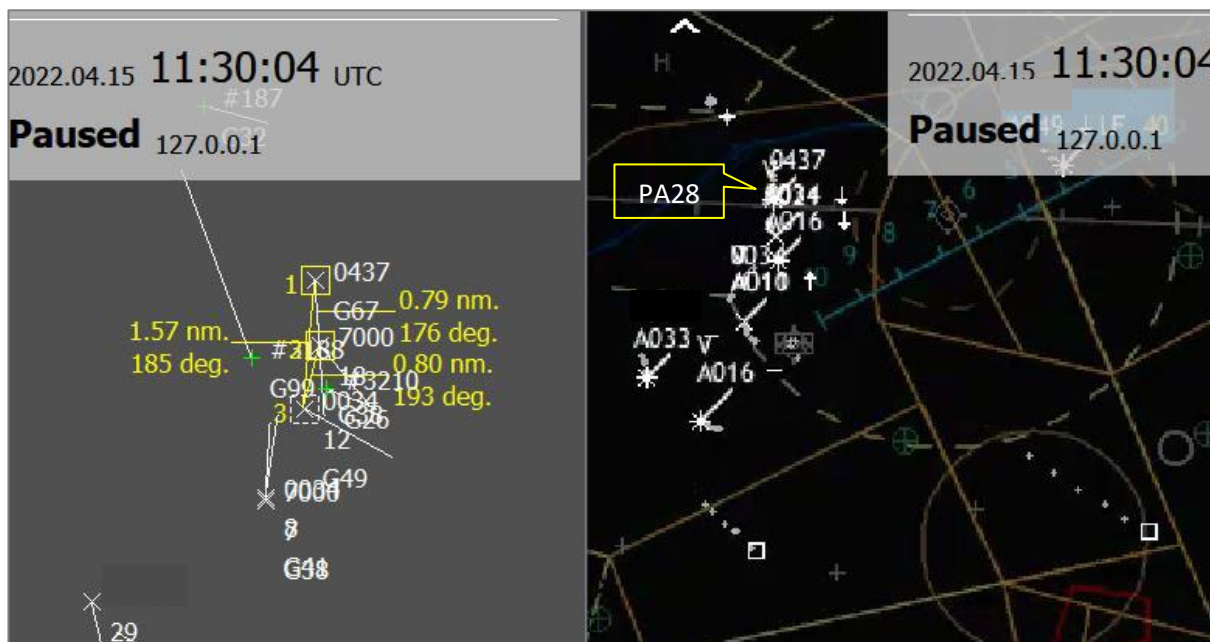
Figure 2 – 1130:04

At 1130 [the PA28]'s squawk could be seen operating in close proximity to a considerable number of transponding and non-transponding aircraft as its route took it close to the Lasham overhead but to the west of it by approximately 1 mile.

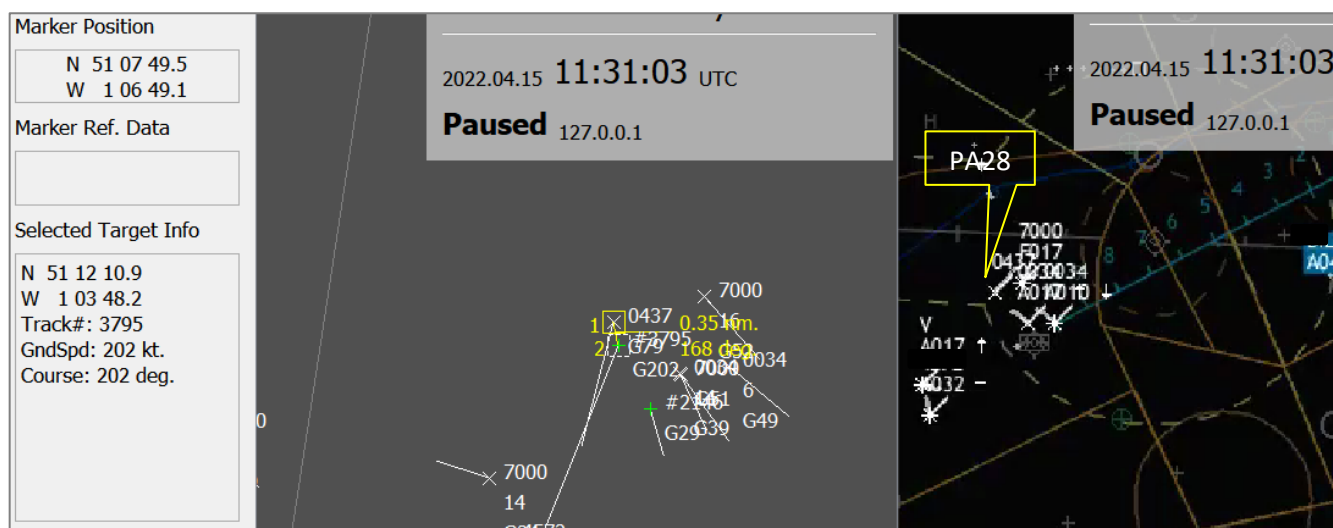
Figure 5 – 1131:03

At 1131 [The PA28] came into close proximity with what is believed to be gliding traffic – track number 3795 (Figure 5).

As can be seen from the density and nature of traffic at Lasham at this time, it has not been possible to positively identify the conflict as reported in the submitted Airprox.
