AIRPROX REPORT No 2022050

Date: 14 Apr 2022 Time: 1328Z Position: 5247N 00044E Location: IVO West Raynham

PART A: SUMMARY OF INFORMATION REPORTED TO UKAB

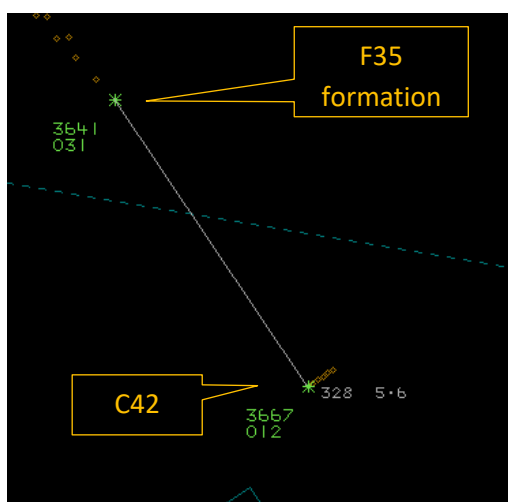
Figure 1:
The F35 pilot was given descent as required.

Shortly after handover from Swanwick Mil, the F35 pilot was given the QFE and descent as required for their visual recovery. Separation was measured at 5.6NM and 1900ft.

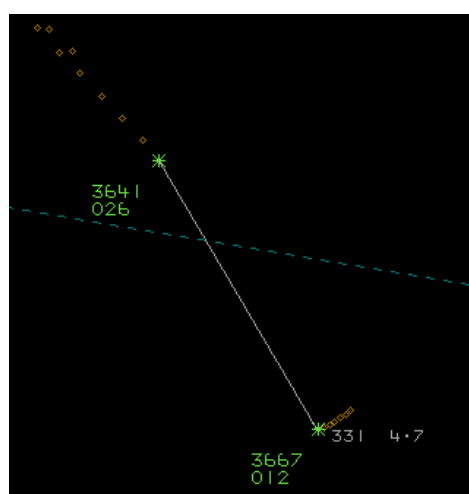
Figure 2:
Traffic Information was passed to the F35 pilot regarding the C42.

Six seconds after the descent approval was given, the Marham Approach controller passed Traffic Information to the F35 pilot regarding the C42. Separation decreased to 4.7NM and 1400ft. The F35 lead pilot acknowledged the Traffic Information but did not report visual.

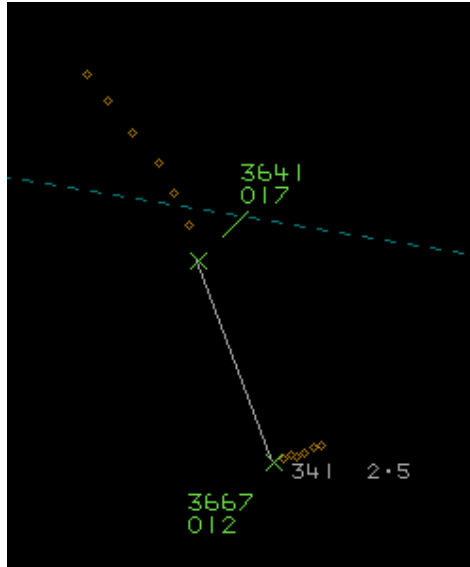
Figure 3:

Traffic Information is passed to the F35 regarding other conflicting traffic.

Twenty seconds later the Approach controller provided further Traffic Information relating to another conflicting track that was transiting beneath the MATZ stub, approximately 8NM south of the F35 formation position. Separation decreased to 2.5NM and 500ft.

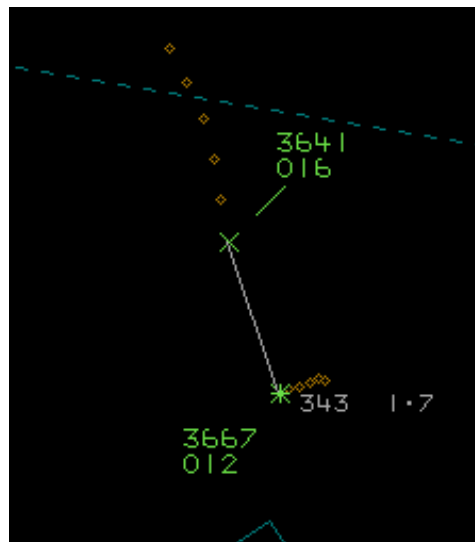
Figure 4:

Traffic Information on the other conflicting traffic is updated.

Nine seconds after the Traffic Information had been passed the Approach controller updated the height which was missed from the initial Traffic Information report. Separation decreased to 1.7NM and 400ft (Figure 4). CPA was measured at 0.2NM and 200ft.
