AIRPROX REPORT No 2022065

Date: 03 May 2022 Time: 1556Z Position: 5149N 00046W Location: 1.5NM NW Halton airfield

PART A: SUMMARY OF INFORMATION REPORTED TO UKAB

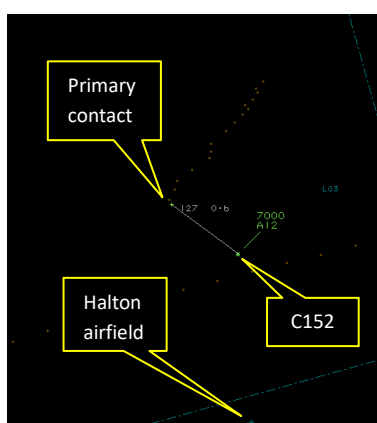
The C152 was first detected at 1555:20 as it passed 1200ft climbing out from RW02 at Halton on the crosswind leg. At this time the primary contact was to the northwest of the C152 at a range of 0.6NM (Figure 1).

Figure 1 – C152 first detected.

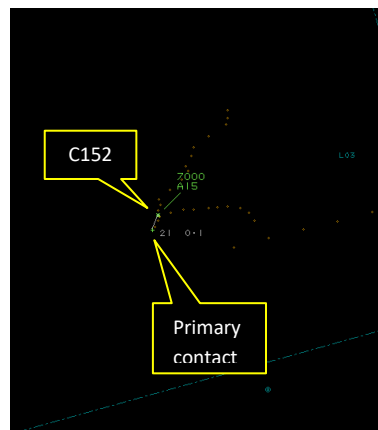
The C152 was seen to continue the climb into the circuit whilst the primary contact tracked south-southwest. The C152 crossed behind the primary contact at 1555:58. The horizontal separation at this time was 0.1NM (Figure 2).

Figure 2 – C152 crossed behind primary contact.

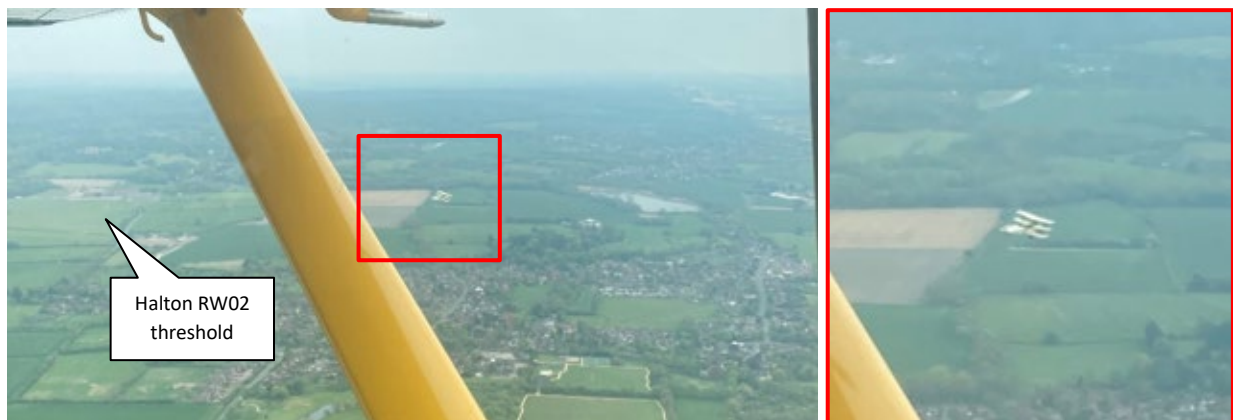
Shortly afterwards, the C152 pilot took a photograph of the Triplane which appeared to be below the C152 and between the C152 and Halton airfield (Figure 3).

Figure 3 – Photograph taken by C152 pilot.

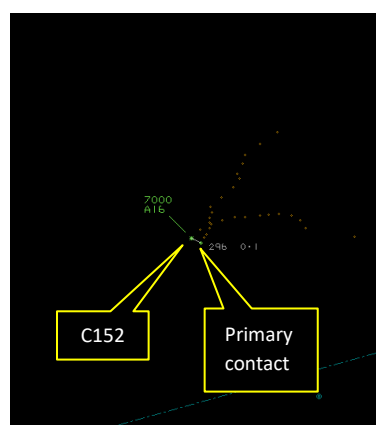
After crossing behind the primary track, the C152 was seen to overtake it. The measured horizontal separation remained at 0.1NM; however, on the radar replay the two returns were visually at their closest at 1556:06, the time of CPA (Figure 4).

Figure 4 – CPA.
