## AIRPROX REPORT No 2022055

Date: 19 Apr 2022 Time: 1300Z Position: 5149N 00044W Location: Halton ATZ

### PART A: SUMMARY OF INFORMATION REPORTED TO UKAB

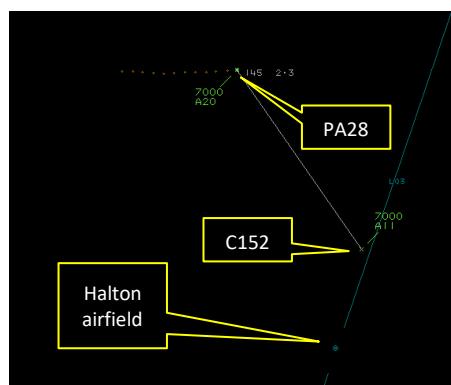
Figure 1 – 1259:02

An analysis of the NATS radar replay was undertaken and both of the aircraft had been detected and identified using Mode-S information. The C152 was first detected on the extended centreline for RW02 as it climbed-out of Halton at 1259:02, passing 1100ft. At this point the PA28 was tracking eastwards and was separated from the C152 by 2.3NM horizontally and 900ft vertically (Figure 1).

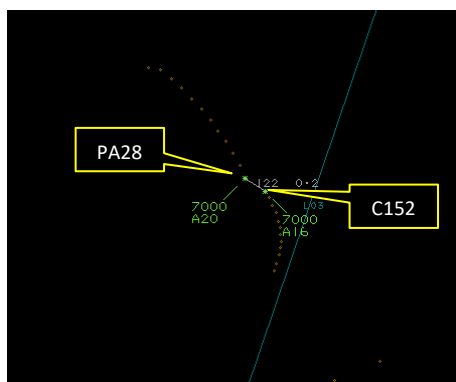
Figure 2 – 1259:58

Both aircraft continued on their respective trajectories until 1259:15, when the PA28 pilot altered course onto a more south-easterly track; at this time the separation was 2NM horizontally and 800ft vertically. Shortly afterwards, the C152 pilot turned on to a climbing crosswind leg whilst the PA28 pilot, maintaining track and 2000ft altitude, entered the ATZ at 1259:58, the upper-limit of which is 2389ft, at which point the separation had decreased to 0.2NM horizontally and 400ft vertically (Figure 2). On the next radar sweep, at 1300:02, the aircraft had started to diverge and so it is assessed that the separation at CPA would have been less than indicated and, as such, it has been recorded as <0.1NM horizontally and 400ft vertically (Figure 3).
