AIRPROX REPORT No 2022059

Date: 26 Apr 2022 Time: 1522Z Position: 5125N 00201W Location: 4NM N Lyneham

PART A: SUMMARY OF INFORMATION REPORTED TO UKAB

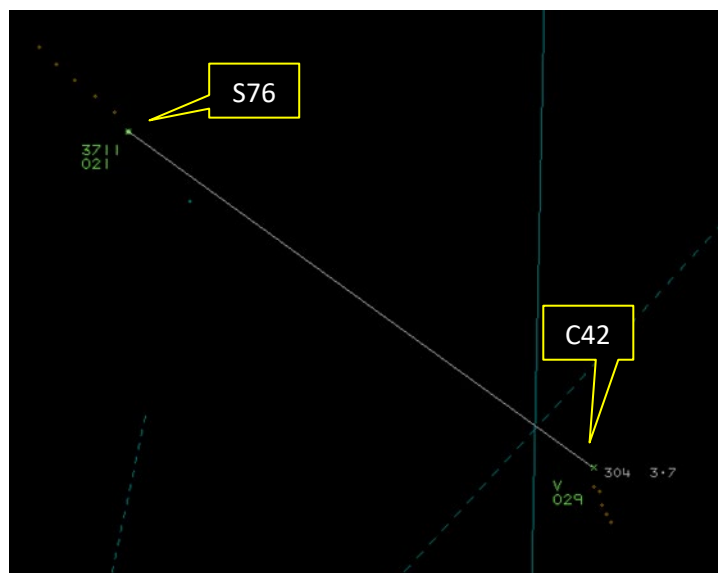
Figure 1: Handover commenced to Benson.

Forty-four seconds after the S76 pilot was identified and placed under a reduced Traffic Service, the Brize controller commenced a telephone call to Benson to handover another aircraft. During this period the Brize LARS controller confirmed the type of approach for the S76 at [destination airfield] and confirmed the intentions of the other aircraft to be handed over. Separation was measured as 3.7NM and 800ft (Figure 1).

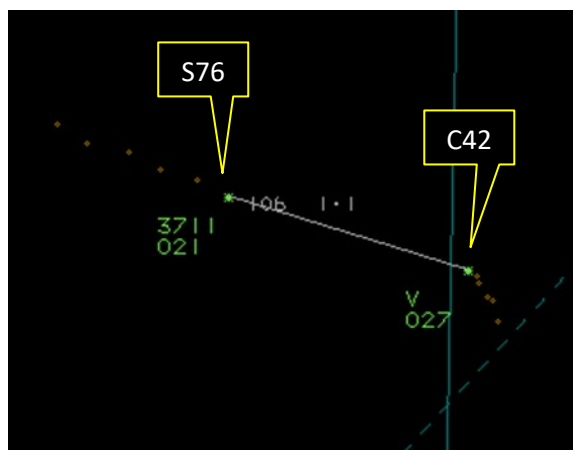
Figure 2.

Fifty seconds later the handover was complete to Benson on the other aircraft, including releasing the aircraft from the frequency. During the call with Benson an additional aircraft freecalled the Brize LARS controller requesting a LARS service advising they would also require a MATZ crossing. Immediately after releasing the handover aircraft from their frequency, the Brize LARS controller requested the freecalling aircraft to pass their details again. Separation decreased to 1.1NM and 600ft (Figure 2).

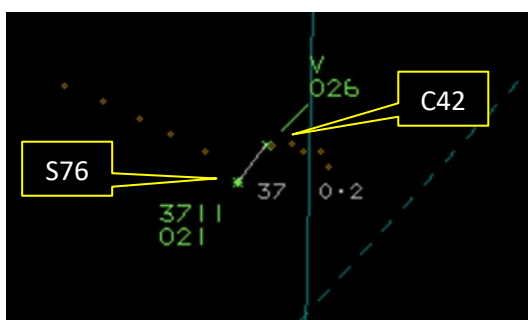
Figure 3: Traffic Information passed and CPA.

Eighteen seconds after the freecalling aircraft began to pass their details, the Brize LARS controller passed Traffic Information to the S76 pilot, to which the S76 pilot responded that they were visual with the C42. Separation was measured at 0.2NM and 500ft (Figure 3).

The projected paths of the C42 and S76 were such that a conflict was evident from the point at which the S76 pilot was placed under a reduced Traffic Service. The Brize LARS controller could have passed Traffic Information earlier however, opted to conduct other tasks which resulted in the Traffic Information being passed later than expected. The Supervisor was conducting a handover at the time of the incident, and it is unknown whether the Brize LARS controller felt that they could request support. Had the Brize LARS controller requested additional support, or had the Supervisor witnessed the tasks building up, then they may have been able to offer support, increasing the capacity of the Brize LARS controller to allow them to pass Traffic Information earlier.
